# NOTE ON POST DIASER LANDSLIDE STUDIES IN MALAPPUAM AND PALAKKAD DISTRICTS, KERALA DURING JUNE 2018

(Field Season: 2018 - 19, Item No.: M4SI/NC/SR/SU-KRL/2018/21108)

Sachin R., Superintending Geologist &  
Vishnu C. S., Senior Geologist

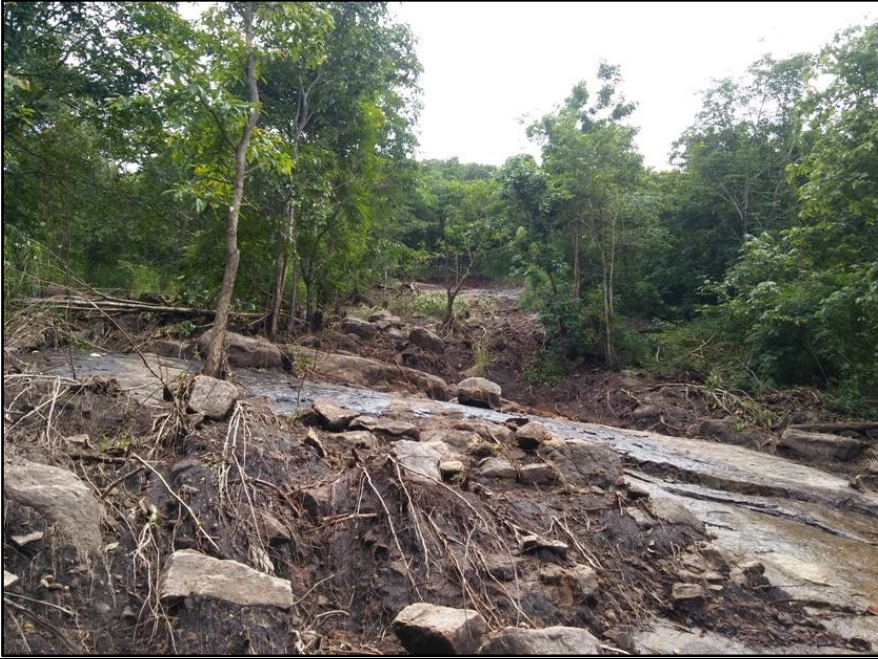
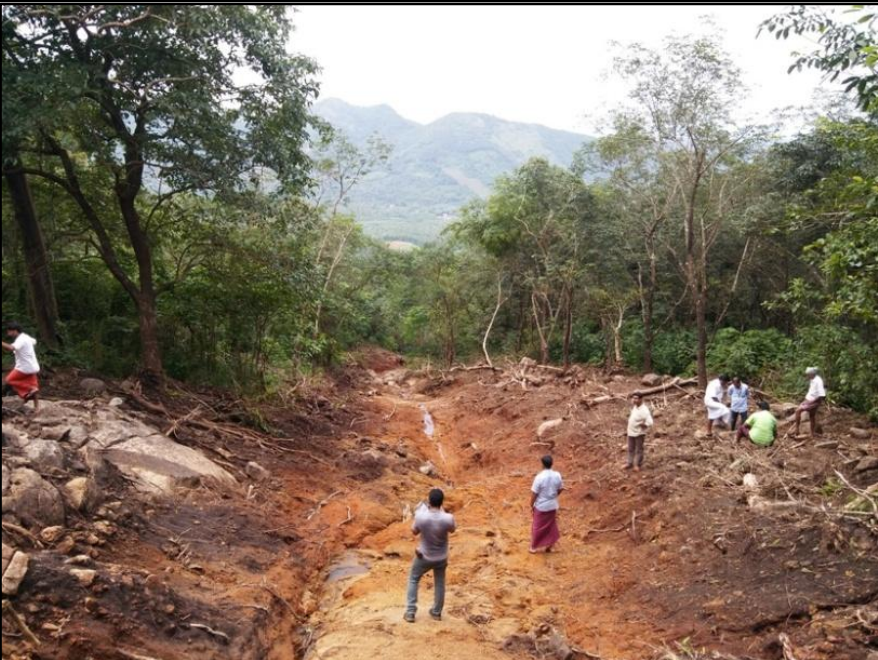
### Slide-1:

No	Field	Description
1	Slide No.	: <i>KRL/MPM/58A3/2018/01</i>
2	State	: <i>Kerala</i>
3	District	: <i>Malappuram</i>
4	Toposheet No.	: <i>58A/03</i>
5	Name of the slide	: <i>Perakamanna</i>
6	NH/SH/Locality	: <i>West Chathalloor- Odanpara, Ernad Taluk</i>
7	Latitude	: <i>11.26246° N</i>
8	Longitude	: <i>76.11503° E</i>
9	Length	: <i>650 m</i>
10	Width	: <i>~20 m</i>

11	Height	:	<i>230 m</i>
12	Area	:	
13	Depth	:	<i>3 m</i>
14	Volume	:	
15	Run out distance	:	<i>300 m</i>
16	Type of Material	:	<i>rock-cum- debris</i>
17	Type of movement	:	<i>Flows</i>
18	Rate of movement	:	<i>Very Rapid</i>
19	Activity	:	<i>Suspended</i>
20	Distribution	:	<i>Confined</i>
21	Style	:	<i>Complex</i>
22	Failure mechanism	:	<i>Initiated as shallow planar failure</i>
23	History	:	<i>14<sup>th</sup> June, 2018 at 03:00 hrs.</i>
24	Geomorphology	:	<i>Moderately dissected slope</i>
25	Geology/Lithology	:	<i>Charnockite</i>
26	Structure	:	<i>J1(Foliation &amp; parallel Joint): N80°E- S80°W / sub-vertical to vertical dip, J2:N30°W- S30°E/80° NE, J3:N15°E- S15°W/65°SE, J3:N20°E – S20°W/60°NW</i>
27	Landuse/ Landcover	:	<i>Rubber plantation. Area upslope of the scar at the source area is forested</i>
28	Hydrological condition	:	<i>Flowing at toe area and damp at source area</i>
29	Triggering Factor	:	<i>Rainfall</i>

30	Death of persons	:	<i>Nil</i>
31	People affected	:	<i>Residents of 3 houses on the runout path were evacuated just before the slide. Debris accumulated in the compounds of these houses.</i>
32	Livestock Loss	:	<i>Nil</i>
33	Communication	:	<i>Road blocked</i>
34	Infrastructure	:	<i>2 dug wells filled up by the debris. Electric pole and lines were damaged.</i>
35	Agriculture/forest/Barren	:	<i>Agriculture (High Height Plantation)</i>
36	Geo-scientific Causes	:	<i>Natural slope had been benched for rubber cultivation thereby blocking natural drainage. Heavy antecedent rainfall for 3 days preceding the event resulted in building up of excess pore water pressure and reduction of strength on saturation. Landslide was initiated as planar failure along rock-overburden contact and then transformed into debris flow in sequence.</i>
37	Remedial measures	:	<i>The overburden material has been stripped off exposing bed rock along the runout path. Dislodged boulders along the runout path/nala may be removed. Natural drainage paths may not be encroached.</i>

40	Summary/Abstract	:	<p><i>A debris flow occurred on 14<sup>th</sup> June, 2018 at 03:00 hrs at Perakamanna, West Chathaloor in Malappuram District. Natural slope at the area had been benched for rubber cultivation thereby blocking natural drainage. Heavy antecedent rainfall for 3 days preceding the event resulted in building up of excess pore water pressure and reduction of strength on saturation. Landslide was initiated as planar failure along rock-overburden contact and then transformed into debris flow in sequence. The overburden material has been stripped off exposing bed rock along the runout path. Dislodged boulders along the runout path/nala may be removed. Natural drainage paths may not be encroached.</i></p>
41	Date of Reporting	:	03/07/2018
42	Landslide Category	:	III

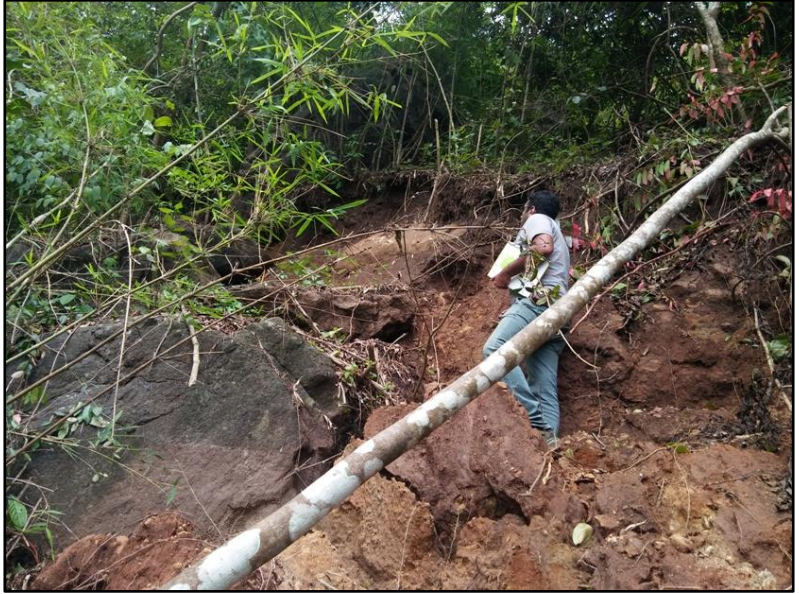
**Slide-2:**

No	Field		Description
1	Slide No.	:	<i>KRL/MPM/58A3/2018/02</i>
2	State	:	<i>Kerala</i>
3	District		<i>Malappuram</i>
4	Toposheet No.	:	<i>58A/03</i>
5	Name of the slide	:	<i>Cholara</i>
6	NH/SH/Locality	:	<i>Cholara-Karinchola, Ernad Taluk</i>
7	Latitude	:	<i>11.26152° N</i>
8	Longitude	:	<i>76.13833° E</i>
9	Length	:	<i>15 m</i>
10	Width	:	<i>~20 m</i>
11	Height	:	<i>15 m</i>
12	Area	:	
13	Depth	:	<i>2-3 m</i>
14	Volume	:	
15	Run out distance	:	
16	Type of Material	:	<i>Debris</i>
17	Type of movement	:	<i>Slide</i>
18	Rate of movement	:	<i>Rapid</i>
19	Activity	:	<i>Suspended</i>
20	Distribution	:	<i>Retrogressive and widening</i>
21	Style	:	<i>Single</i>
22	Failure mechanism	:	<i>Shallow Rotational failure</i>
23	History	:	<i>14<sup>th</sup> June, 2018</i>
24	Geomorphology	:	<i>Moderately dissected slope</i>
25	Geology/Lithology	:	<i>Charnockite</i>
26	Structure	:	<i>Foliation:N55°E-S55°W/70°S</i>
27	Landuse/ Landcover	:	<i>Forest</i>

28	Hydrological condition	:	<i>Damp</i>
29	Triggering Factor	:	<i>Rainfall</i>
30	Death of persons	:	<i>Nil</i>
31	People affected	:	<i>Nil</i>
32	Livestock Loss	:	<i>Nil</i>
33	Communication	:	<i>Road (unmetalled) blocked</i>
34	Infrastructure	:	<i>Electric line damaged</i>
35	Agriculture/forest/Barren	:	<i>Forest</i>
36	Geo-scientific Causes	:	<i>Toe was removed during widening of the road about 5 years back leaving a vertical cut with no lateral support. Heavy rainfall resulted in reduction of strength due to saturation and subsequent failure.</i>
37	Remedial measures	:	<i>Easing of the slope may be carried out and removal of precariously resting boulders upslope of the crown is recommended. Heavy rains will erode the base resulting in toppling of these boulders which will endanger houses located downslope of the road.</i>
38	Remarks, if any

40	Summary/Abstract	:	<i>A debris slide due to cut slope failure occurred on 14<sup>th</sup> June, 2018 at Cholara-Karinchola road in Ernad taluk, Malappuram district. Toe was removed during widening of the unmetalled road about 5 years back leaving a vertical cut with no lateral support. Heavy rainfall resulted in reduction of strength due to saturation and subsequent failure. Easing of the slope may be carried out and removal of precariously resting boulders upslope of the crown is recommended.</i>
41	Date of Reporting	:	03/07/2018
42	Landslide Category	:	III

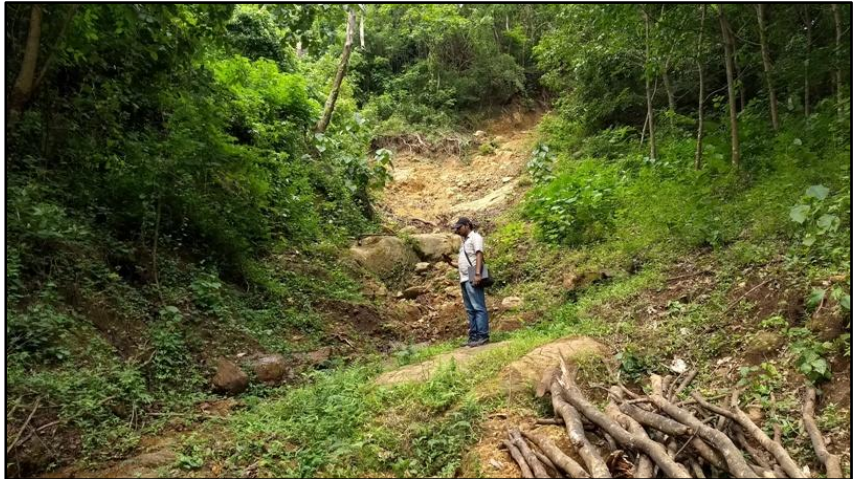
### Slide-3:

No	Field		Description
1	Slide No.	:	KRL/MPM/58A3/2018/03
2	State	:	Kerala
3	District		Malappuram
4	Toposheet No.	:	58A/03
5	Name of the slide	:	Kappakallu
6	NH/SH/Locality	:	East Chathaloor, Ernad Taluk
7	Latitude	:	11.25106° N
8	Longitude	:	76.13881° E
9	Length	:	50 m
10	Width	:	~12 m
11	Height	:	25 m
12	Area	:	
13	Depth	:	2-3 m
14	Volume	:	
15	Run out distance	:	50 m
16	Type of Material	:	Rock cum Debris
17	Type of movement	:	Flow
18	Rate of movement	:	Very Rapid
19	Activity	:	Suspended
20	Distribution	:	Confined
21	Style	:	Complex
22	Failure mechanism	:	Shallow planar failure. (Initiated as rock slide)

23	History	:	<i>September, 2017</i>
24	Geomorphology	:	<i>Moderately dissected slope</i>
25	Geology/Lithology	:	<i>Charnockite</i>
26	Structure	:	<i>J1(Foliation &amp; parallel Joint): N80°E- S80°W / sub-vertical to vertical dip, J2:N30°W- S30°E/80° NE</i>
27	Landuse/ Landcover	:	<i>Forest</i>
28	Hydrological condition	:	<i>Damp</i>
29	Triggering Factor	:	<i>Rainfall</i>
30	Death of persons	:	<i>Nil</i>
31	People affected	:	<i>Nil</i>
32	Livestock Loss	:	<i>Nil</i>
33	Communication	:	<i>Road (unmetalled) blocked</i>
34	Infrastructure	:	<i>Debris accumulated in the compound of one house.</i>
35	Agriculture/forest/Barren	:	<i>Forest</i>
36	Geo-scientific Causes	:	<i>Initiated as rock slide due to root wedging and built up of cleft water pressure. It transformed into debris flow resulting in runout of debris material up to a nala down slope.</i>
37	Remedial measures	:	<i>The overburden material has been stripped off exposing bed rock along the run out path. Dislodged boulders along the runout path/nala may be removed.</i>

40	Summary/Abstract	:	<i>In September 2017, a debris flow occurred at Kappakallu in East Chathalloor, Ernad Taluk, Malappuram district. The slide was initiated as rock slide due to root wedging and built up of cleft water pressure. It transformed into debris flow resulting in runout of debris material up to a nala downslope. The overburden material has been stripped off exposing bed rock along the runout path. Dislodged boulders along the runout path/nala may be removed.</i>
41	Date of Reporting	:	<i>03/07/2018</i>
42	Landslide Category	:	<i>III</i>

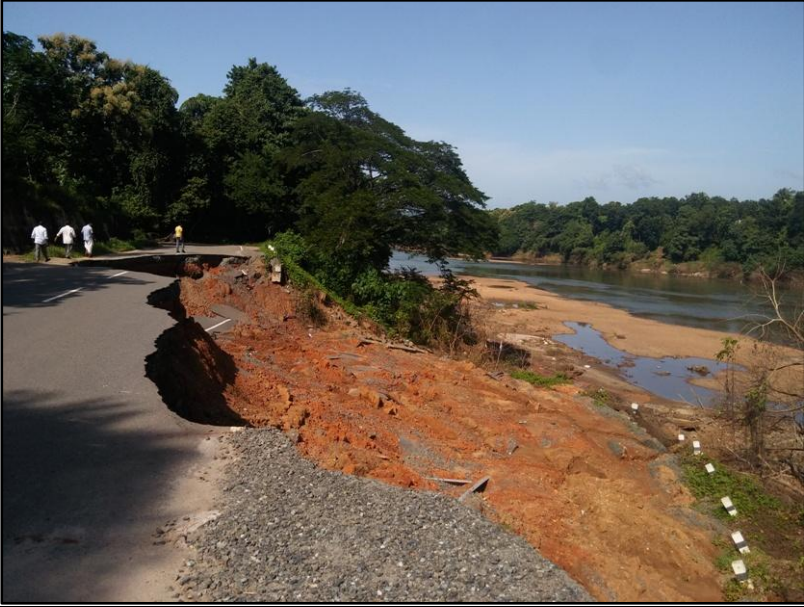
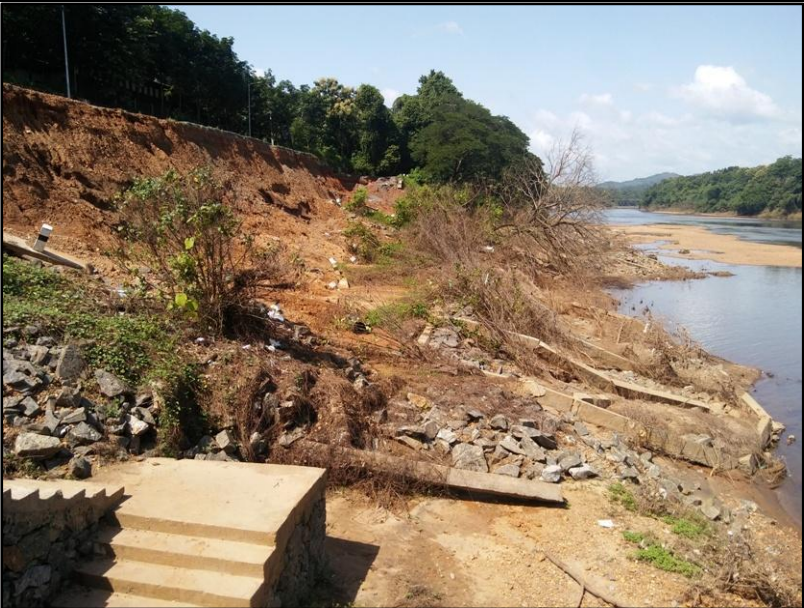
#### Slide-4:

5	Name of the slide	:	<i>Bheemangal</i>
6	NH/SH/Locality	:	<i>Odayikkal-Edavanna, Pullipadam Vilage, Ernad Taluk</i>
7	Latitude	:	<i>11.25171° N</i>
8	Longitude	:	<i>76.18100° E</i>
9	Length	:	<i>~10 m</i>
10	Width	:	<i>100 m</i>
11	Height	:	<i>8-9 m</i>
12	Area	:	
13	Depth	:	<i>10 m</i>
14	Volume	:	
15	Run out distance	:	<i>50 m</i>
16	Type of Material	:	<i>Soil</i>
17	Type of movement	:	<i>Slide</i>
18	Rate of movement	:	<i>Rapid</i>
19	Activity	:	<i>Suspended</i>
20	Distribution	:	<i>Retrogressive and widening</i>
21	Style	:	<i>Single</i>
22	Failure mechanism	:	<i>Deep rotational failure</i>
23	History	:	<i>14<sup>th</sup> June, 2018</i>
24	Geomorphology	:	<i>Rolling plain</i>
25	Geology/Lithology	:	<i>Hornblende biotite gneiss</i>
26	Structure	:	<i>N5°E-S5°W/75°E</i>
27	Landuse/ Landcover	:	<i>Cultivated and settlement area</i>
28	Hydrological condition	:	<i>Damp</i>
29	Triggering Factor	:	<i>Rainfall</i>
30	Death of persons	:	<i>Nil</i>

31	People affected	:	<i>Nil</i>
32	Livestock Loss	:	<i>Nil</i>
33	Communication	:	<i>A 100 m section of road caved into the river.</i>
34	Infrastructure	:	<i>Bank protection works along with road damaged</i>
35	Agriculture/forest/Barren	:	<i>Agriculture</i>
36	Geo-scientific Causes	:	<i>River bank erosion</i>
37	Remedial measures	:	<i>RCC flood protection walls to be constructed on both banks with foundation on bed rock which is available at the river bed.</i>
38	Remarks, if any		<i>The Odayikkal regulator cum bridge across Chaliyar River was constructed in 2015. The approach road to the bridge on the left bank was laid by filling earth over loose alluvium and terrace deposits. The distressed area forms part of the inner bank and similar failures are also noticed in the outer right bank. Though the RCC flood protection walls were provided along the left bank for a distance of about 225 m in the downstream of the bridge, the further downstream was protected only by RR pitching using grids of reinforced beams. The latter structure was installed at about 5m towards the bank with a bathing ghat in between without any smooth transition. The length of flood protection walls provided for the outer right bank is even shorter and the bank witnesses more frequent failures during floods.</i>

40	Summary/Abstract	:	<p><i>A soil slide due to bank erosion occurred on 14<sup>th</sup> June 2018 at Bheemangal, near Odayikkal regulator cum bridge in Pullipadam Village, Ernad Taluk, Malappuram district. The bank erosion resulted in caving in of a 100m section of newly laid road and bank protection work. Unscientific construction of flood protection walls seems to be the cause for failure. It is recommended to construct RCC flood protection walls on both banks with foundation on bed rock which is available at the river bed.</i></p>	
41	Date of Reporting	:	05/07/2018	
42	Landslide Category	:	II

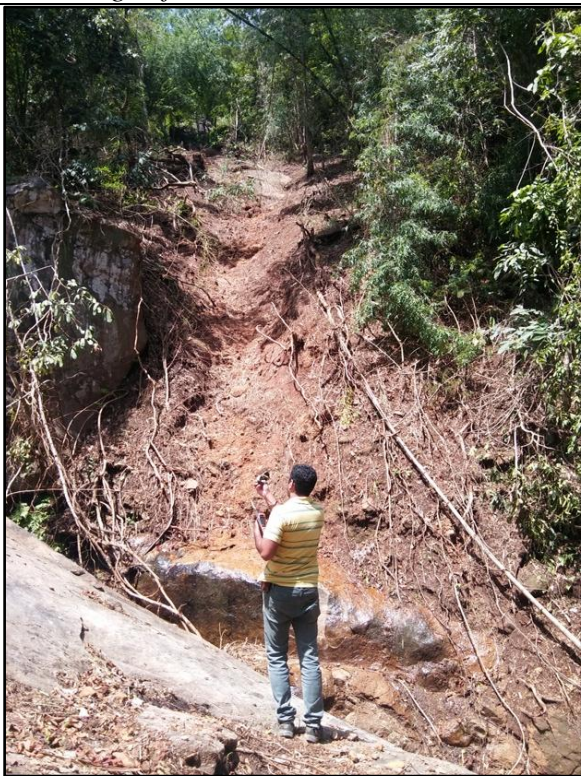
#### Slide-5:

4	Toposheet No.	: 58A/03
5	Name of the slide	: <i>Madam Colony 1</i>
6	NH/SH/Locality	: <i>Pullipadam Village, Nilambur Taluk</i>
7	Latitude	: <i>11.27061° N</i>
8	Longitude	: <i>76.14651° E</i>
9	Length	: <i>50 m</i>
10	Width	: <i>3-4 m</i>
11	Height	: <i>15 m</i>
12	Area	:
13	Depth	: <i>2-3 m</i>
14	Volume	:
15	Run out distance	: <i>850 m</i>
16	Type of Material	: <i>Rock cum Debris</i>
17	Type of movement	: <i>Flows</i>
18	Rate of movement	: <i>Very Rapid</i>
19	Activity	: <i>Suspended</i>
20	Distribution	: <i>Confined</i>
21	Style	: <i>Complex</i>
22	Failure mechanism	: <i>Initiated as shallow planar slide</i>
23	History	: <i>14<sup>th</sup> June, 2018 at 05:00 hrs</i>
24	Geomorphology	: <i>Moderately dissected slope</i>
25	Geology/Lithology	: <i>Charnockite</i>
26	Structure	: <i>Foliation N60°E – S60°W/85° NW</i>
27	Landuse/ Landcover	: <i>Forest in the source area and the runout area is inhabited.</i>
28	Hydrological condition	: <i>Flowing</i>

29	Triggering Factor	: <i>Rainfall</i>
30	Death of persons	: <i>Nil</i>
31	People affected	: <i>Residents of 3 houses in the immediate downstream below the road bench has been evacuated just before the slide. Debris accumulated in the compounds of 15 houses about 850m downstream causing partial damage of two houses.</i>
32	Livestock Loss	: <i>Nil</i>
33	Communication	: <i>Road (unmetalled) and culvert blocked. Road scoured for a distance of 450 m.</i>
34	Infrastructure	: <i>Debris accumulated in the compounds of three houses and partially damaged two houses.</i>
35	Agriculture/forest/Barren	: <i>Forest</i>
36	Geo-scientific Causes	: <i>Heavy antecedent rainfall for 3 days preceding the event resulted in raising of water levels in natural streamlets causing erosion of flanks. Landslide was initiated as planar failure along rock-overburden contact due to toe erosion and then transformed into debris flow along heavily flowing stream path.</i>

<i>The other followed the original course and debris material got accumulated in the compounds of 15 houses further downstream and caused partial damage of two houses.</i>
39	Photos. Sketch of Plan & section of the slide	:

40	Summary/Abstract	:	<i>A debris flow occurred on 14<sup>th</sup> June 2018 at Madam Colony in Pullipadam Village, Nilambur Taluk, Malappuram district. Landslide was initiated as planar failure along rock-overburden contact due to toe erosion and then transformed into debris flow along existing stream path. Due to culvert of insufficient span, debris got accumulated and resulted in bifurcation of flow. The diverted arm flown through the road bench heavily scouring it for a distance of about 450m. Along the original course, debris laden stream breached and entered into compounds of about 15 houses and damaging two houses partially. Large sized dislodged boulders hampering the smooth flow of water along the stream path may be removed. Larger culvert to be provided for smoother passage of debris. The houses in the brim of the stream may be relocated to higher, safer grounds.</i>

37	Remedial measures	: <i>The overburden material has been stripped off exposing bed rock along the depleted zone. Large sized dislodged boulders hampering the smooth flow of water along the stream path may be removed. Larger culvert to be provided at road for smoother passage of debris.</i>
38	Remarks, if any	: <i>The debris flow followed the natural streamlet up to the road level. The bigger boulders got stuck at the culvert and hampered the flow resulting in its bifurcation. The diverted debris laden stream scoured the road for a distance of about 450m before joining another stream.</i>

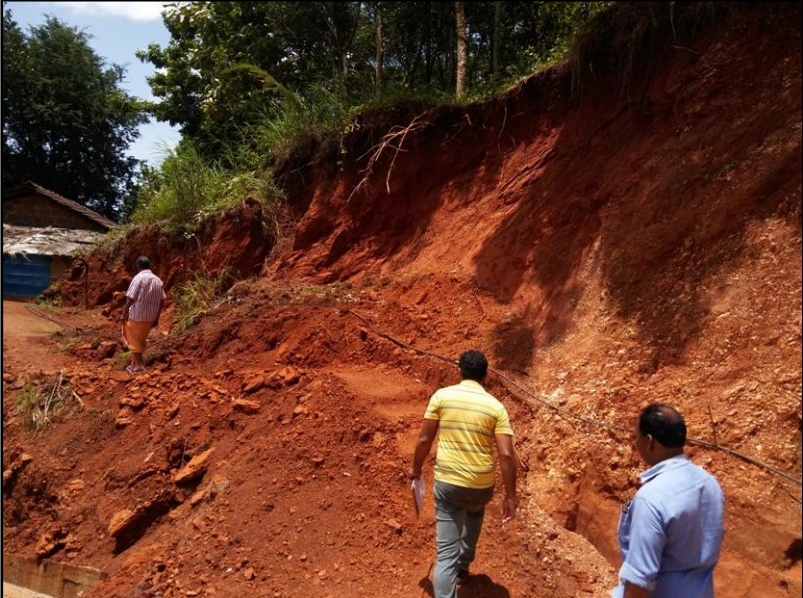
#### Slide-6:

8	Longitude	:	76.14928° E
9	Length	:	5 m
10	Width	:	20 m
11	Height	:	4-5 m
12	Area	:	
13	Depth	:	1-2 m
14	Volume	:	
15	Run out distance	:	
16	Type of Material	:	Debris
17	Type of movement	:	Slide
18	Rate of movement	:	Rapid
19	Activity	:	Suspended
20	Distribution	:	Retrogressive and widening
21	Style	:	Single
22	Failure mechanism	:	Shallow planar failure
23	History	:	14 <sup>th</sup> June, 2018
24	Geomorphology	:	Moderately dissected slope
25	Geology/Lithology	:	Lateritic soil and moderately weathered charnockite .
26	Structure	:	Foliation N60°E – S60°W/85° NW; Joint N60°W- S60°E/60° NE (Plane of movement)
27	Landuse/ Landcover	:	Cultivated
28	Hydrological condition	:	Damp
29	Triggering Factor	:	Rainfall
30	Death of persons	:	
31	People affected	:	Residents from a house have been evacuated prior to the event.
32	Livestock Loss	:	
33	Communication	:	Road blockade
34	Infrastructure	:	Debris and water entered into compounds of about 15 houses.

35	Agriculture/forest/Barren	:	Agricultural (High height plantation)
36	Geo-scientific Causes	:	Failure of overburden (lateritic soil) material along the joint N60°W- S60°E/60° NE. Day-lighting of the joint plane in the near vertical cut causes the failure.
37	Remedial measures	:	Easing of the slope with installation of proper toe support.
38	Remarks, if any	:	
39	Photos. Sketch of Plan & section of the slide	:

40	Summary/Abstract	:	<i>A debris slide occurred on 14<sup>th</sup> June 2018 at Madam Colony in Pullipadam Village, Nilambur Taluk, Malappuram district. Slide is of translational type resulting in failure of loose overburden material sliding along a day-lighting joint in a near vertical road cut. Towards the flanks, especially in the right, the depth of loose overburden is greater and in view of the arcuate tension cracks in the crown area, the slope may be eased in conjunction with toe support.</i>
41	Date of Reporting	:	<i>05/07/2018</i>
42	Landslide Category	:	<i>II</i>

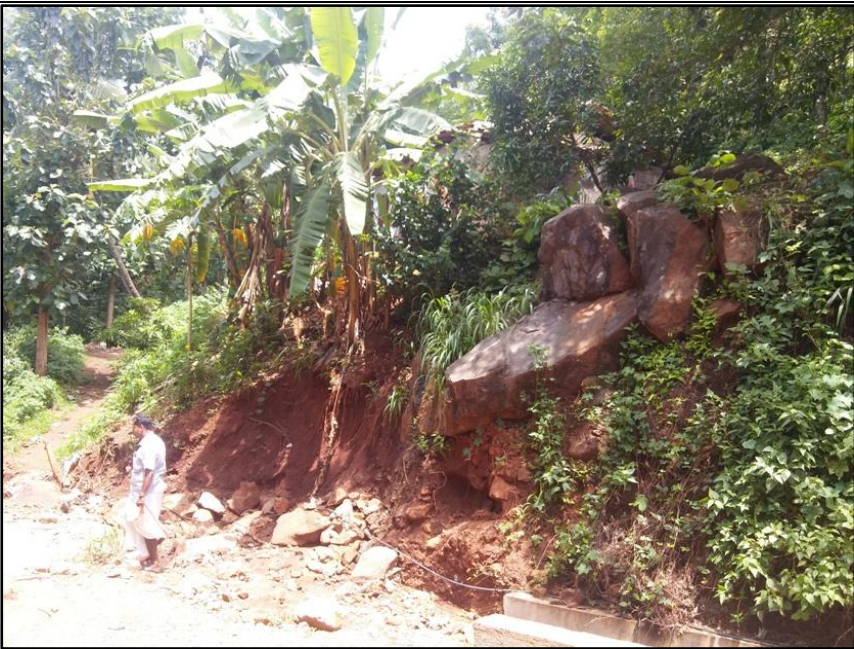
#### Slide-7:

27	Landuse/ Landcover	:	<i>Cultivated and inhabited</i>
28	Hydrological condition	:	<i>Dry</i>
29	Triggering Factor	:	<i>Rainfall in mm</i>
30	Death of persons	:	<i>Nil</i>
31	People affected	:	<i>Residents from a house upslope of the crown were evacuated prior to the event</i>
32	Livestock Loss	:	<i>Nil</i>
33	Communication	:	<i>Road blockade</i>
34	Infrastructure	:	
35	Agriculture/forest/Barren	:	<i>Agricultural (High height plantation)</i>
36	Geo-scientific Causes	:	<i>The toe has been removed for widening of the road leaving a vertical</i>

<i>cut in the loose overburden without any support intervention. To aggravate the situation, the toe has been eroded by heavily flowing water diverted from a stream due to blockade of a culvert. The lined road side drain arrangement channelized the water and caused heavy flow. In the distressed site, the side ditch was left unlined causing scouring of the toe area.</i>
37	Remedial measures	:	<i>Roadside drain should be lined throughout. RCC retaining wall with proper drainage arrangement should be constructed at the location.</i>
38	Remarks, if any		
39	Photos. Sketch of Plan & section of the slide	:

40	Summary/Abstract	:	<i>On 14<sup>th</sup> June 2018, a debris slide occurred at Madam Colony in Pullipadam Village, Nilambur Taluk, Malappuram district. The material from the diverted Madam colony 1 debris flow got channelized along the lined roadside drain and eroded away the toe of the vertical cut at the point where the lined drain ends which resulted in the failure. Residents from a house upslope of the crown were evacuated prior to the event. It is recommended that the roadside drain should be lined throughout. RCC retaining wall with proper drainage arrangement should be constructed at the location.</i>

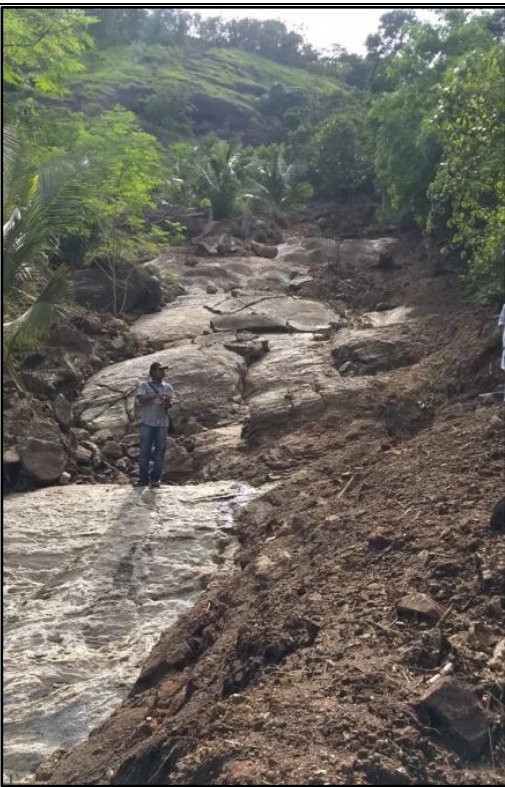
#### Slide-8:

10	Width	:	<i>5-7 m</i>
11	Height	:	<i>~ 35-40m</i>
12	Area	:	
13	Depth	:	<i>1-2 m</i>
14	Volume	:	
15	Run out distance	:	<i>~250</i>
16	Type of Material	:	<i>Rock cum debris</i>
17	Type of movement	:	<i>Flow</i>
18	Rate of movement	:	<i>Very Rapid</i>
19	Activity	:	<i>Suspended</i>
20	Distribution	:	<i>Confined</i>
21	Style	:	<i>Complex</i>
22	Failure mechanism	:	<i>Initiated as shallow planar failure</i>
23	History	:	<i>15<sup>th</sup> June, 2018</i>
24	Geomorphology	:	<i>Moderately dissected slope</i>
25	Geology/Lithology	:	<i>Charnockite</i>
26	Structure	:	<i>Foliation and parallel joints N10°E- S10°W/75° NNW, Joint N55°W-S55°E/72° NE</i>
27	Landuse/ Landcover	:	<i>Cultivated</i>
28	Hydrological condition	:	<i>Damp</i>
29	Triggering Factor	:	<i>Rainfall</i>
30	Death of persons	:	<i>Nil</i>
31	People affected	:	<i>Nil</i>
32	Livestock Loss	:	<i>Nil</i>
33	Communication	:	<i>Road blockade</i>
34	Infrastructure	:	<i>Damaged mixed plantation (High height)</i>

35	Agriculture/forest/Barren	:	<i>Agricultural (High height plantation)</i>
36	Geo-scientific Causes	:	<i>Natural slope had been modified for planting crops by blocking natural gullies and streamlets. Heavy antecedent rainfall for 3 days preceding the event resulted in building up of excess pore water pressure and reduction of strength on saturation. Landslide was initiated as shallow planar failure along rock-overburden contact and then transformed into debris flow in sequence.</i>
37	Remedial measures	:	<i>The overburden material (1-2 m thick) has been stripped off exposing fresh bed rock along the runout path. Dislodged boulders along the runout path/nala should be removed. Natural drainage should be maintained.</i>
38	Remarks, if any	:

40	Summary/Abstract	:	A debris flow occurred on 14 <sup>th</sup> June, 2018 at Chettiyampara colony in Kurumbilangod Village in Malappuram District. The slope has been modified for plantation purpose by blocking natural drainage. Heavy antecedent rainfall for 3 days preceding the event resulted in building up of excess pore water pressure and reduction of strength on saturation. Landslide was initiated as a shallow planar failure along rock-overburden contact and then transformed into debris flow in sequence. Though the most of the overburden material has been stripped off exposing bed rock, the run out path should be cleared from dislodged rock fragments and debris. The natural gullies and streamlets may be maintained		
41	Date of Reporting	:	05/07/2018		
42	Landslide Category	:	III

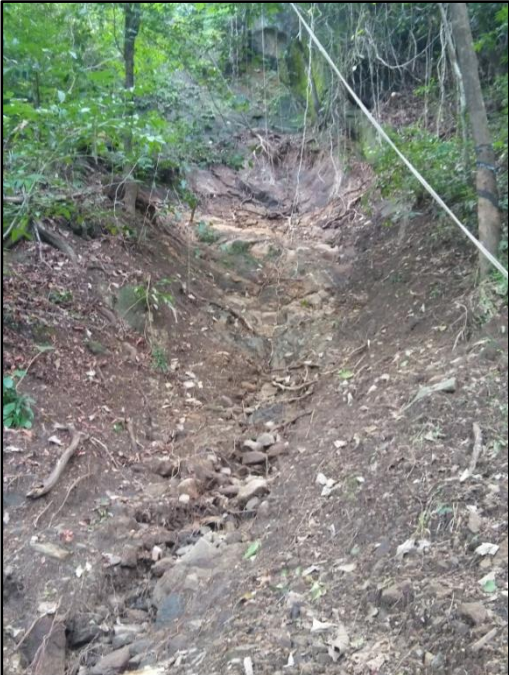
#### Slide-9:

14	Volume	:	
15	Run out distance	:	30 m
16	Type of Material	:	Rock cum debris
17	Type of movement	:	Flow
18	Rate of movement	:	Very Rapid
19	Activity	:	Reactivated
20	Distribution	:	Confined
21	Style	:	Complex
22	Failure mechanism	:	Shallow planar failure
23	History	:	14 <sup>th</sup> June, 2018; Rock/debris slide had occurred at the same spot about 5-6 years back also. Also about 40 years back, a huge rock block of about 6m x 4m x3m had displaced further upslope of this location, rolled down till road bench and killed three people.
24	Geomorphology	:	Moderately dissected slope
25	Geology/Lithology	:	Charnockite
26	Structure	:	Foliation:N10°E- S10°W/75° NNW
27	Landuse/ Landcover	:	High Height Plantation
28	Hydrological condition	:	Dry
29	Triggering Factor	:	Rainfall
30	Death of persons	:	Nil
31	People affected	:	Nil
32	Livestock Loss	:	Nil
33	Communication	:	Unpaved road blocked
34	Infrastructure	:	
35	Agriculture/forest/Barren	:	Agriculture

36	Geo-scientific Causes	:	Initiated as rock slide. Failure happened along weathered seam developed within a valley dipping plane. It further graded into a debris flow collecting more debris and soil, following a natural stream path.
37	Remedial measures	:	Precariously positioned boulders along the runout path should be removed.
38	Remarks, if any	:	
39	Photos. Sketch of Plan & section of the slide	:

40	Summary/Abstract	:	<i>A debris flow occurred on 14<sup>th</sup> June, 2018 at Vilakkennanpara, Kurumbilangod Village, Nilambur Taluk, Malappuram district. The debris flow initiated as shallow planar failure along a weathered seam developed within a valley dipping plane and further graded into a debris flow collecting more debris and soil, following a natural stream path. Precariously positioned boulders along the runout path should be removed and natural drainage paths not to be blocked.</i>
41	Date of Reporting	:	<i>05/07/2018</i>
42	Landslide Category	:	<i>III</i>

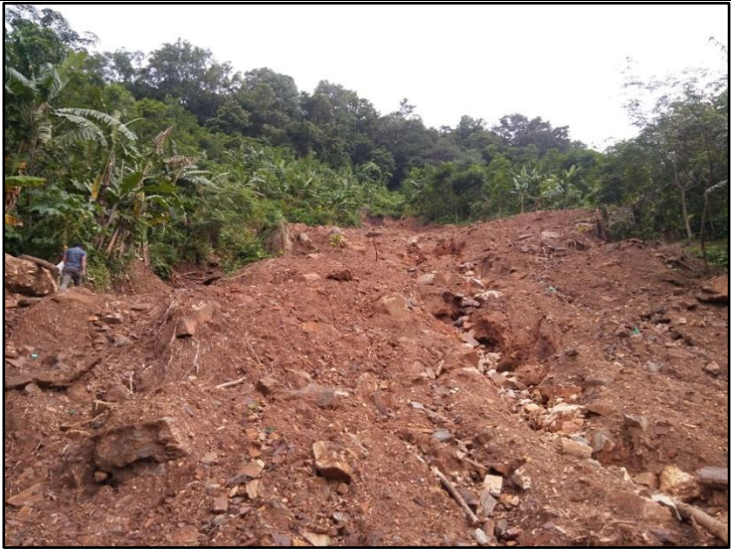
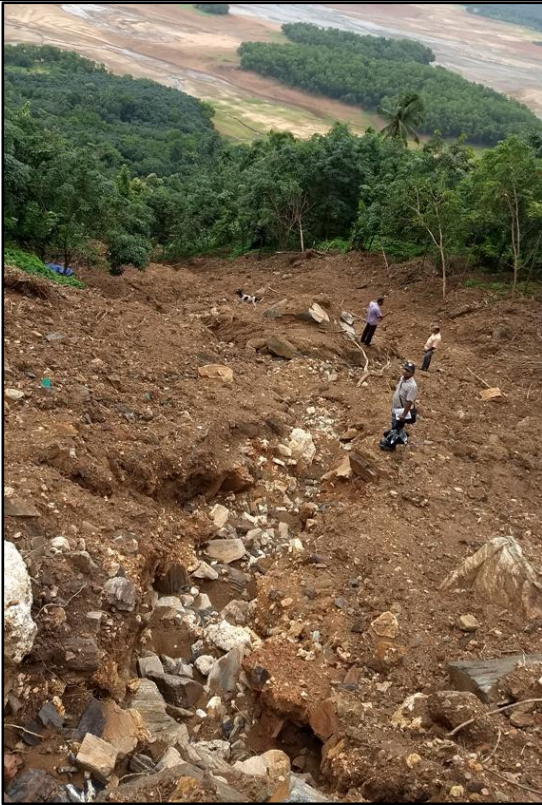
**Slide-10:**

25	Geology/Lithology	:	<i>Granite gneiss</i>
26	Structure	:	<i>N85°E-S85°W/Vertical</i>
27	Landuse/ Landcover	:	<i>High Height Plantation</i>
28	Hydrological condition	:	<i>Dry at source region and flowing at toe area</i>
29	Triggering Factor	:	<i>Rainfall</i>
30	Death of persons	:	<i>Nil</i>
31	People affected	:	<i>Residents of 2 houses could escape just before the event. One single-storied house completely washed away. Another single storied house partially damaged</i>
32	Livestock Loss	:	<i>Nil</i>
33	Communication	:	<i>Road and road side drain blocked</i>
34	Infrastructure	:	<i>Telephone and electric lines damaged</i>

35	Agriculture/forest/Barren	:	<i>Agriculture</i>
36	Geo-scientific Causes	:	<i>Natural slope had been benched for cash crops thereby blocking natural drainage. Heavy antecedent rainfall for 3 days preceding the event resulted in building up of excess pore water pressure and reduction of strength on saturation. Landslide was initiated as planar failure along rock-overburden contact and then transformed into debris flow in sequence.</i>
37	Remedial measures	:	<i>The overburden material (1-2 m thick) has been stripped off exposing fresh bed rock along the runout path. Dislodged boulders along the runout path/nala should be removed. Natural drainage should be maintained. A culvert of suitable dimensions to be constructed at the road bench to facilitate smooth water/debris flow.</i>
38	Remarks, if any		
39	Photos. Sketch of Plan & section of the slide	:

40	Summary/Abstract	:	<i>On 12<sup>th</sup> June 2018, a debris flow occurred at Paypullu, Palakayam Village, Mannarkad Taluk in Palakkad district. One house was</i>

<i>completely destroyed while another was partially damaged by the runout. The natural slope at the source area had been benched for cash crops thereby blocking natural drainage. Heavy antecedent rainfall for 3 days preceding the event resulted in building up of excess pore water pressure and reduction of strength on super-saturation. Landslide was initiated as planar failure along rock-overburden contact and then transformed into debris flow in sequence. The overburden material (1-2 m thick) has been stripped off exposing fresh bed rock along the runout path. Dislodged boulders along the runout path/nala should be removed. Natural drainage should be maintained. A culvert of suitable dimensions to be constructed at the road bench to facilitate smooth water/debris flow</i>
41	Date of Reporting	:	06/07/2018
42	Landslide Category	:	II

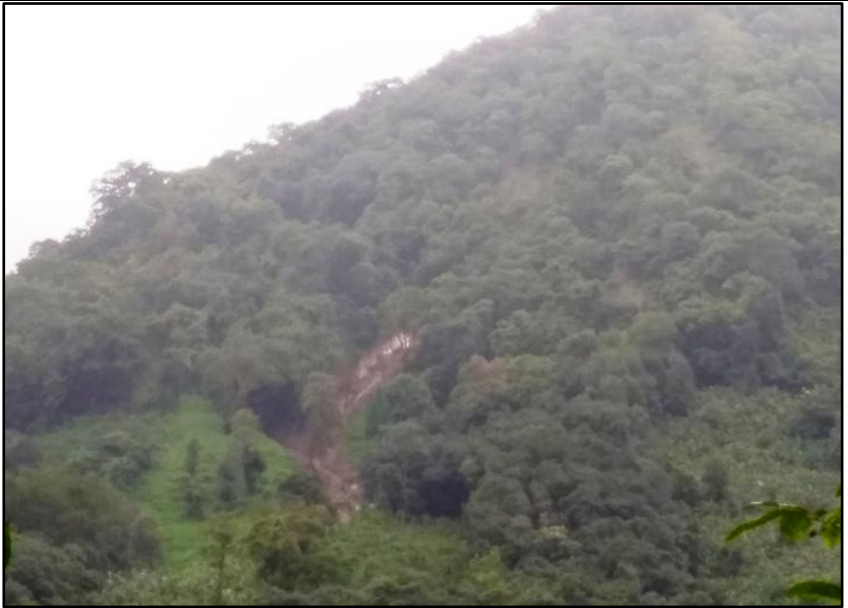
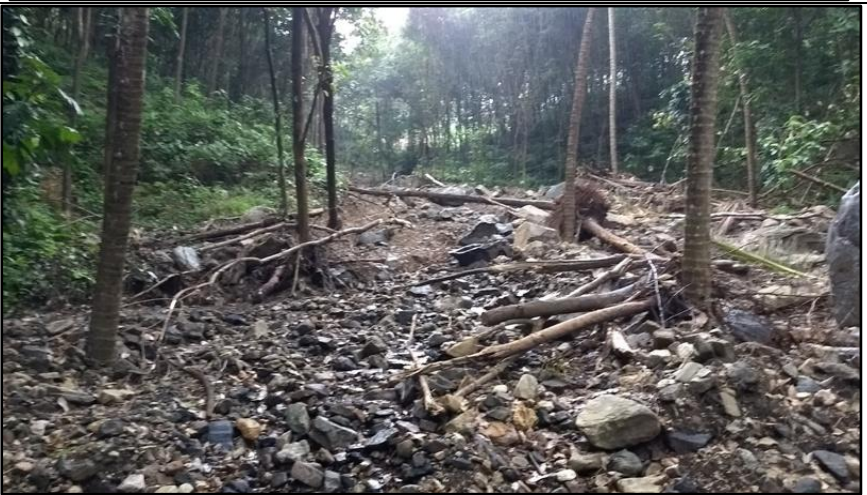
#### Slide-11:

34	Infrastructure	:	
35	Agriculture/forest/Barren	:	<i>Rubber plantation</i>
36	Geo-scientific Causes	:	<i>Initiated as rock slide dislodging huge boulders that size up to 3m X 3m X 2m. It further graded into a debris flow collecting more debris and soil, following a natural stream path.</i>
37	Remedial measures	:	<i>Precariously positioned boulders in the flow path should be removed. Natural drainage should be left unaltered.</i>
38	Remarks, if any		
39	Photos. Sketch of Plan & section of the slide	:

40	Summary/Abstract	:	<i>A debris flow occurred on 12<sup>th</sup> June, 2018 at Kundampotti-Vattapara, Palakayam Village, Palakkad district. The debris flow initiated as rock slide within forest area and further graded into a debris flow collecting more debris and soil, following a natural stream path through a plantation area. Precariously positioned boulders in the flow path should be removed. Natural drainage should be left unaltered.</i>

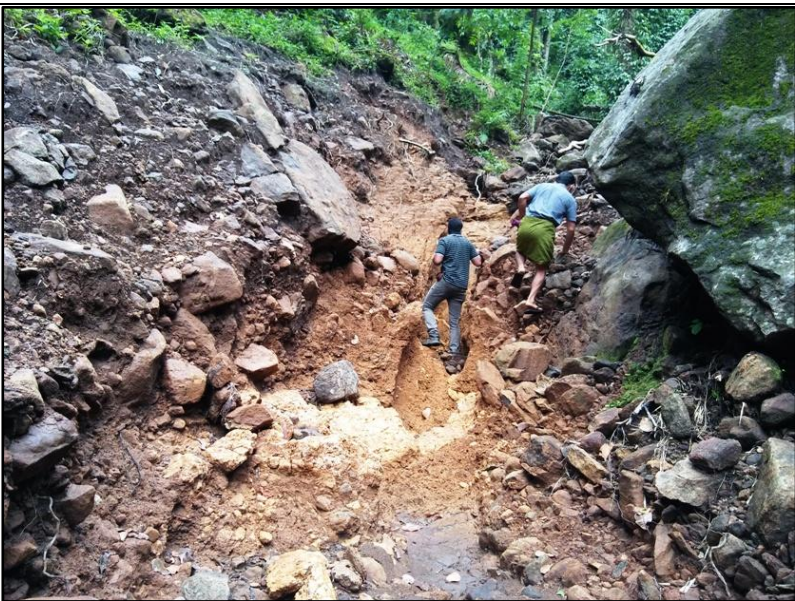
**Slide-12:**

26	Structure	:	<i>J1(Foliation &amp; parallel Joint): N40°W- S40°E/15°NE</i>
27	Landuse/ Landcover	:	<i>High Height Plantation</i>
28	Hydrological condition	:	<i>Flowing</i>
29	Triggering Factor	:	<i>Rainfall</i>
30	Death of persons	:	<i>Nil</i>
31	People affected	:	<i>Nil</i>
32	Livestock Loss	:	<i>Nil</i>
33	Communication	:	<i>Jeep road blocked</i>
34	Infrastructure	:	
35	Agriculture/forest/Barren	:	<i>Mainly Rubber plantation</i>
36	Geo-scientific Causes	:	<i>Incessant rainfall for 3 days resulted in built up of cleft water pressure initiating rock slide. It further graded into a debris flow collecting more debris and soil, following a natural stream path and joined a higher order stream.</i>
37	Remedial measures	:	<i>Precariously positioned boulders in the flow path should be removed. Natural drainage should be left unaltered.</i>
38	Remarks, if any	:	<i>The stream is debris flow prone as evidenced by the presence of old slide debris along the flanks.</i>

40	Summary/Abstract	:	<i>A debris flow occurred on 13<sup>th</sup> June, 2018, 0130 hrs at Mannannakayam, Kizhekkencherry Village, Palakkad district. The debris flow initiated as rock slide and further graded into a debris flow along a natural stream path through a plantation area. Precariously positioned boulders in the flow path should be removed. Natural drainage should be left unaltered.</i>
41	Date of Reporting	:	07/07/2018
42	Landslide Category	:	III

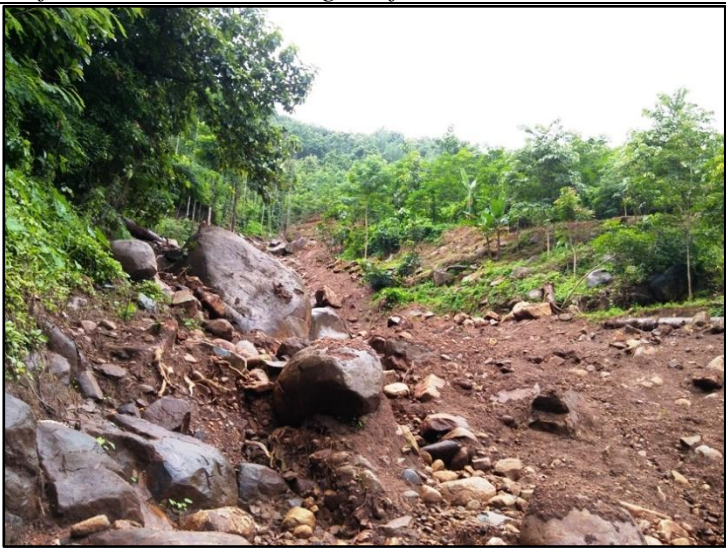
### Slide-13:

23	History	:	<i>13<sup>th</sup> June, 2018</i>
24	Geomorphology	:	<i>Moderately dissected slope</i>
25	Geology/Lithology	:	<i>Charnockite</i>
26	Structure	:	<i>J1(Foliation &amp; parallel Joint): N40°W- S40°E/35°NE</i>
27	Landuse/ Landcover	:	<i>High Height Plantation</i>
28	Hydrological condition	:	<i>Flowing</i>
29	Triggering Factor	:	<i>Rainfall</i>
30	Death of persons	:	<i>Nil</i>
31	People affected	:	<i>Nil</i>
32	Livestock Loss	:	<i>Nil</i>
33	Communication	:	<i>Jeep road blocked</i>
34	Infrastructure	:	<i>Electrical line damaged</i>
35	Agriculture/forest/Barren	:	<i>Mainly Rubber plantation</i>
36	Geo-scientific Causes	:	<i>Initiated as shallow rotational failure due to super saturation of slope debris following incessant rain for 3 days. It further graded into a debris flow collecting more debris and soil, following a natural stream path and joined a higher order stream.</i>
37	Remedial measures	:	<i>Precariously positioned boulders in the flow path should be removed. Natural drainage should be left unaltered. One house located on the right flank of this stream and another located on the adjoining parallel stream should be relocated.</i>

38	Remarks, if any	:	<i>The streams in the area are debris flow prone as evidenced by the presence of old slide debris along the flanks.</i>
39	Photos. Sketch of Plan & section of the slide	:

40	Summary/Abstract	:	<i>A debris flow occurred on 13<sup>th</sup> June, 2018 at Kadapparam, Kizhekkencherry Village, Palakkad district. The debris flow initiated as shallow rotational failure due to super saturation of slope debris following incessant rain for 3 days. It further graded into a debris flow collecting more debris and soil, following a natural stream path and joined a higher order stream. Precariously positioned boulders in the flow path should be removed. Natural drainage should be left unaltered. One house located on the right flank of this stream and another located on the adjoining parallel stream should be relocated.</i>
41	Date of Reporting	:	<i>07/07/2018</i>
42	Landslide Category	:	<i>II</i>
