**NOTE ON POST DISASTER STUDIES FOR LANDSLIDES
OCCURRED IN JUNE 2018 AT KOZHIKODE, WAYANAD AND
KANNUR DISTRICTS, KERALA**

Field Season 2018-2019

FSP No: M4SI/NC/SR/SU-KRL/2018/21108

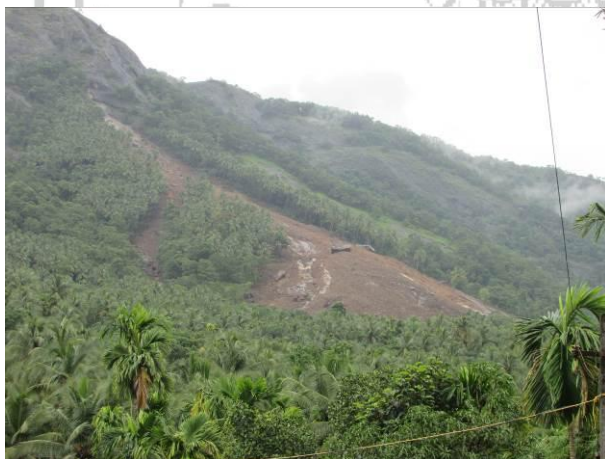
Fig. 2: Distant view of Karinchola mala landslide

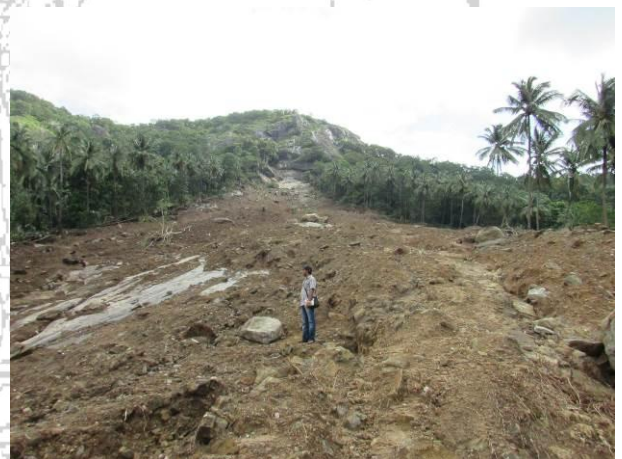
Fig. 3: Close view of Karinchola mala landslide

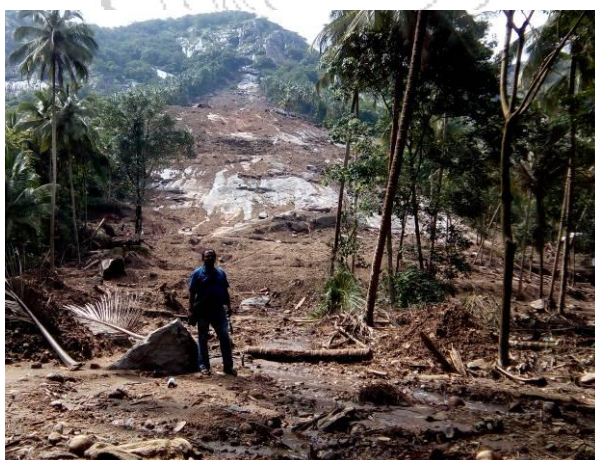
Fig. 4: View towards uphill - Karinchola mala landslide

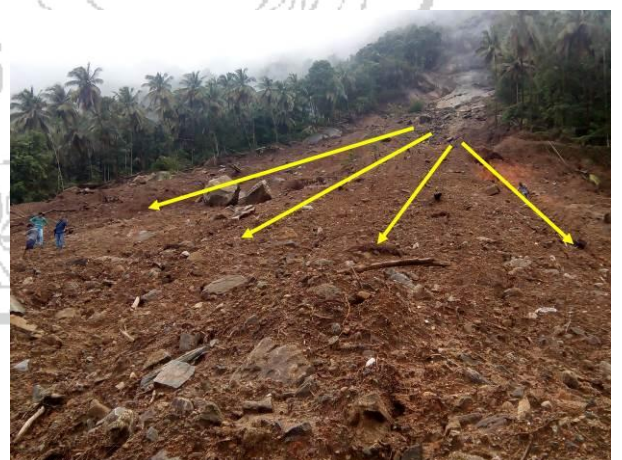
Fig. 5: Flow chutes through which debris material flown

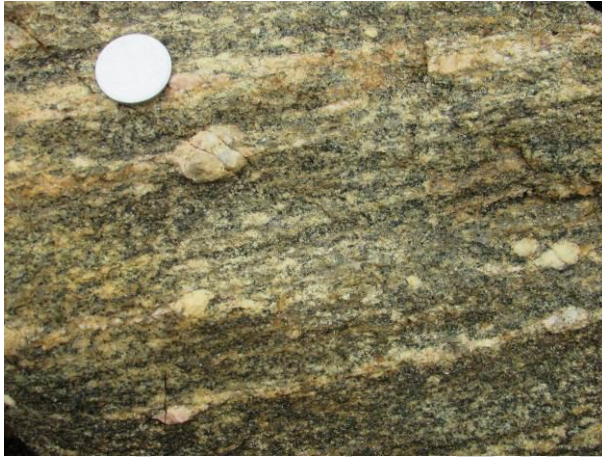
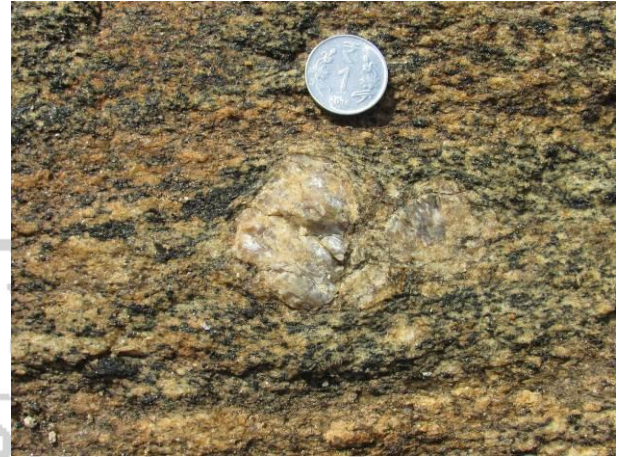
Fig. 6: Mylonites representing shear zone exposed at the landslide plane

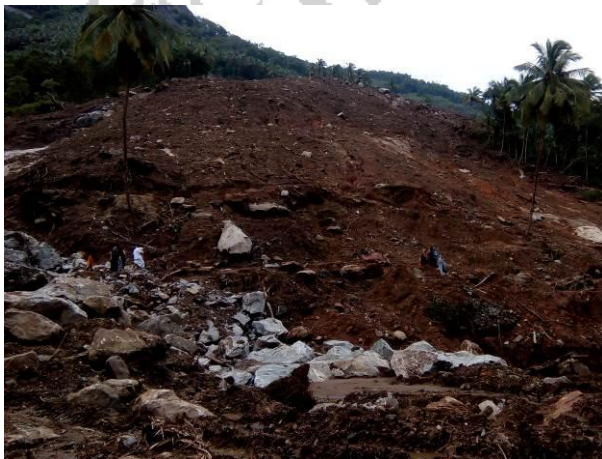
Fig. 7: Location of the houses washed out during the landslide

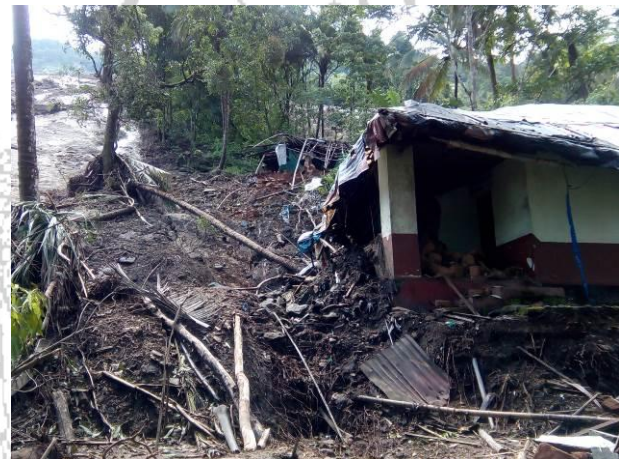
Fig. 8: Houses damaged during the landslide

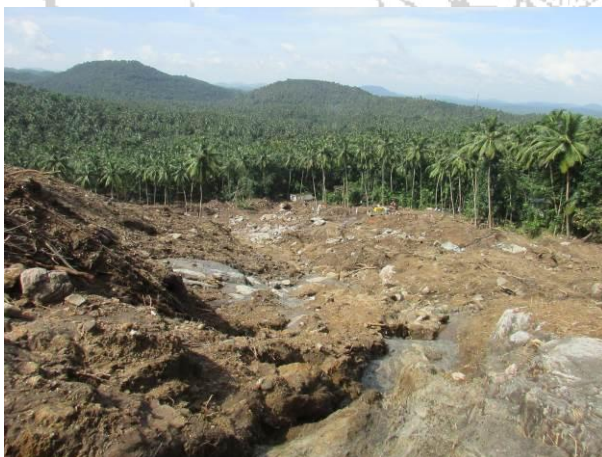
Fig. 9: View from crown towards the toe portion of the landslide

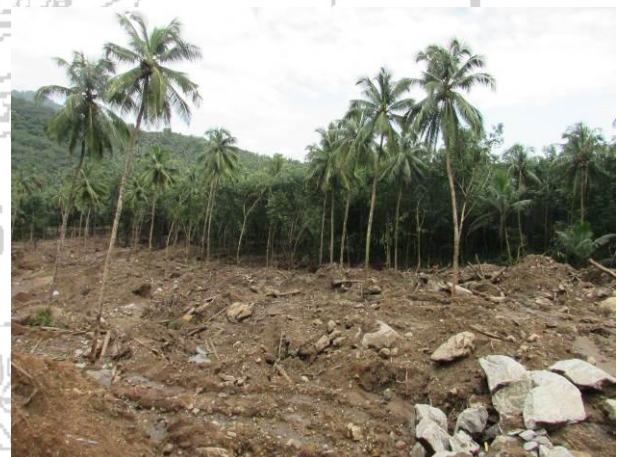
Fig. 10: Accumulation zone of the Karinchola mala landslide.

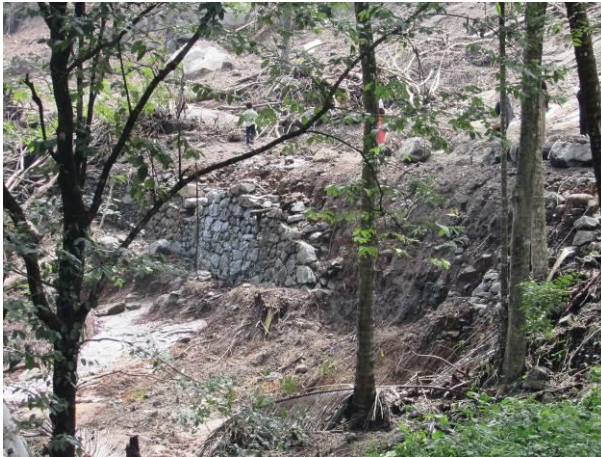
Fig. 11: Damaged RR masonry retaining wall of the road.

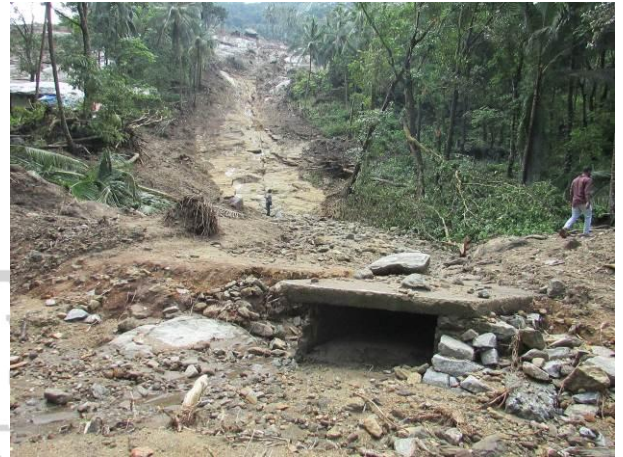
Fig. 12: Damaged road and culvert due to the debris flow

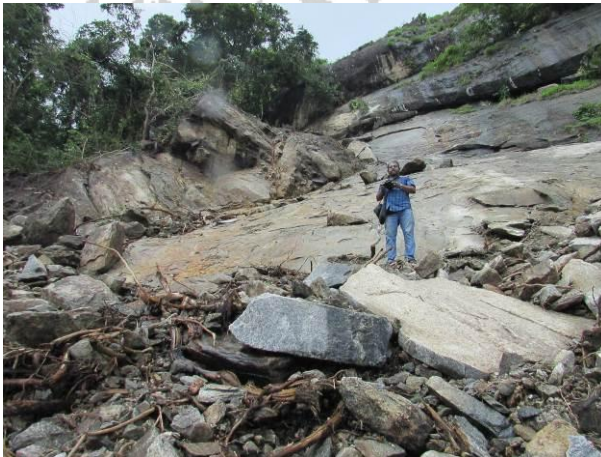
Fig. 13: Crown portion of the Karinchola mala landslide

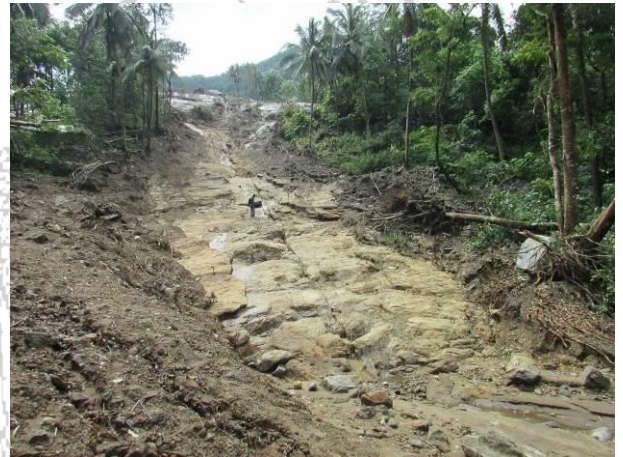
Landslide initiated as planar failure at the contact between rock and overburden in the form of debris slide and then transformed into debris flow and discharged through four run-out chutes. It accounts for a death of 14 persons including children. During the downward flow it totally washed out five houses and three houses got partly damaged at downslope area (Figs. 7 & 8). Four persons were severely injured and livestock were also affected. The entire vegetation and plantation along the hill slope area got washed out during this slide and the material got transported up to a distance of about 620 m from the crown (Figs. 9 & 10). The approach road located downslope of the Karinchola mala, its RR masonry retaining wall, the culverts at the road level, electric transmission lines, electric poles and 2 nos. of transformers were washed away (Figs. 11 & 12). One motor car is also trapped in the debris material. The slide initiated as a planar failure with the slide plane dipping 35° towards N 176° (Fig. 13). One penetrative sub-vertical joint is present along one of the chutes on the left flank which passes through the entire length of the slide plane (Fig. 14).

Fig. 14: Sub-vertical penetrative joint along one of the debris chutes exposed on the left flank

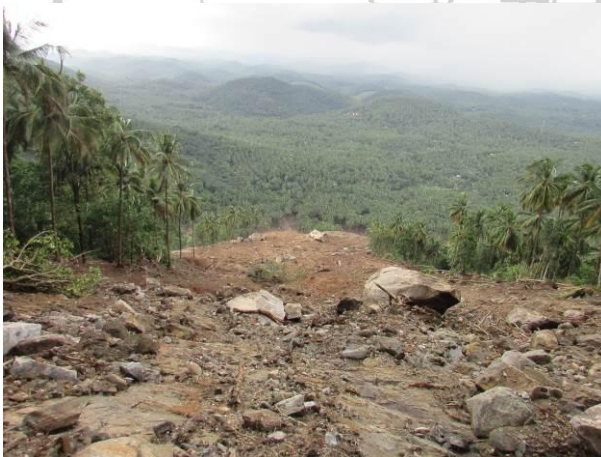
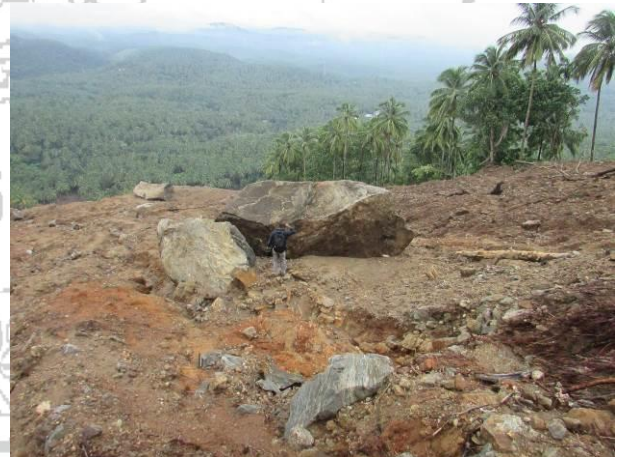
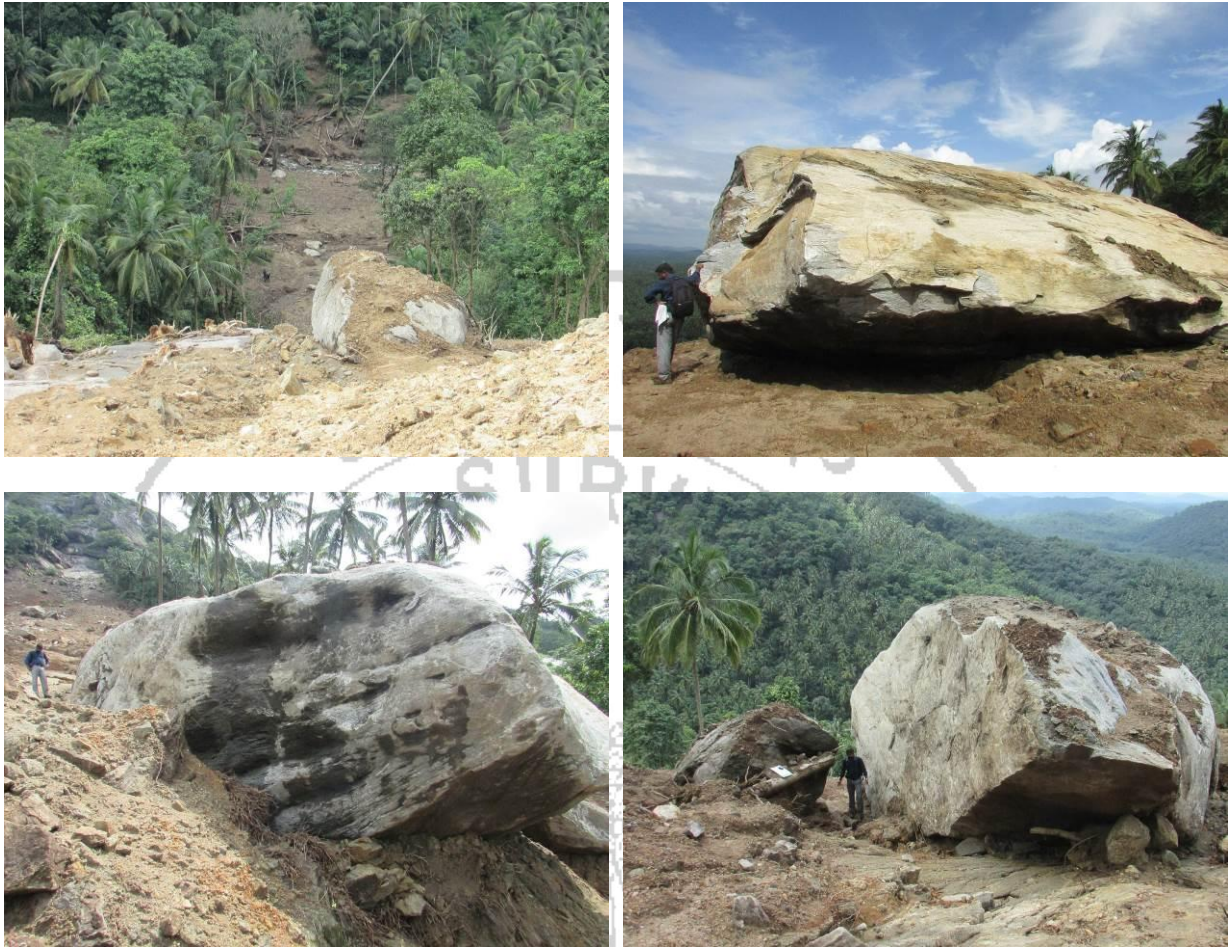
During field investigation it is observed that a number of precarious rock boulders are perched within the distressed zone (Fig. 15). The details of the prominent precarious boulders on the slide plane are as follows:

Fig. 15: Precarious boulders of various sizes observed along the slide plane

37	Remedial measures	:	<i>The precarious boulders of different dimensions (Details of prominent precarious boulders are given in the note) present along the slide plane are to be removed immediately. Debris material along the naturally occurring nala on the right flank of the landslide has to be removed for the free flow of water.</i>
38	Remarks, if any		<i>Vertical rock cut observed below the crown area may have disturbed the toe which is inferred as one of the causative factors. The depression made by this rock cut to hold huge amount of water at that level which may have breached due to the impact of huge rock boulder transported from upslope augmented the intensity of the landslide. During this slide most of the debris material present on the hill slope has been washed out and the rock outcrop is exposed at several places. The threat of downward movement of the remaining disturbed material and the huge rock blocks are still there and it is advised to avoid habitations in this slope. The material and the rock blocks may be removed and it also suggested that a detailed geo-technical study of the distressed portion and adjacent area may be conducted prior to any construction or development work at this location.</i>

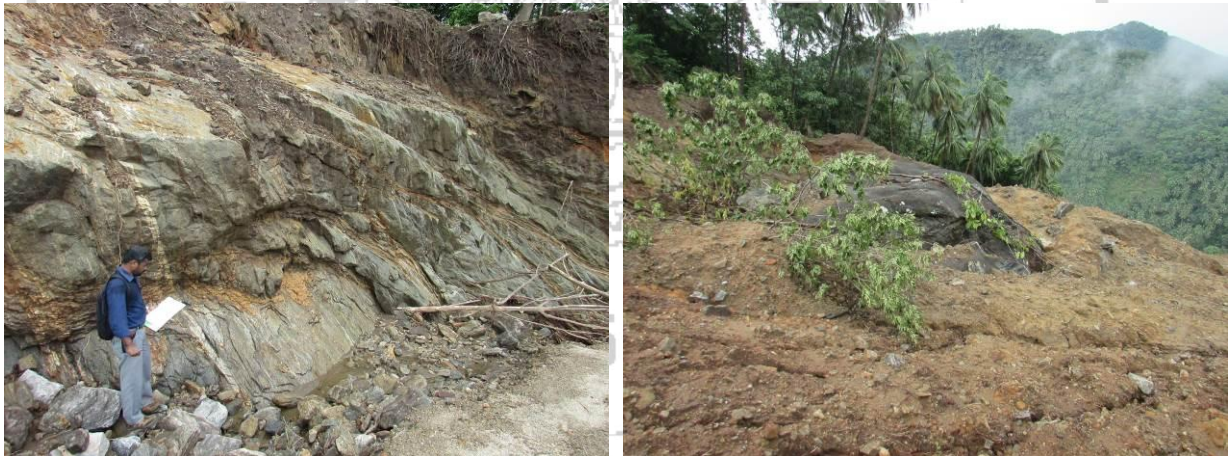
A vertical rockcut observed below the crown area may have disturbed the toe which is inferred as one of the causative factors (Fig. 16). The depression made by this rockcut to hold huge amount of water at that level may have breached due to the impact of huge rock boulder transported from upslope (Fig. 17) augmented the intensity of the landslide. During this slide most of the debris material present on the hill slope has been washed out and the rock outcrop is exposed at several places. The threat of downward movement of the remaining disturbed material and the huge rock blocks are still there and it is advised to avoid habitations in this slope. The material and the rock blocks may be removed and it is also suggested that a detailed geo-technical study of the distressed portion and adjacent area may be conducted prior to any construction or development work at this location.

Fig. 16: Sharp rock cut at top of the hill

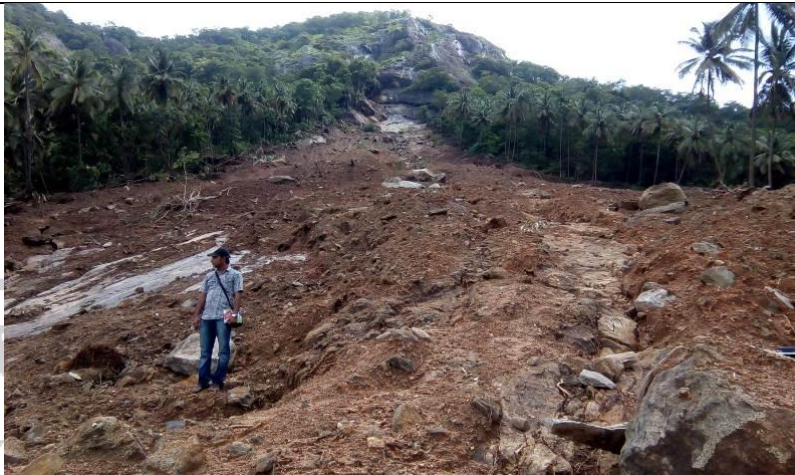
40	Summary/Abstract	:	<i>On 14th June 2018 a huge landslide occurred at Karinchola mala in Kattipara Panchayat resulted in the death of 14 people along with huge property loss. The landslide initiated as a planar failure and then transformed to debris flow along four runout chutes. The important geoscientific causes include unscientific hill slope modification that resulted in the removal of toe support. Excessive rainfall is the triggering factor which resulted in the reduction of strength on saturation and increase in pore water pressure. The depression made by the rock cut to hold huge amount of water below the crown level may have breached due to the impact of huge rock boulder transported from upslope augmented the intensity of the landslide. The immediate remedial measures include the removal of precarious boulders present along the slide plane and the remaining disturbed debris material. For further modification of the hill slope, a detailed geo-technical study of the distressed portion and adjacent area is recommended.</i>

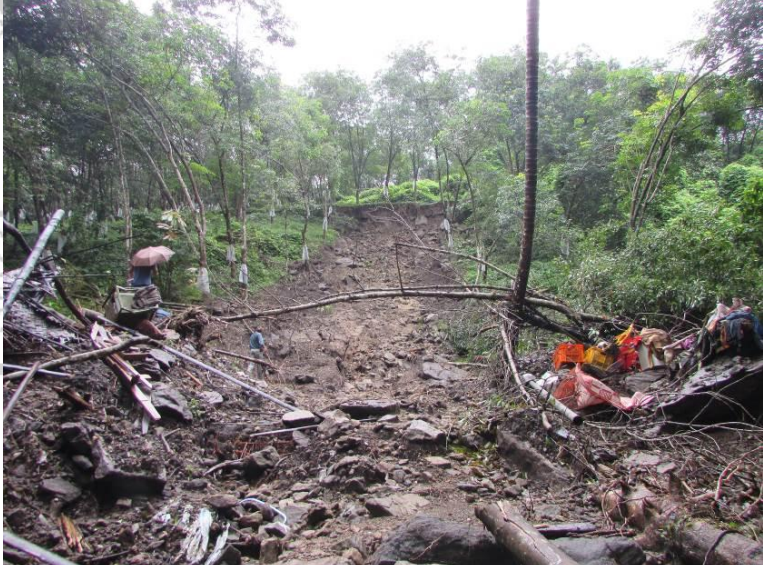
40	Summary/Abstract	:	<i>A debris flow has occurred on 14th June 2018 along the southern slope of the hill at Vettiozhinja thottam. Unscientific hill slope modification for construction of houses and plantation along with incessant rainfall resulted in the reduction of strength on saturation and increase in pore water pressure. Immediate remedial measures include construction of retaining wall with proper drainage outlet. Natural flow of water along the hill slope should not be blocked.</i>
41	Date of Reporting	:	29/06/2018
42	Landslide Category	:	Category II

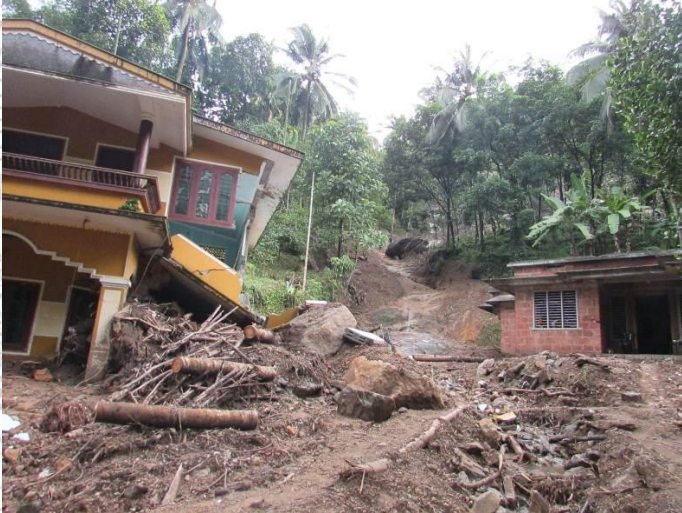
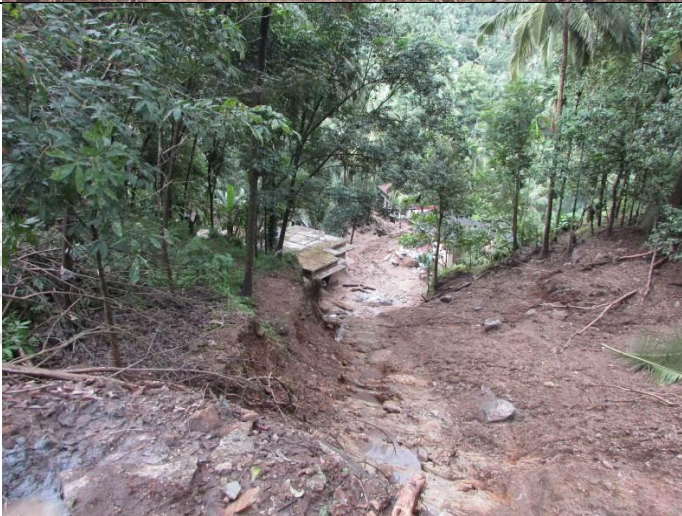
40	Summary/Abstract	:	On 14 th June 2018, a debris flow occurred on the northern flank of Karinchola mala. The landslide initiated as deep

<i>rotational failure at the contact between rock and overburden in the form of debris slide and then transformed in to debris flow along two runout chutes. Excessive rainfall is the triggering factor which resulted in the reduction of strength on saturation and increase in pore water pressure. Precarious boulders present in the debris flown path may be safely removed. Natural drainage path has to be maintained for avoiding water logged situation.</i>
41	Date of Reporting	:	29/06/2018
42	Landslide Category	:	Category II

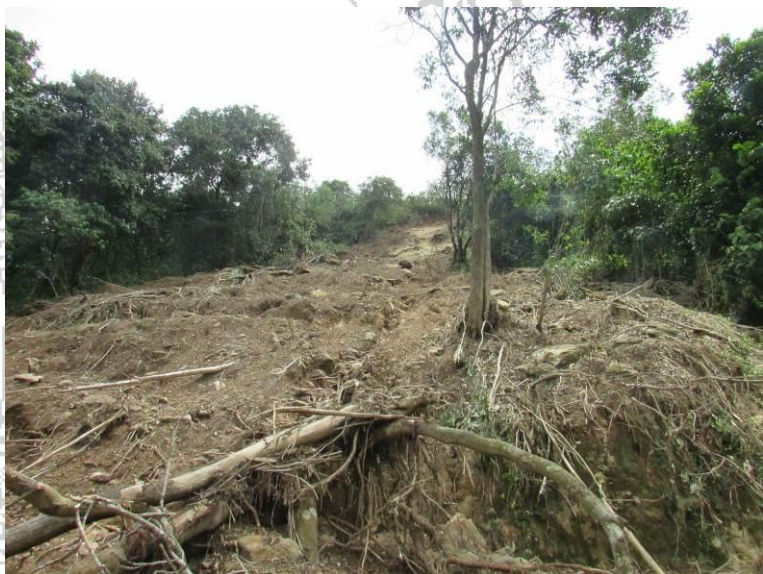
40	Summary/Abstract	:	<i>A debris slide occurred on 14th June 2018 downhill side of the water theme park located at Kakkadampoyil. The landslide occurred as planar failure at the contact between rock and overburden in the form of debris slide. Unscientific hill slope modification resulted in the removal of toe support. Excessive rainfall is the triggering factor which resulted in the reduction of strength on saturation and increase in pore water pressure. The overburden thickness varies from 0 to 0.5 m at top and towards downslope it increases to 0.5 to 5 m. Proper retaining structures with drain holes has to be provided.</i>
41	Date of Reporting	:	<i>01/07/2018</i>
42	Landslide Category	:	<i>Category III</i>

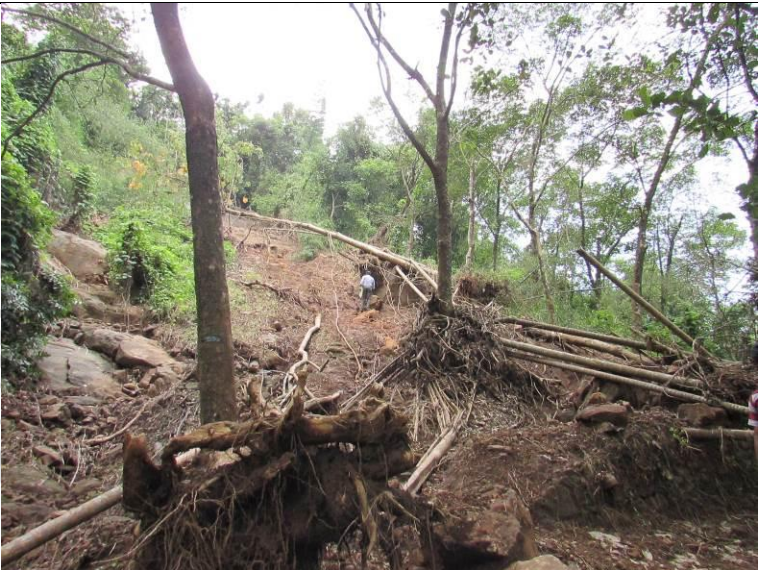
40	Summary/Abstract	:	<i>A debris flow occurred on 14th June 2018 at Kooderanji. Landslide initiated as debris slide and then transformed in to debris flow along the pre-existing nala path. Excessive rainfall is the triggering factor which resulted in the reduction of strength on saturation and increase in pore water pressure. Precarious boulders along the debris flow path have to be removed. The natural flow should not be blocked along the nala.</i>
41	Date of Reporting	:	01/07/2018
42	Landslide Category	:	Category III

26	Structure	:	<i>-</i>
27	Landuse/ Landcover	:	<i>Mixed vegetation</i>
28	Hydrological condition	:	<i>Dry</i>
29	Triggering Factor	:	<i>Heavy Rainfall</i>
30	Death of persons	:	<i>Nil</i>
31	People affected	:	<i>Nil</i>
32	Livestock Loss	:	<i>Nil</i>
33	Communication	:	<i>Kooderanji – Kakkadampoyil road blocked</i>
34	Infrastructure	:	<i>Nil</i>
35	Agriculture/forest/Barren	:	<i>Mixed vegetation area damaged</i>
36	Geo-scientific Causes	:	<i>Landslide initiated as rotational failure at the contact between rock and overburden in the form of debris slide and then transformed in to debris flow along the pre-existing nala path. Excessive rainfall is the triggering factor which resulted in the reduction of strength on saturation and increase in pore water pressure.</i>
37	Remedial measures	:	<i>Precarious boulders along the debris flow path have to be removed. The natural flow should not be blocked along the nala.</i>

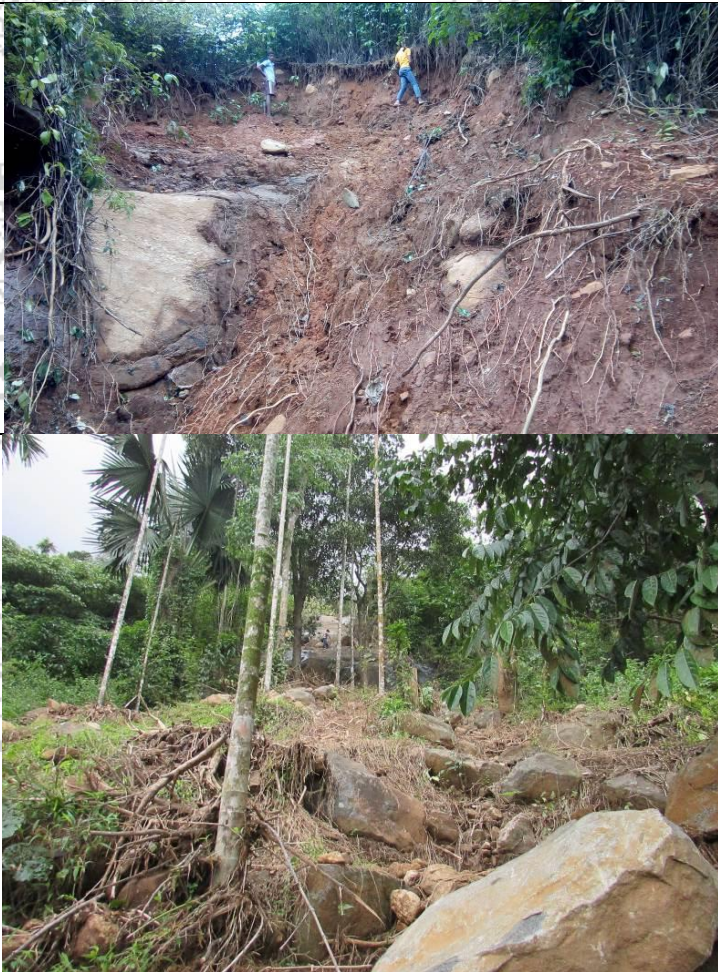
40	Summary/Abstract	:	<i>On 13th June 2018 a debris-cum-rock flow occurred at</i>

37	Remedial measures	:	<i>Precarious boulders along the debris flow path have to be removed. Ensure free flow of water along the hill slopes.</i>
38	Remarks, if any	:	-
39	Photos. Sketch of Plan & section of the slide	:

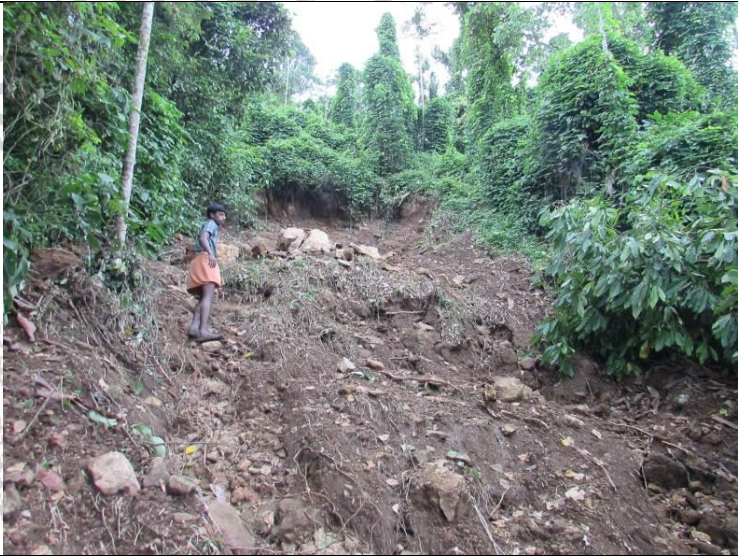
40	Summary/Abstract	:	<i>A debris flow occurred at Karimbu on 14th June 2018. Landslide initiated as planar failure at the contact between rock and overburden in the form of debris slide and then transformed in to debris flow. Excessive rainfall is the triggering factor which resulted in the reduction of strength on saturation and increase in pore water pressure. At the crown area, three huge precarious boulders seem to occupy and which is advised to be removed/treated. Proper retaining wall with drain holes at the cut slope may be provided.</i>

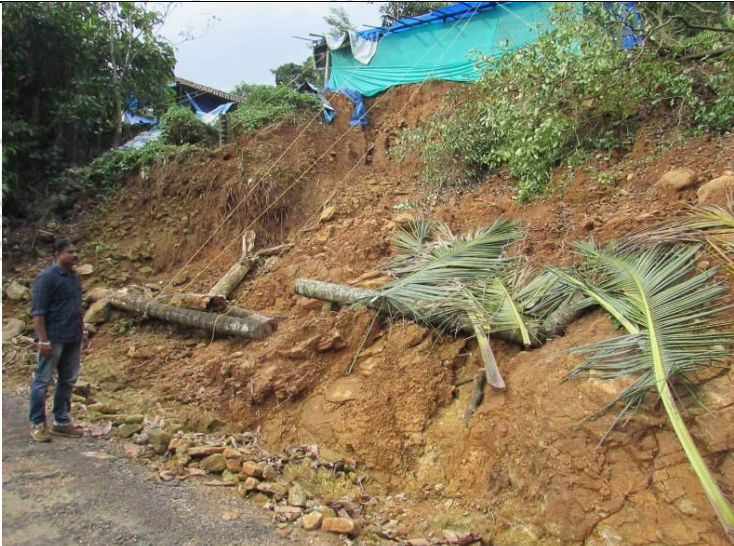
40	Summary/Abstract	:	<i>On 12th June 2018, a debris slide occurred at melemuthappanpuzha. Geoscientific causes include unscientific slope modification and unprotected cut slope made for road construction. Incessant rainfall is the triggering factor which resulted in the reduction of strength on saturation and increase in pore water pressure. Retaining wall with proper drainage outlets has to be provided.</i>
41	Date of Reporting	:	<i>01/07/2018</i>
42	Landslide Category	:	<i>Category II</i>

37	Remedial measures	:	Retaining wall with proper drainage outlets
38	Remarks, if any	:	Another cut slope failure noticed behind the nearby house located above this landslide
39	Photos. Sketch of Plan & section of the slide	:

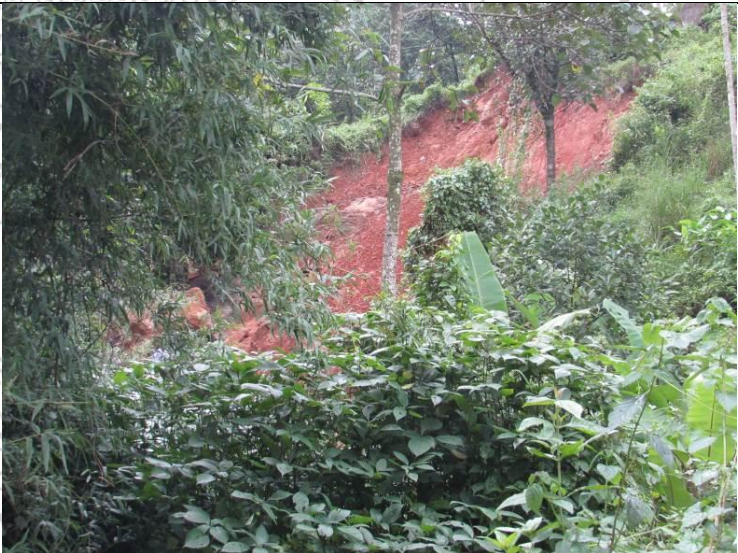
40	Summary/Abstract	:	<i>A debris slide occurred near maripuzha on 12th June 2018. The main causes include removal of toe due to the flow of water in the nala at the downslope. Incessant rainfall is the triggering factor which resulted in the reduction of strength on saturation and increase in pore water pressure. Retaining wall with proper weep holes has to be provided.</i>

37	Remedial measures	:	<i>Retaining structure with proper weep holes has to be provided</i>
38	Remarks, if any	:	-
39	Photos. Sketch of Plan & section of the slide	:

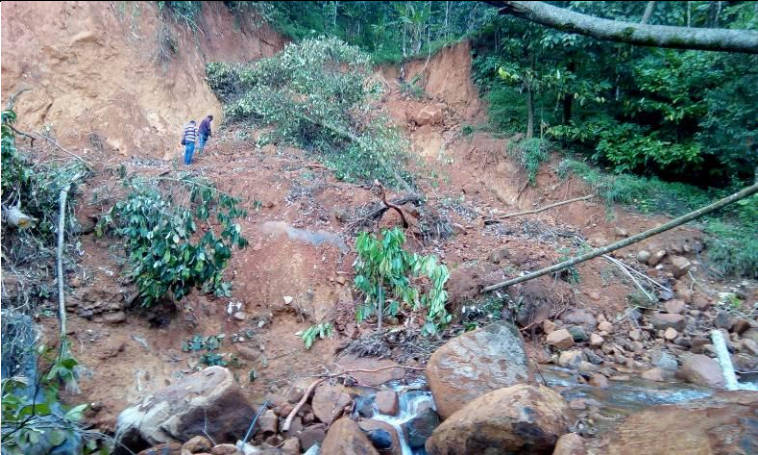
40	Summary/Abstract	:	<i>On 12th June 2018 a debris slide occurred at Maripuzha. Important causes include removal of toe support due to river bank erosion. Incessant rainfall is the triggering factor which resulted in the reduction of strength on saturation and increase in pore water pressure. It is to provide retaining structures / river bank protection structures with proper drainage holes.</i>
41	Date of Reporting	:	01/07/2018
42	Landslide Category	:	Category III

32	Livestock Loss	:	Nil
33	Communication	:	Nil
34	Infrastructure	:	Nil
35	Agriculture/forest/Barren	:	Agricultural land damaged
36	Geo-scientific Causes	:	Removal of toe support due to river bank erosion. Incessant rainfall is the triggering factor which resulted in the reduction of strength on saturation and increase in pore water pressure.
37	Remedial measures	:	Provide retaining structures/river bank protection structures with proper drainage holes.

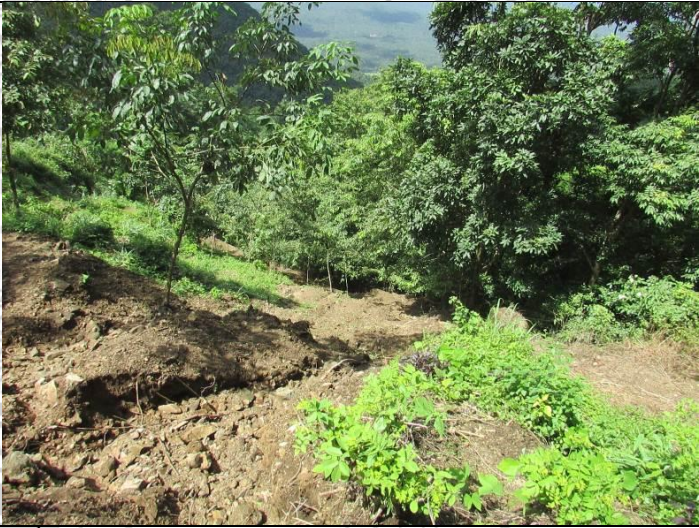
40	Summary/Abstract	:	<i>On 14th June 2018 a debris flow was occurred at Kurumpoyil. This landslide initiated as planar failure at the contact between rock and overburden in the form of debris slide and then transformed in to debris flow. Excessive rainfall is the triggering factor which resulted in the reduction of strength on saturation and increase in pore water pressure. Unscientific hill slope modification has to avoided.</i>
41	Date of Reporting	:	<i>02/07/2018</i>
42	Landslide Category	:	<i>Category III</i>

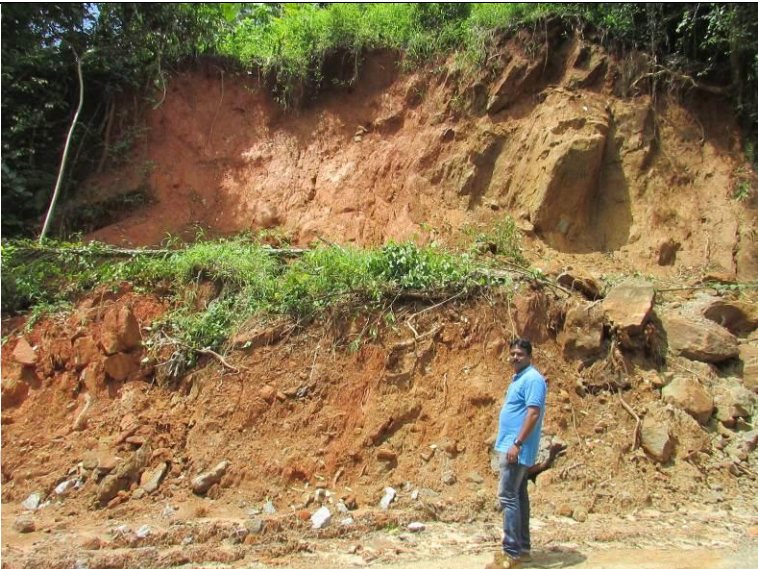
40	Summary/Abstract	:	<i>A debris slide was occurred on 14th June 2018 at Thalayad. Unscientific slope modification and unprotected cut slope made for road construction. Incessant rainfall is the triggering factor which resulted in the reduction of strength on saturation and increase in pore water pressure. Retaining wall with proper weep holes has to be provided.</i>
41	Date of Reporting	:	02/07/2018
42	Landslide Category	:	Category III

35	Agriculture/forest/Barren	:	Agricultural land damaged
36	Geo-scientific Causes	:	Unscientific slope modification and unprotected cut slope made for road construction. Incessant rainfall is the triggering factor which resulted in the reduction of strength on saturation and increase in pore water pressure.
37	Remedial measures	:	Retaining wall with proper weep holes.
38	Remarks, if any	:

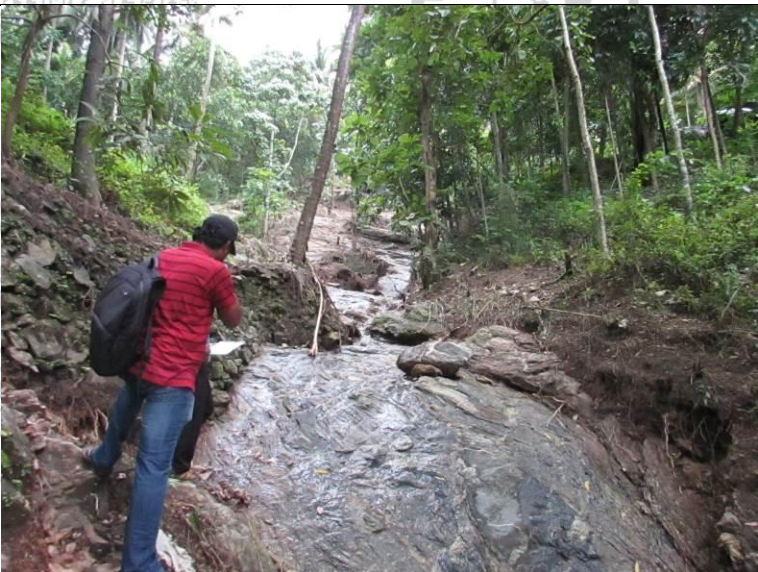
40	Summary/Abstract	:	<i>On 14th June 2018, a debris flow occurred at Poovanmala near Chamal. This landslide initiated as debris slide and then transformed to debris flow. Excessive rainfall is the triggering factor which resulted in the reduction of strength on saturation and increase in pore water pressure. The existing nala path has to be preserved and avoid its blockage.</i>
41	Date of Reporting	:	<i>02/07/2018</i>
42	Landslide Category	:	<i>Category II</i>

23	History	:	<i>14th June 2018 (03:00 hrs)</i>
24	Geomorphology	:	<i>Lowly dissected slope. Debris flow towards N 100°</i>
25	Geology/Lithology	:	<i>Migmatized gneiss</i>
26	Structure	:	<i>-</i>
27	Landuse/ Landcover	:	<i>Mixed cultivation</i>
28	Hydrological condition	:	<i>Wet</i>
29	Triggering Factor	:	<i>Heavy Rainfall</i>
30	Death of persons	:	<i>Nil</i>
31	People affected	:	<i>Nil</i>
32	Livestock Loss	:	<i>Nil</i>
33	Communication	:	<i>Kattipara – Chamal road and one unmetalled road got damaged</i>
34	Infrastructure	:	<i>Pipe culvert damaged.</i>
35	Agriculture/forest/Barren	:	<i>Agricultural land damaged</i>
36	Geo-scientific Causes	:	<i>Landslide initiated as debris slide and then transformed to debris flow. Excessive rainfall is the triggering factor which resulted in the reduction of strength on saturation and increase in pore water pressure.</i>
37	Remedial measures	:	<i>The existing nala path has to be preserved and avoid its blockage</i>

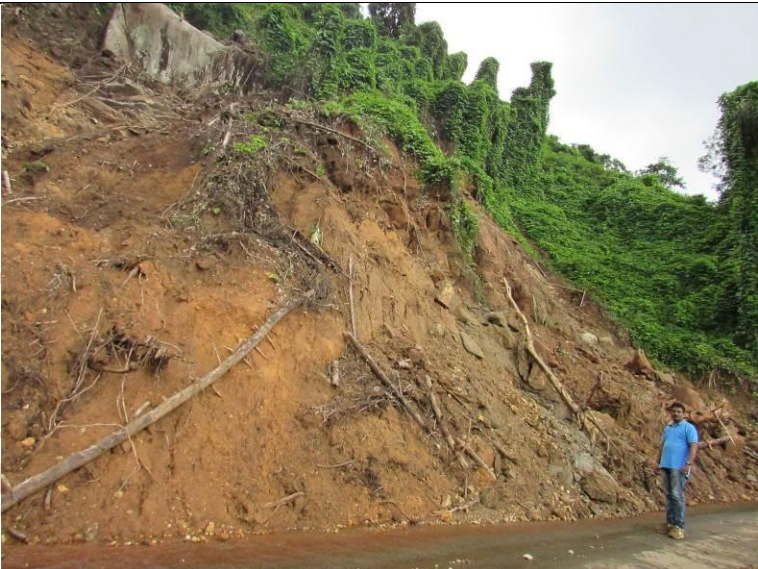
40	Summary/Abstract	:	<i>A debris slide was occurred on 14th June 2018 at Theyyapara. Unscientific slope modification and unprotected cut slope made for road construction. Incessant rainfall is the triggering factor which resulted in the reduction of strength on saturation and increase in pore water pressure. The important remedial measures include provision of retaining wall with proper drainage outlet.</i>
41	Date of Reporting	:	02/07/2018
42	Landslide Category	:	Category II

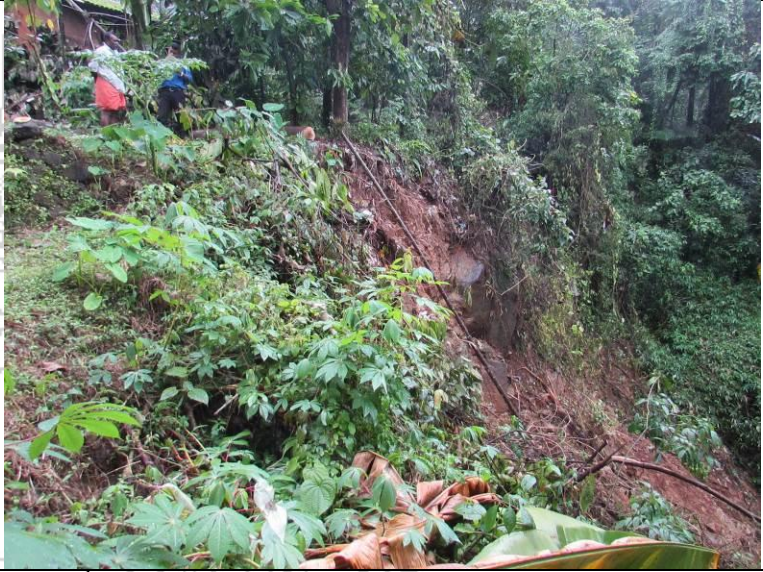
40	Summary/Abstract	:	<i>On 13th June 2018, a debris slide was occurred at Kandapanchal. The main causes include removal of toe support due to river bank erosion. Incessant rainfall is the triggering factor which resulted in the reduction of strength on saturation and increase in pore water pressure. Provide retaining structures/river bank protection structures with proper drainage holes.</i>
41	Date of Reporting	:	<i>02/07/2018</i>
42	Landslide Category	:	<i>Category III</i>

37	Remedial measures	:	<i>Provide retaining structures/river bank protection structures with proper drainage holes.</i>
38	Remarks, if any	:	<i>-</i>
39	Photos. Sketch of Plan & section of the slide	:

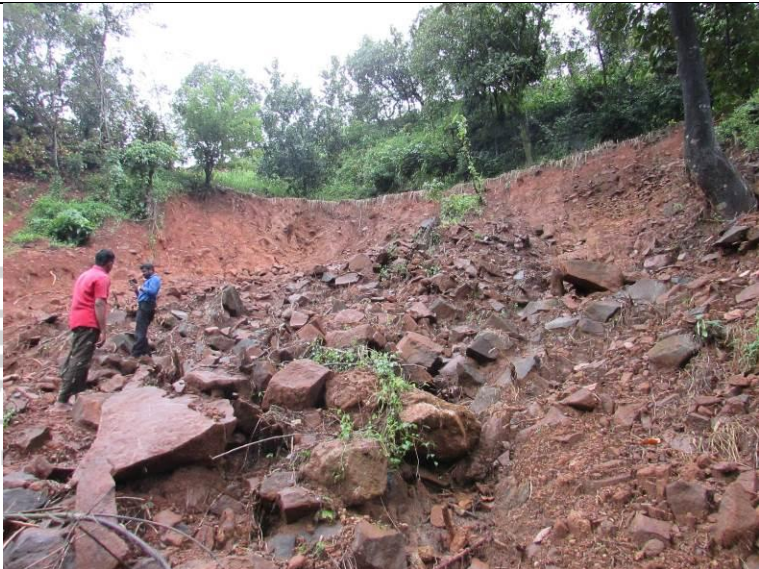
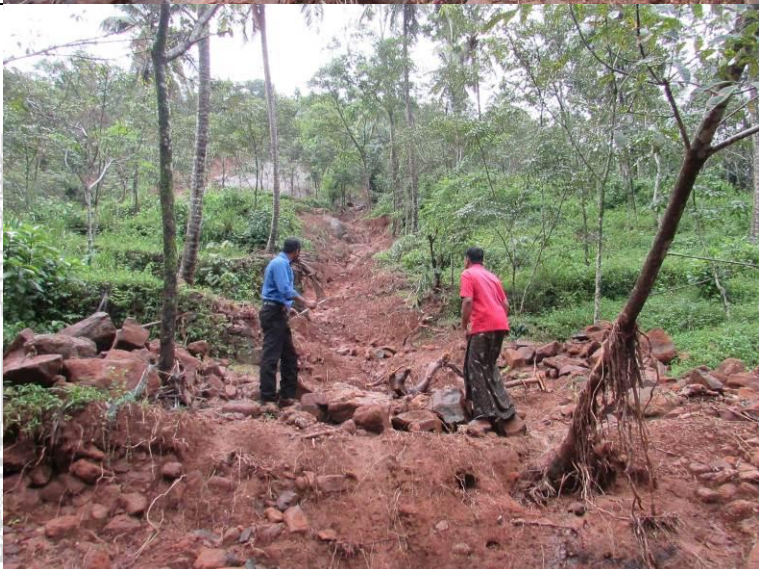
40	Summary/Abstract	:	<i>A debris slide was occurred on 13th June 2018 at Kandapanchal. Geoscientific cause includes unscientific slope modification made for road construction and cultivation. Incessant rainfall is the triggering factor which resulted in the reduction of strength on saturation and increase in pore water pressure. It is suggested to remove precarious boulders along the slide plane. Natural drainage system has to be preserved.</i>
41	Date of Reporting	:	02/07/2018
42	Landslide Category	:	Category II

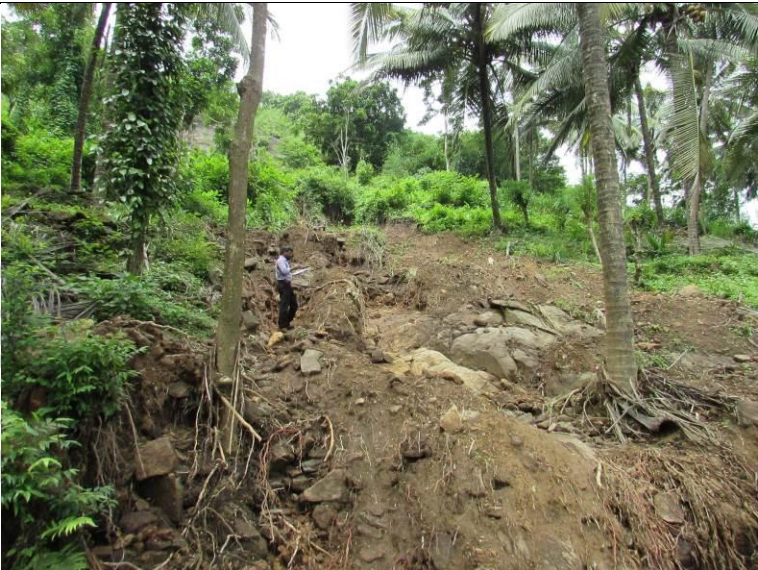
40	Summary/Abstract	:	<i>On 14th June 2018 a debris flow occurred at Kulakkadanmala. Landslide initiated at the contact between rock and overburden in the form of debris slide and then transformed in to debris flow. Excessive rainfall is the triggering factor which resulted in the reduction of strength on saturation and increase in pore water pressure. Important remedial measures include removal of precarious boulders along the slide path and to avoid unscientific hill slope modifications.</i>
41	Date of Reporting	:	03/07/2018
42	Landslide Category	:	Category III

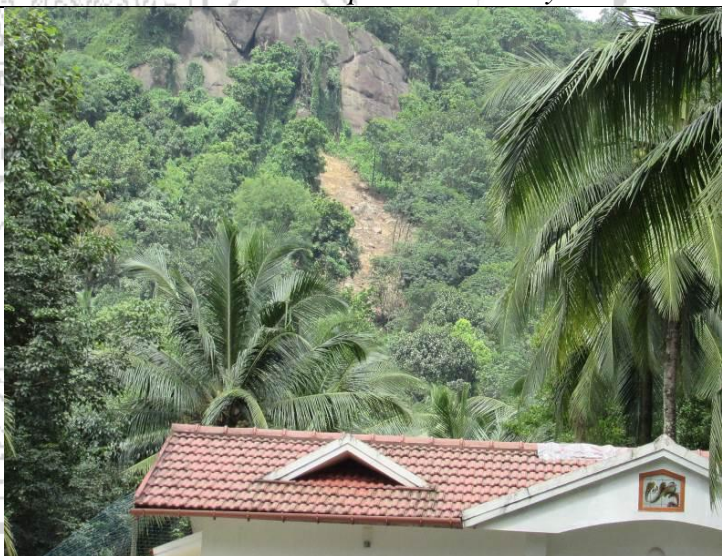
40	Summary/Abstract	:	At Vattachuvadu, one debris flow was occurred on 12 th June 2018. Landslide initiated as debris slide at the contact between rock and overburden and then transformed in to debris flow. Excessive rainfall is the triggering factor which resulted in the reduction of strength on supersaturation and increase in pore water pressure. Precarious boulders along the slide flow path have to be removed/treated. Avoid blockage of drainage system along the hill slope.
41	Date of Reporting	:	03/07/2018
42	Landslide Category	:	Category II

37	Remedial measures	:	<i>Precarious boulders along the slide flow path have to be removed/treated. Avoid blockage of drainage system along the hill slope.</i>
38	Remarks, if any	:	<i>At the crown area the debris slide fall upto about 50 to 60 m towards N 275° and then converted to debris flow downstream towards N 285° upto the tributary below.</i>
39	Photos. Sketch of Plan & section of the slide	:

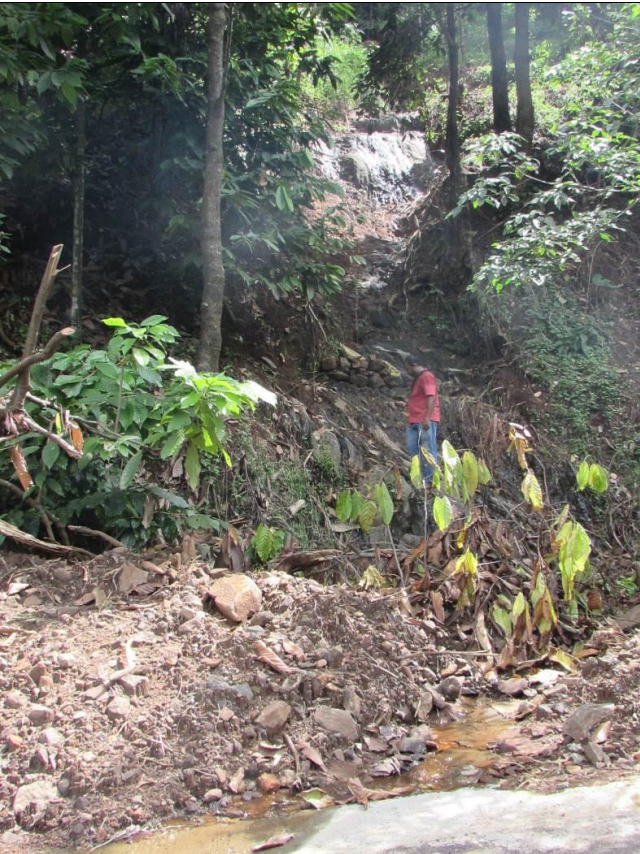
40	Summary/Abstract	:	<i>A debris flow was occurred on 13th June 2018 at Vendekkumpoyil. The debris material flows through the already existing nala path. Excessive rainfall is the triggering factor which resulted in the reduction of strength on saturation and increase in pore water pressure. The natural flow may not be blocked along the nala.</i>
41	Date of Reporting	:	03/07/2018
42	Landslide Category	:	Category III

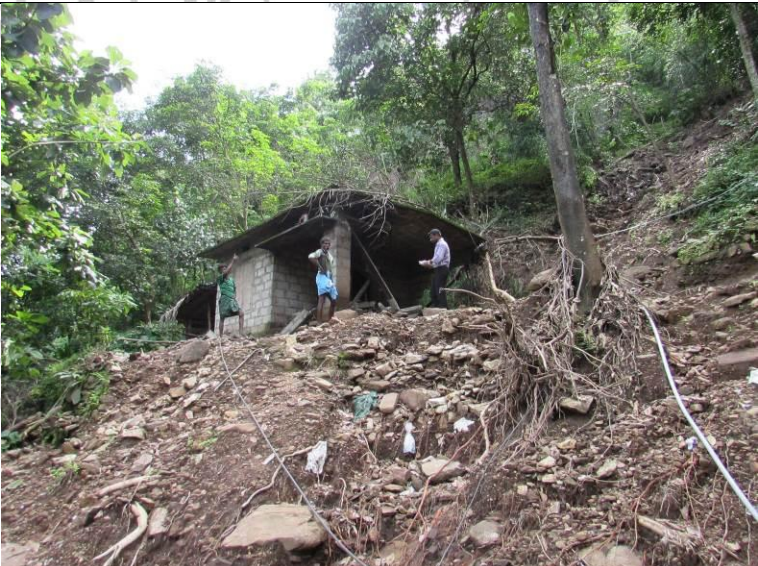
40	Summary/Abstract	:	<i>Another debris flow occurred on 13th June 2018 at Vendekumpoyil which resulted in the destruction of one house and blockage to Chempukadavu-Vendekumpoyil road. Crown cracks are present which increases the threat at this location. The landslide initiated as debris slide and then transformed in to debris flow. Excessive rainfall is the triggering factor which resulted in the reduction of strength on saturation and increase in pore water pressure. Remedial measures include (a) precarious boulders along the debris flow path has to be removed, (b) the natural flow of water may not be blocked along the hill slopes and (c) Retaining structure with proper drain holes has to be provided.</i>
41	Date of Reporting	:	03/07/2018
42	Landslide Category	:	Category II

37	Remedial measures	:	Precarious boulders along the debris flow path have to be removed. The natural flow of water may not be blocked along the hill slopes. Retaining structure with proper drain holes has to be provided.
38	Remarks, if any	:	Crown cracks are present which increases the threat at this location.
39	Photos. Sketch of Plan & section of the slide	:

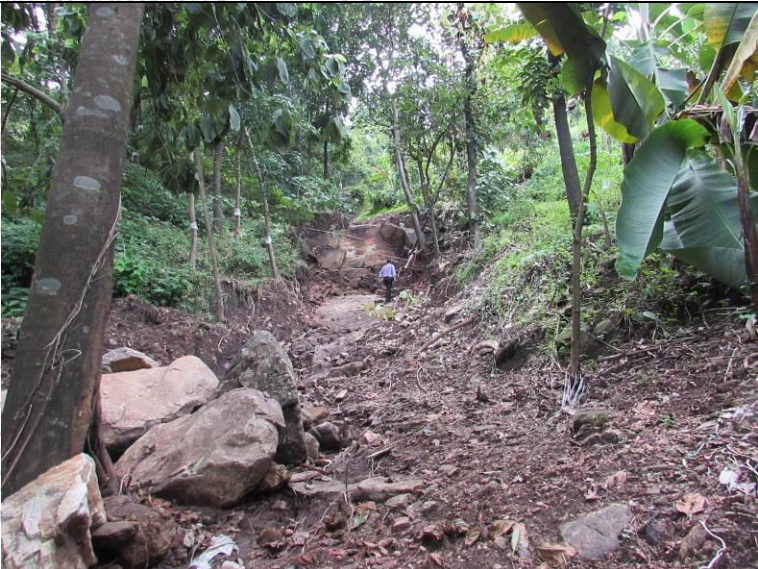
40	Summary/Abstract	:	<i>On 12th June 2018, a debris flow was occurred at Kozhikodanchal near Ambedkar Colony. The landslide initiated as debris slide and then transformed in to debris flow. Excessive rainfall is the triggering factor which resulted in the reduction of strength on saturation and increase in</i>
