**NOTE ON POST DISASTER STUDIES FOR LANDSLIDES
OCCURRED IN JUNE 2018 AT KOZHIKODE, WAYANAD AND
KANNUR DISTRICTS, KERALA**

Field Season 2018-2019

FSP No: M4SI/NC/SR/SU-KRL/2018/21108

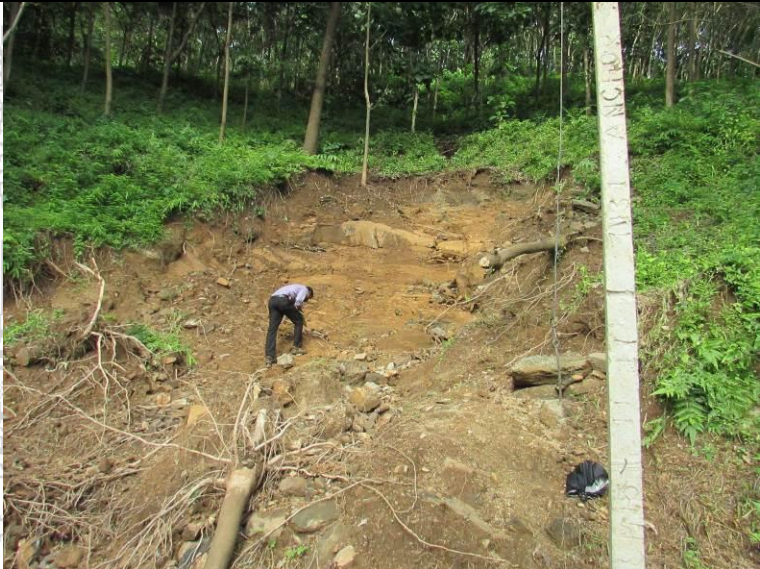
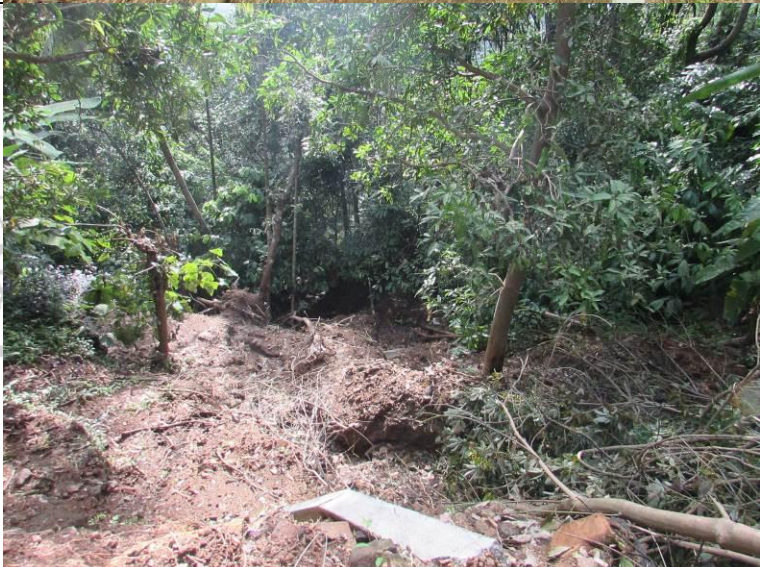
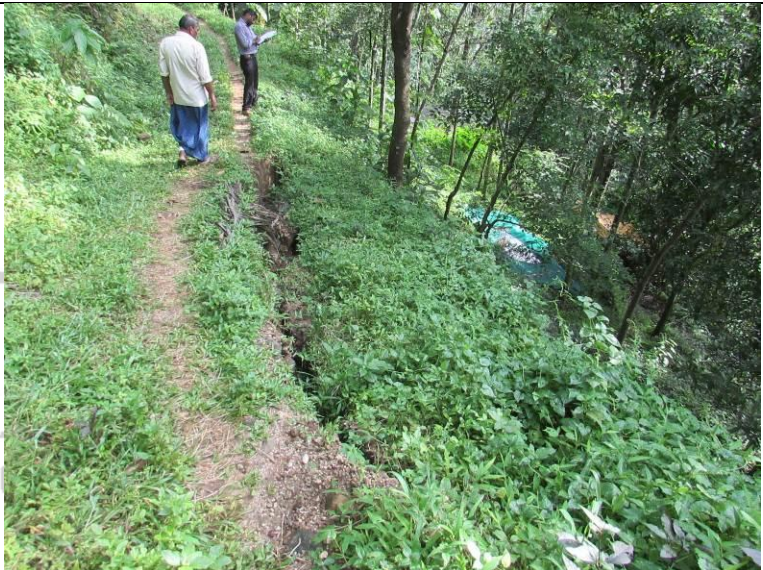
40	Summary/Abstract	:	<i>On 14th June 2018, another debris flow occurred at Ambedkar Colony resulted in the damage to cut road. Transverse cracks were developed and retaining wall also damaged. The landslide initiated as debris slide and then transformed in to debris flow. Excessive rainfall is the triggering factor which resulted in the reduction of strength on saturation and increase in pore water pressure. Remedial measures include (a) removal of precarious boulders along the debris flow path, (b) Natural flow of water should not be blocked along the hill slopes, (c) The cracks are to be sealed and should not permit the water to percolate through it and (d) Retaining wall has to be repaired with proper drain holes.</i>
41	Date of Reporting	:	03/07/2018
42	Landslide Category	:	Category III

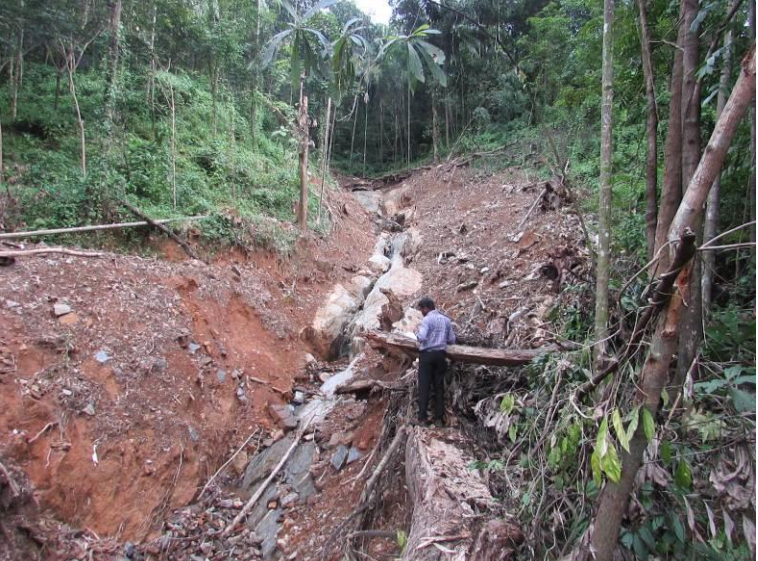
40	Summary/Abstract	:	<p><i>A multiple type debris flow occurred on 12th June 2018 at 18:00 hrs and 19:00 hrs near Nooranthodu LP school. Panchayath road and the side wall of the nala got damaged. One house and one temple got damaged. The temple in the downslope area flooded with debris material. Initially the material flows from eastern side and then diverted to a northward slope. The landslide initiated as debris slide and then transformed in to debris flow along the pre-existing nala path. Excessive rainfall is the triggering factor which resulted in the reduction of strength on saturation and increase in pore water pressure. It is suggested to remove the precarious boulders along the debris flow path and the natural flow may not be blocked along the nala.</i></p>
41	Date of Reporting	:	03/07/2018
42	Landslide Category	:	Category II

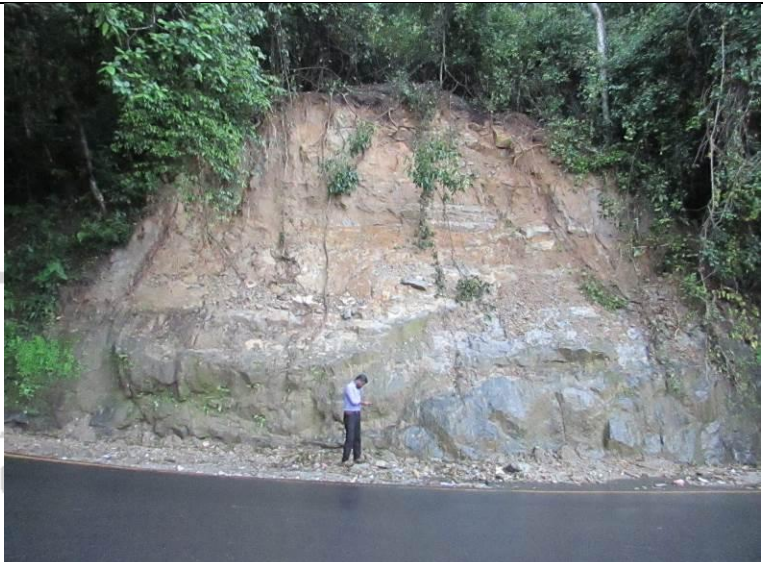
40	Summary/Abstract	:	<i>On 14th June 2018, a debris slide occurred at churam road. The rock – overburden contact is the movement plane. Unscientific slope modification and unprotected cut slope made for road construction. Incessant rainfall is the triggering factor which resulted in the reduction of strength on saturation and increase in pore water pressure. Retaining wall with proper drainage outlet has to be provided.</i>
41	Date of Reporting	:	03/07/2018
42	Landslide Category	:	Category III

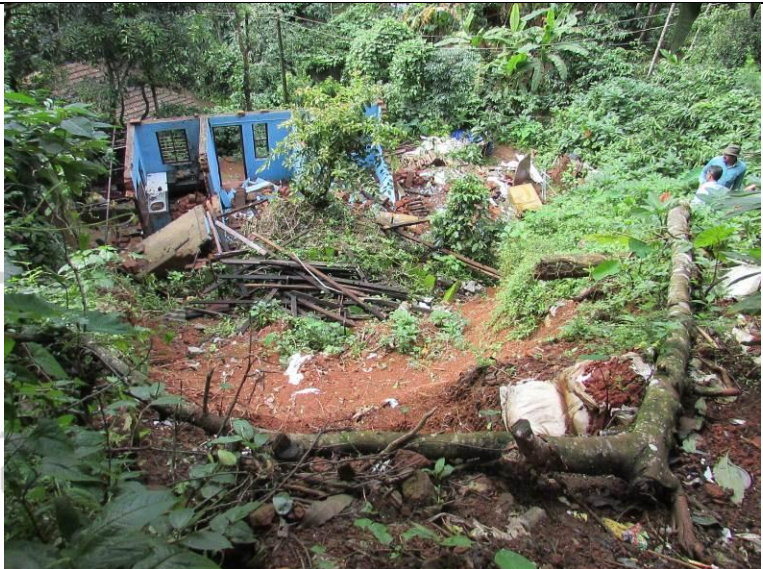
40	Summary/Abstract	:	<i>An earth side occurred on 14th June 2018 at Aramalakunnu which affected the people and damage to the houses. Rock boulders are observed to be embedded in the soil column. Another adjacent house also got damaged with small stripping failures. Crown cracks are developed. Two houses located above this landslide are in threat. Another house adjacent to the damaged one is also partially damaged with development of wall cracks. Two houses are located at the downslope along the flow path. The important causes include (a) unscientific slope modification and unprotected cut slope made for house construction and (b) excessive rainfall is the triggering factor which resulted in the reduction of strength on saturation and increase in pore water pressure. It is suggested to provide proper retaining wall with weep holes at the vertically cut surfaces. Crown cracks are to be treated in order to avoid percolation of water.</i>

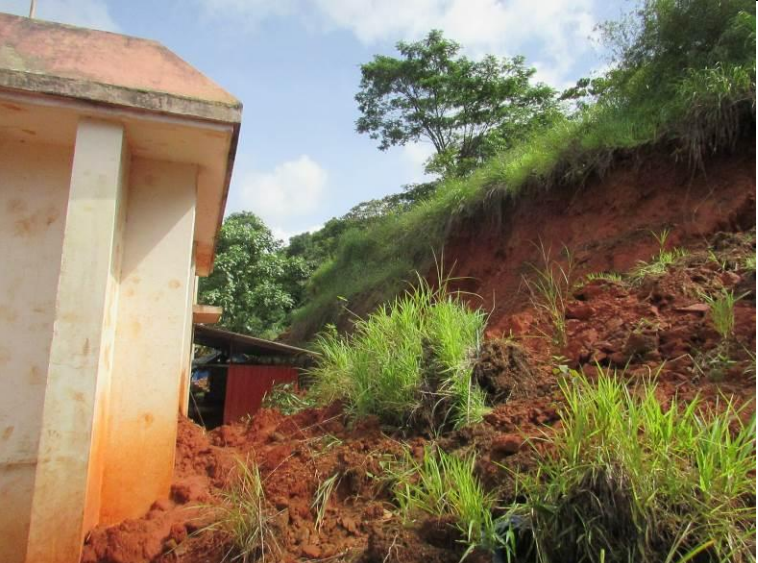
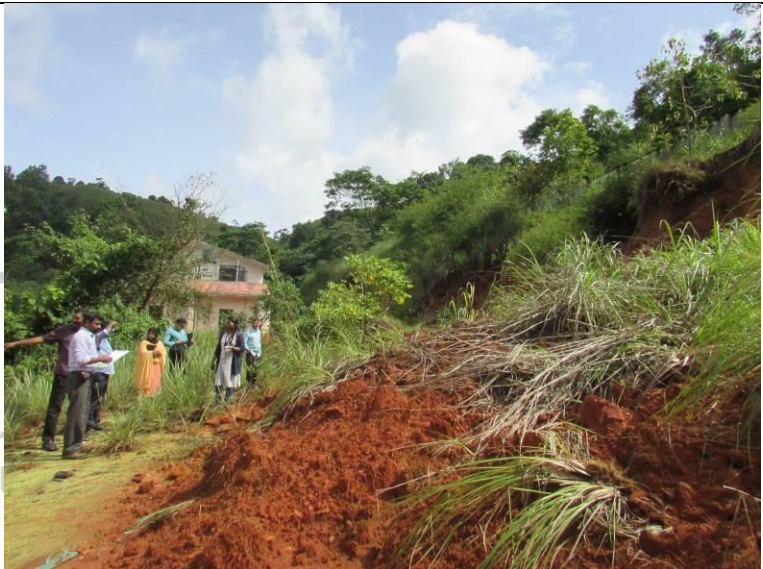
40	Summary/Abstract	:	<i>On 14th June 2018, an earth slide occurred in the compound of Jawahar Vidhya Nagar school. The important causes include unscientific slope modification for building construction. Incessant rainfall resulted in the reduction of strength on saturation and increase in pore water pressure. Proper retaining structures may be provided.</i>
41	Date of Reporting	:	04/07/2018
42	Landslide Category	:	Category III

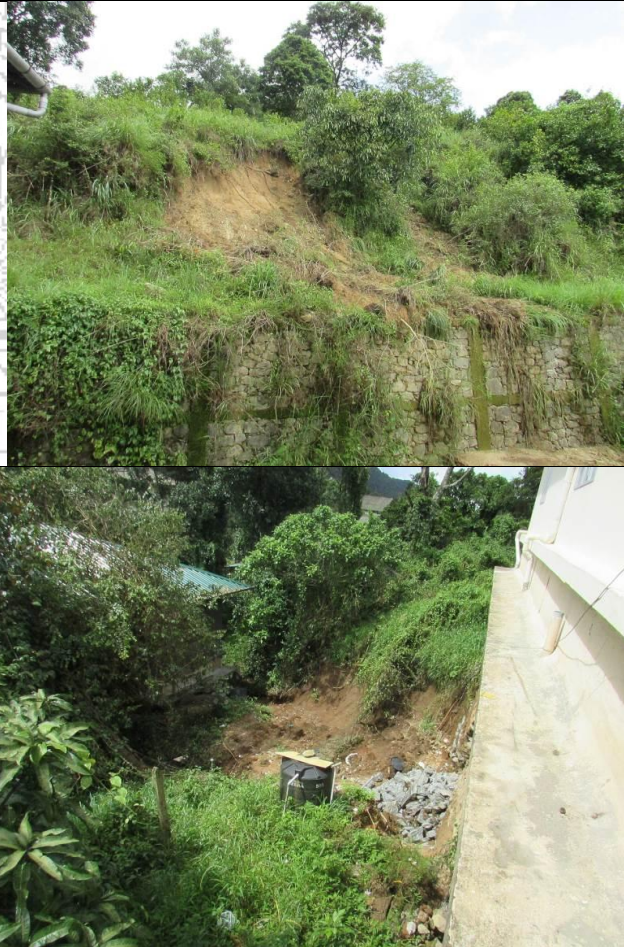
40	Summary/Abstract	:	A debris slide was occurred on 14 th June 2018 at the Veterinary College, Vythiri. The main cause is the unscientific

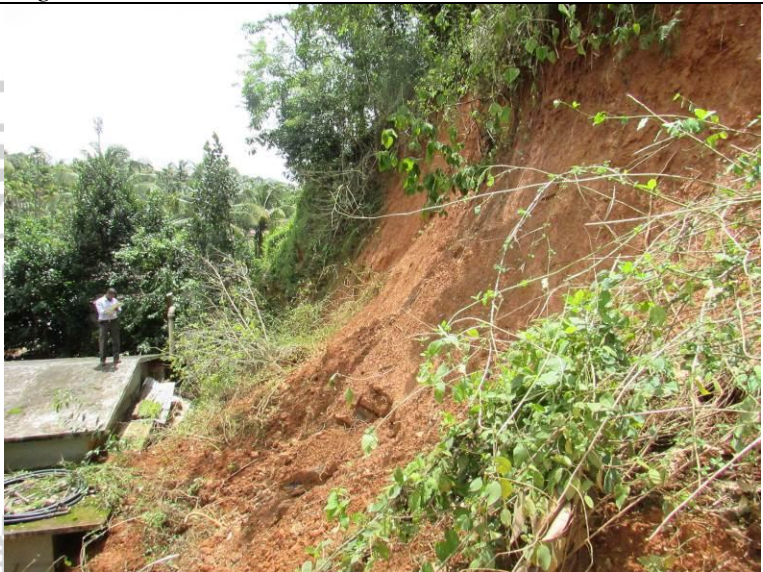
40	Summary/Abstract	:	<i>An earth slide was occurred on 14th June 2018 at Achoor, Vythiri resulted in the death of one person and damage to house. The important causes include (a) Unscientific slope modification and unprotected vertical cut slope made for house construction and (b) Incessant rainfall is the triggering factor which resulted in the reduction of strength on saturation and increase in pore water pressure. Remedial measures include (a) Easing of slope with benches and (b) The vertical cut may be protected with proper retaining wall with weep holes.</i>

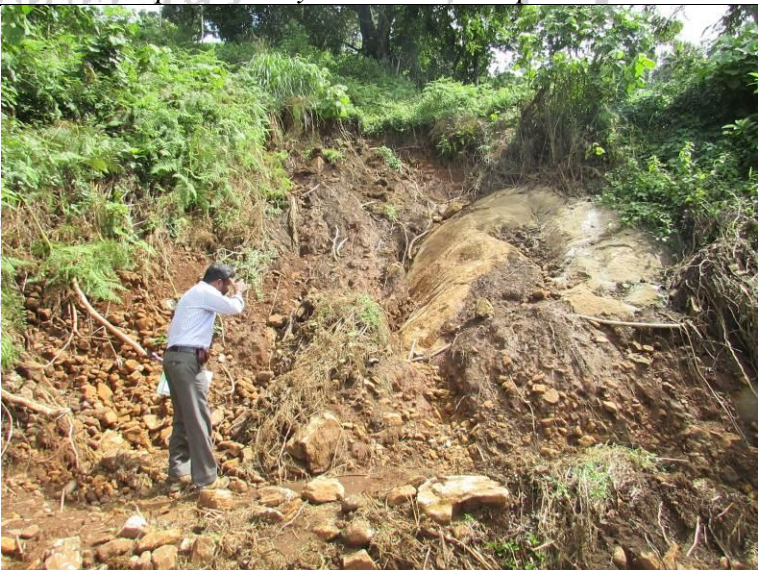
40	Summary/Abstract	:	<i>A debris slide was occurred on 14th June 2018 at Valaramkunnu. Radial cracks developed on the upslope area. Debris material has reached up to nursery school downslope. The main causes include (a) Unscientific slope modification and unprotected cut slope made for road construction and (b) Incessant rainfall is the triggering factor which resulted in the reduction of strength on saturation and increase in pore water pressure. Remedial measures include (a) Toe support with proper drainage conduits may be provided and (b) Radial cracks are to be treated in order to avoid percolation of water.</i>
41	Date of Reporting	:	04/07/2018
42	Landslide Category	:	Category III

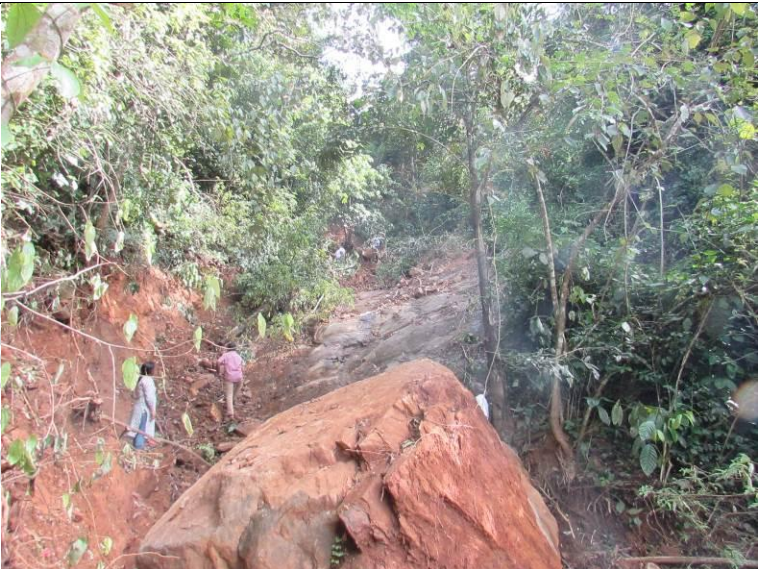
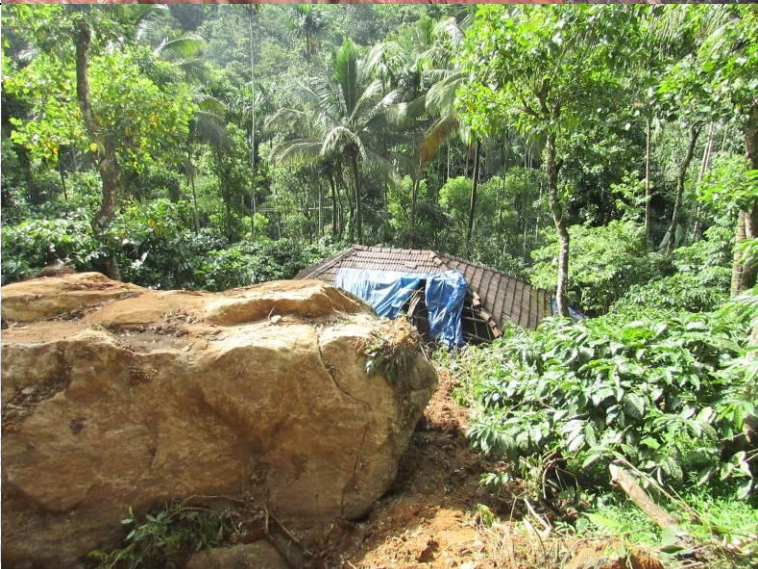
40	Summary/Abstract	:	<p>A rock cum debris slide was occurred on 14th June 2018 at Veetikunnu which resulted in the damage to one house. Incessant rainfall is the triggering factor which resulted in the reduction of strength on saturation and increase in pore water pressure. Remedial measures include removal of precarious boulders along the slide path and ensure free flow of water along the hill slopes. Avoid construction of dwelling units in the vicinity of the flow path.</p>
41	Date of Reporting	:	04/07/2018
42	Landslide Category	:	Category II

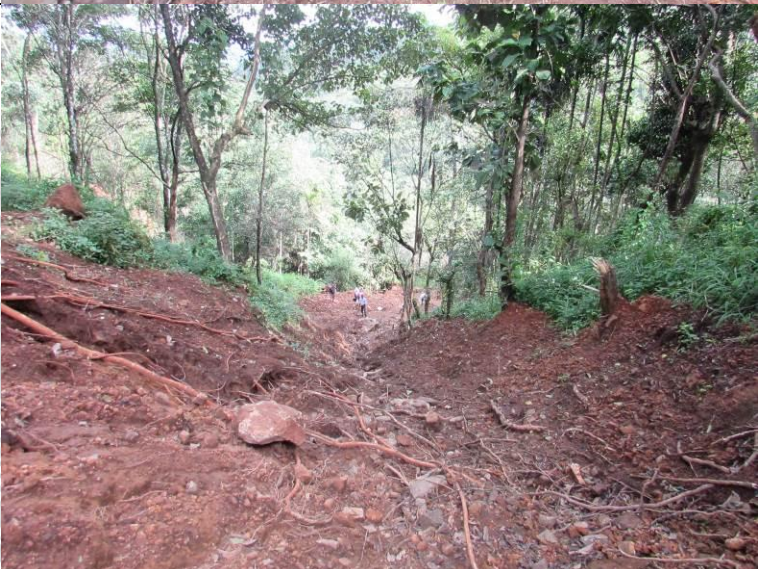
40	Summary/Abstract	:	<p><i>A successive landslide occurred on 14th June 2018 at Pulipparakunnu. The landslide initiated at the contact between rock and overburden in the form of debris slide and then transformed in to debris flow. Excessive rainfall is the triggering factor which resulted in the reduction of strength on saturation and increase in pore water pressure. Precarious boulders along the debris flow path have to be removed. The natural flow of water should not be blocked along the nala.</i></p>
41	Date of Reporting	:	04/07/2018
42	Landslide Category	:	Category III

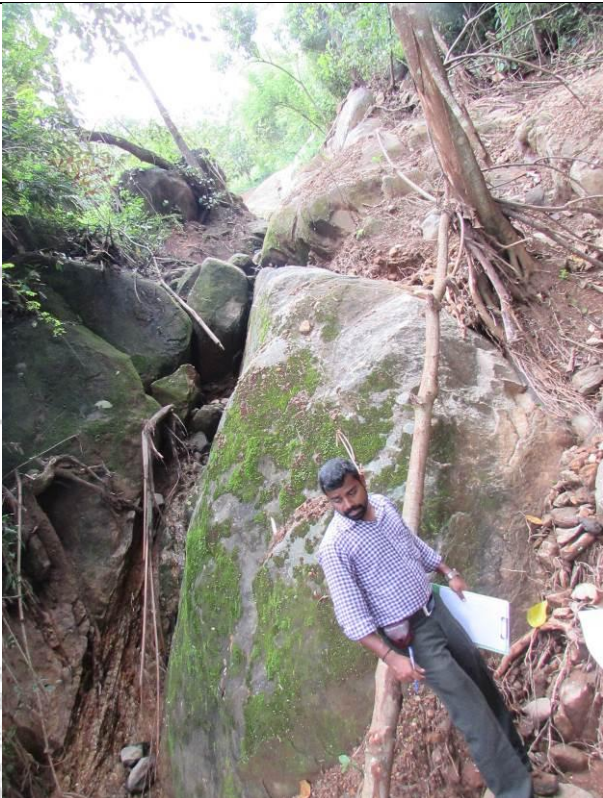
40	Summary/Abstract	:	<i>A debris flow was occurred on 12th June 2018 at Parakkamala where the debris material flown along an already existing nala path. This landslide is a reactivated one. Excessive rainfall is the triggering factor which resulted in the reduction of strength on saturation and increase in pore water pressure is the important cause. Remedial measures include (a) Unscientific hill slope modification has to avoided and (b) Avoid constructing houses/buildings along the debris flown nala path.</i>
41	Date of Reporting	:	05/07/2018
42	Landslide Category	:	Category II
