LANDSLIDES IN NILGIRIS: CAUSAL FACTORS AND REMEDIAL MEASURES

Abstract

Keywords: Nilgiris, Landslides, Causal factors, Rainfall

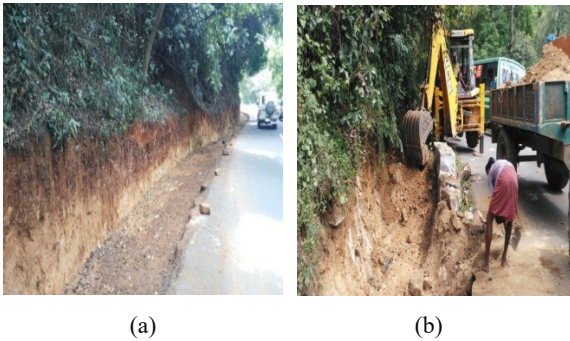
Figure 3a and 3b shows the excavation of slope at toe for widening of road along Mettupalayam – Coonoor highway. Excavation of slope at toe reduces the shear strength of the soil due to yielding of soil mass (Sutejo and Gofar 2015). When rainfall infiltration saturates the slope, the shear stress increases thus increases the driving force. Decrease in shearing resistance and increase in shearing stress due to excavation of slope at toe and rainfall infiltration may lead to slope failure. Hence, the slope failure may end up with complete closer of road traffic in Nilgiris.

Figure 3. View of excavation of slope at toe; (a) & (b) along Mettupalayam - Coonoor road network

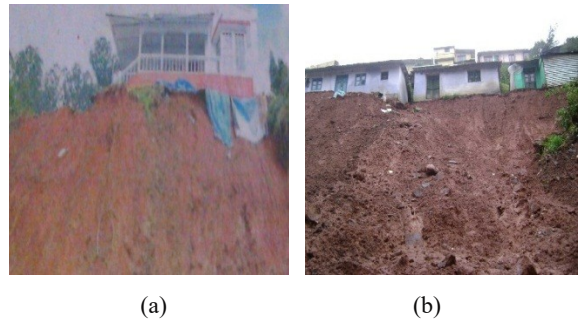
Figure 5a and 5b shows slope failure at Kothagiri and Nondimedu where buildings constructed at slope crest are on the verge of failure. Failure occurred, due to loading of slope at the top, under heavy rainfall. Building weight present on the slope crest adds to gravitational load which increase the driving force and causes slope failure. If overloading occurs away from the crest of the slope the influence is minimal but if it is within the vicinity of the crest of the slope its effect cannot be ignored as observed from figure 5a and 5b.

Figure 5. View of slope failure due to loading the slope at crest; (a) Kothagiri (b) Nondimedu

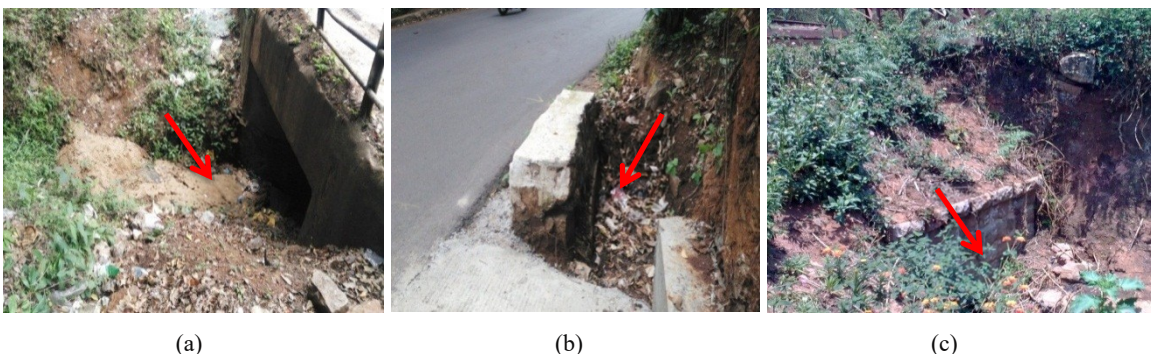
Drainage of water is one of the most effective techniques which increase stability of slopes. Figure 6a, 6b and 6c shows blocking of surface drainage systems (drainage pipes and drainage culverts) along Mettupalaym - Coonoor national highway and Aravankadu location. Blocking of drainage system allows the rain water to infiltrate into the slope, leads to build up of pore water pressure and thereby increases the driving force.

Figure 6. View of blocking of surface drainage pipe and drainage culvert ; (a) & (b) along Mettupalayam–Coonoor road network (c) Aravankadu location
