# Hydrogeological assessment of Demul and Chicham village of Lahaul and Spiti district, Himachal Pradesh

Advanced Center for Water Resources Development And Management

Technical Report no. ACWA/Hydro/2018/H64

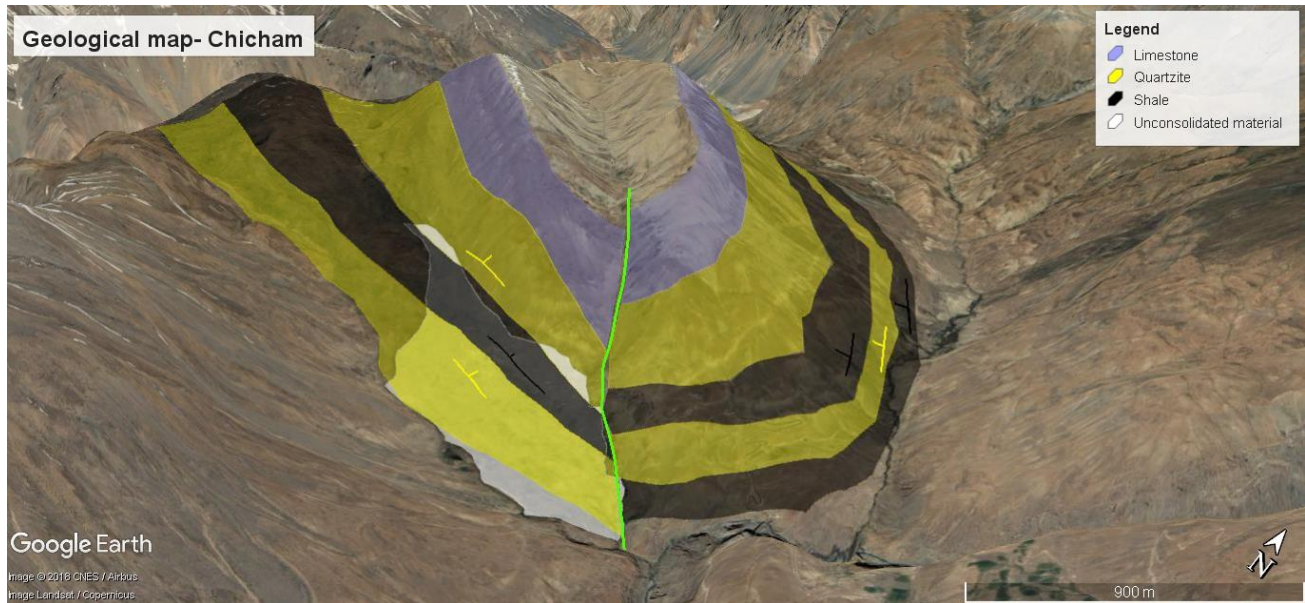
Figure 3: Geological map of Chicham

The geology of Chicham village comprises dominantly of Quartzites, Shales and Limestones (Fig.3). Quartzites are fractured while the shales are highly weathered. Limestones are found only in the ridge areas. The mapping data indicates a synclinal fold with a fault running along the axis of it. The village sits on the top of thick loose colluvial deposit which overlies the quartzites and shales.

The rocks on the left of the fault striking WNW- ESE have dips towards NE while the rocks on the right striking NNW-SSE have dips towards SW. The limestones present on the top forms the core of the syncline. The village lies on the left side of the fault. While mapping it was observed that quartzites exposures were prominent while the shales being fissile were highly weathered with weak traces of fractures.

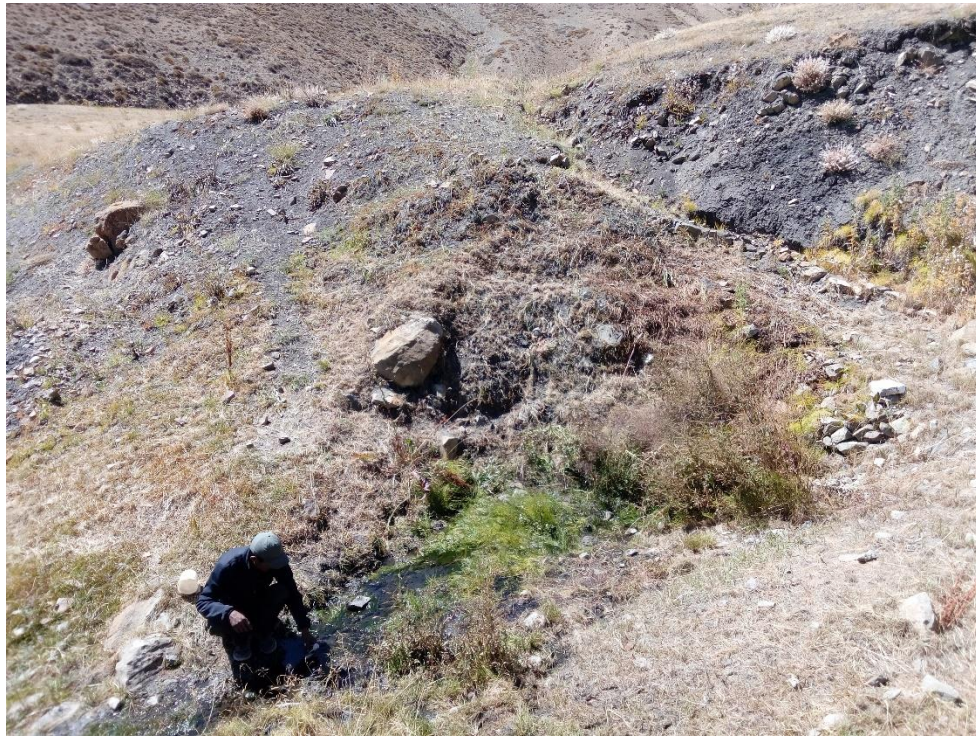
Figure 6: A spring emerging out through the thick pile of loose colluvial deposit

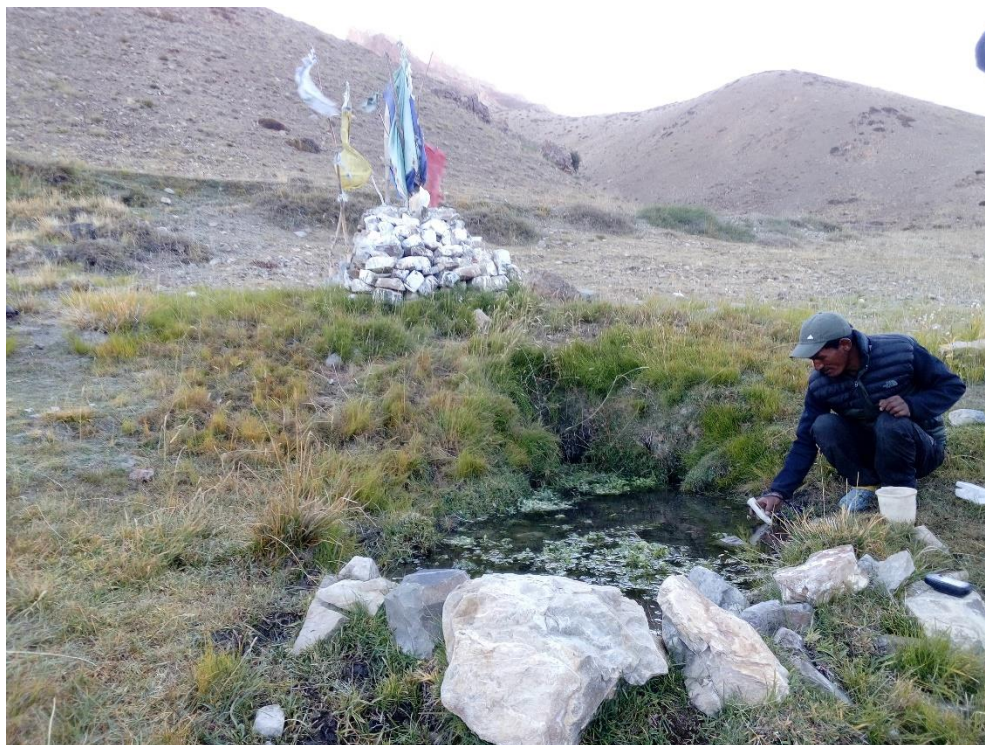
Figure 7: A high altitude spring that forms main source of the village

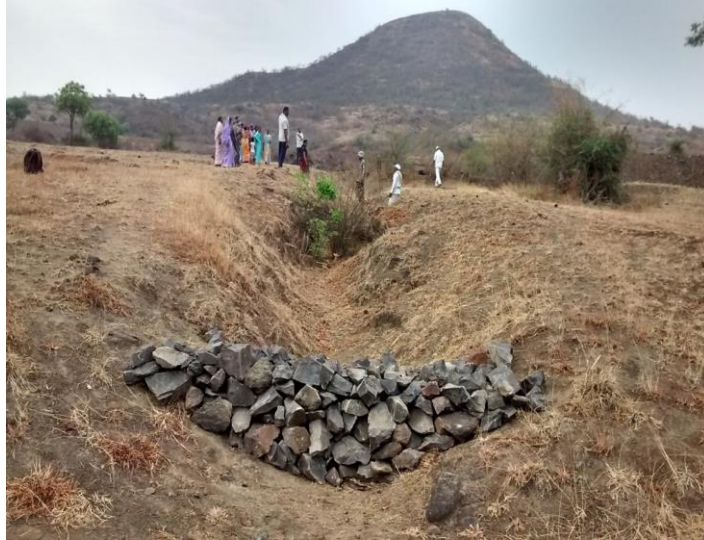
Figure 9: Stone bund structure constructed in a stream channel (Source: Velu GP, Maharashtra)

The slope facing the NE direction is the ideal site for carrying out recharge interventions. However, the slope being steep will make it difficult to undertake any physical treatment measure like trenching, percolation pit etc. Therefore the other potential site for recharge is through the drainage network where some of the drainage line treatment measures can be planned. Stone bunds or loose boulder check dam construction across the stream channel will allow snow/rainwater to get accumulated facilitating recharge (Fig. 9).

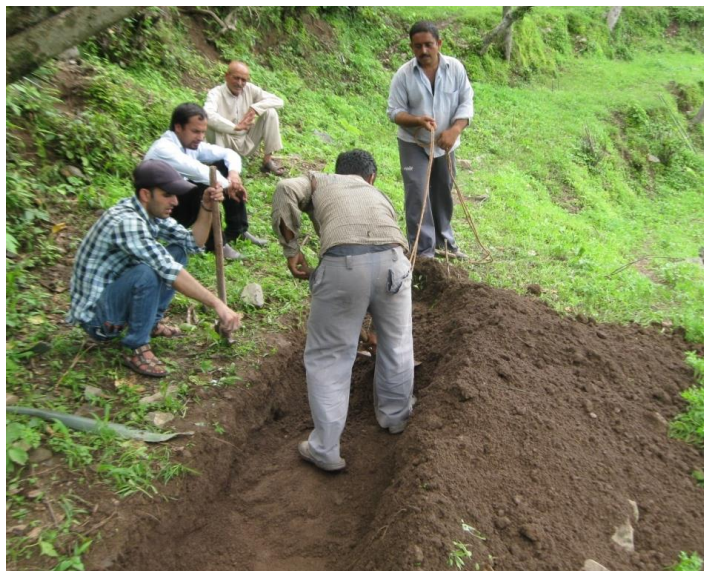
Figure 10: Staggered trenching on the slopes (Source: PSI, Dehradun)

The higher reaches of the watershed have natural depressions which will anyway trap snow/rain. However some physical recharge structures can be planned in the proposed recharge zone. Some primary recharge structures like staggered trenches (Fig.10), small percolation pit can be created to trap rainwater/ snow, which will facilitate recharge to the aquifer system feeding springs.

The slopes facing SW direction and E direction based on hydrogeological setting form the ideal site for undertaking recharge activities. The slope stability has to be accounted before undertaking any recharge intervention. Based on slope conditions, recharge structure like contour trenching (Fig.10) can be undertaken in the identified recharge zones (Fig. 16).

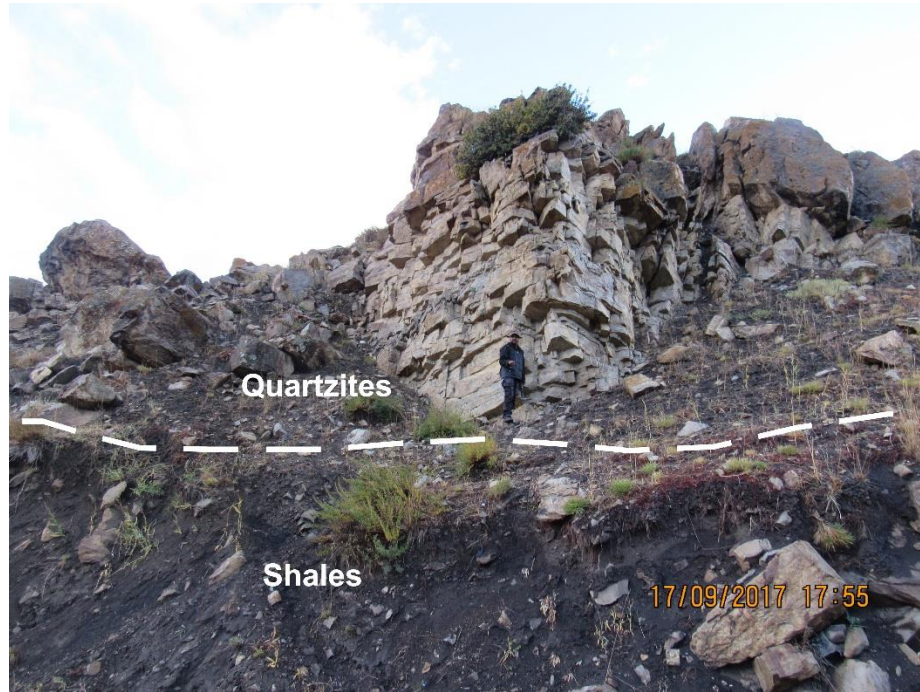
Figure 14: A section showing fractured quartzite overlying weathered shales

Based on primary geological observations and spring locations, groundwater feeding the majority of the springs occur in the weathered shales (Fig.14) and loose colluvial deposit forming the main aquifer system. The synclinal structure facilitates groundwater to move towards the midst of watershed leading to the saturation in sheared-weathered shales and loose colluvial deposit. Some amount of groundwater also occurs in fractured limestones and quartzites. However, the groundwater in these fractures ultimately contribute to the main aquifer system owing to the structure present in the area (Fig.13).

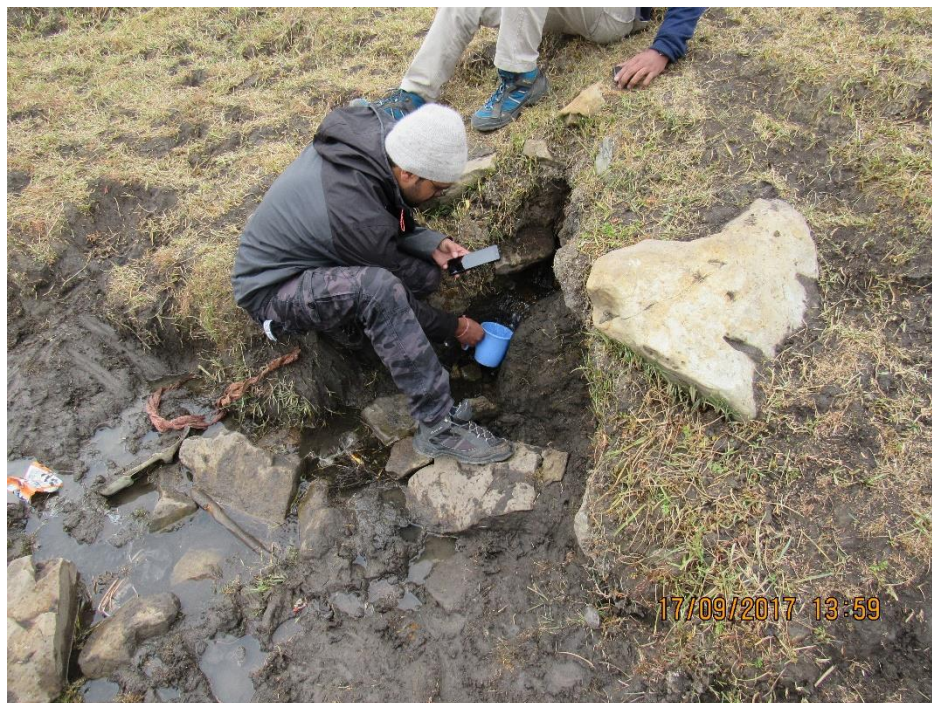
Figure 15: A classical depression spring emerging out through loose colluvial deposits
