# WETLANDS OF THE NILGIRIS

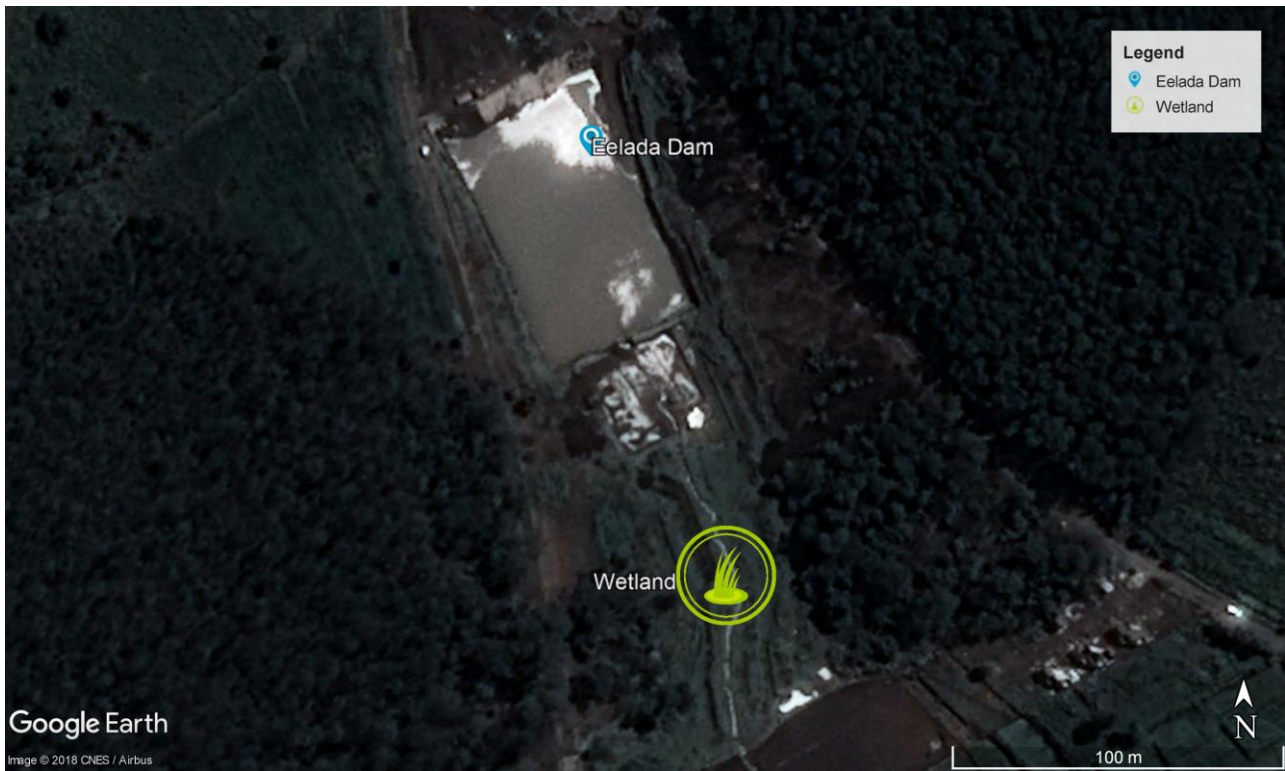
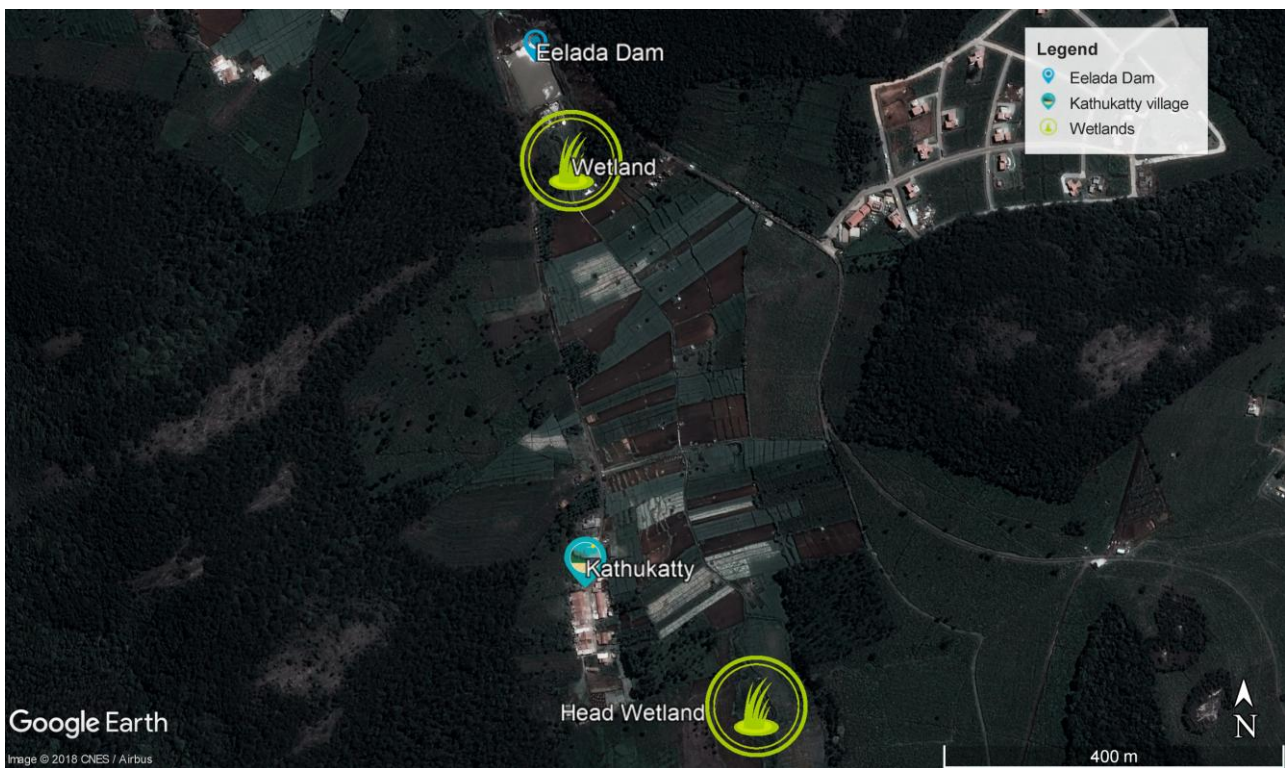
Figure 2: Imagery of the wetlands at Elada

The current wetland is a rectangular land measuring about 160m in length and 70m width with the check dam (56m x 87m) in the middle that holds water for drinking and irrigation for a part of Kotagiri town.

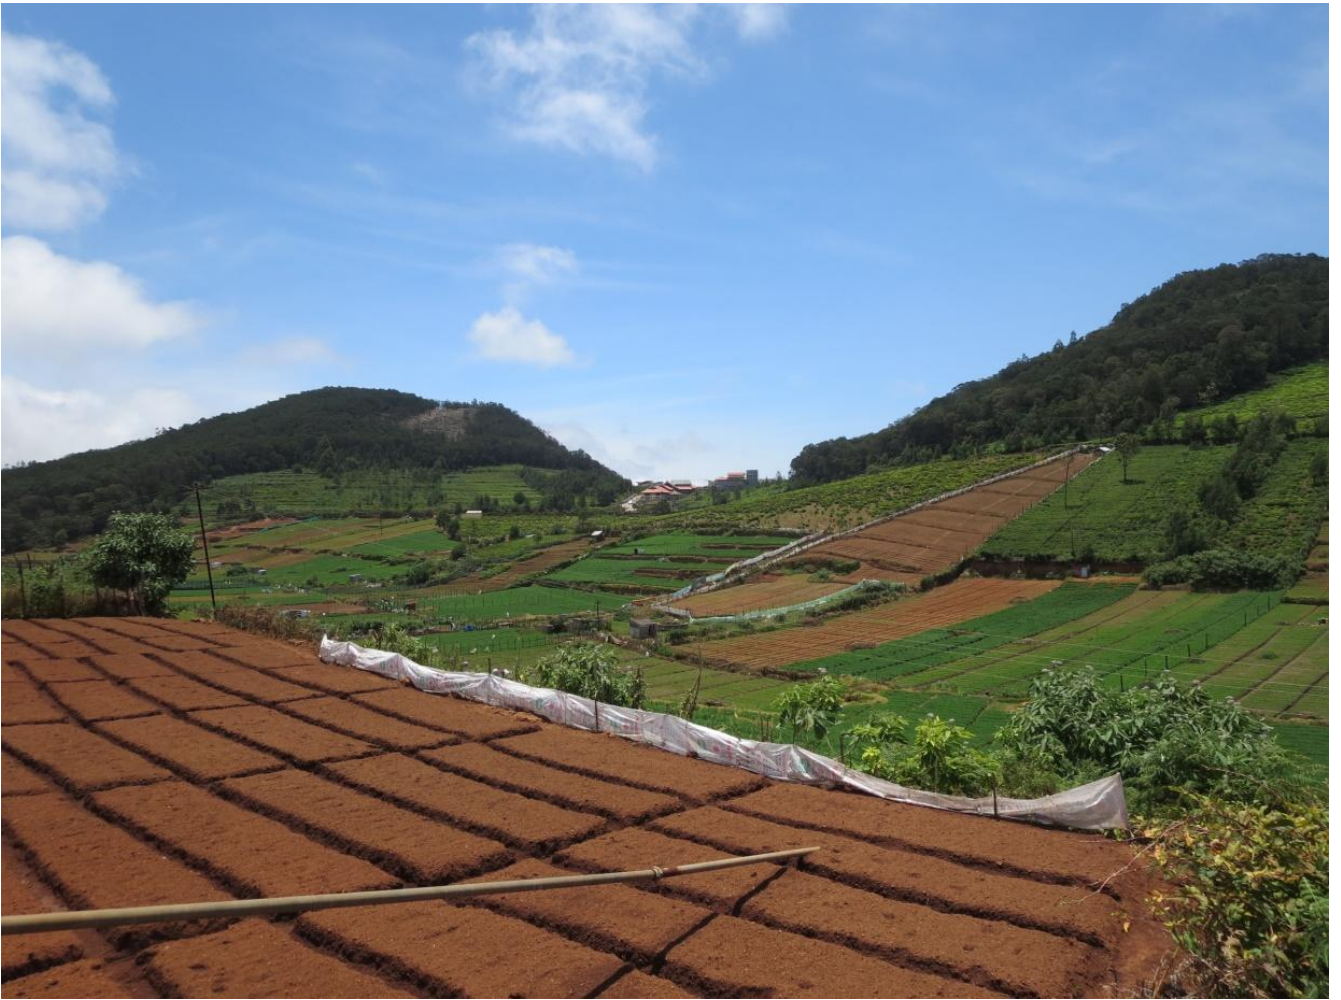
*Figure 3: Agriculture being practised in the valley*

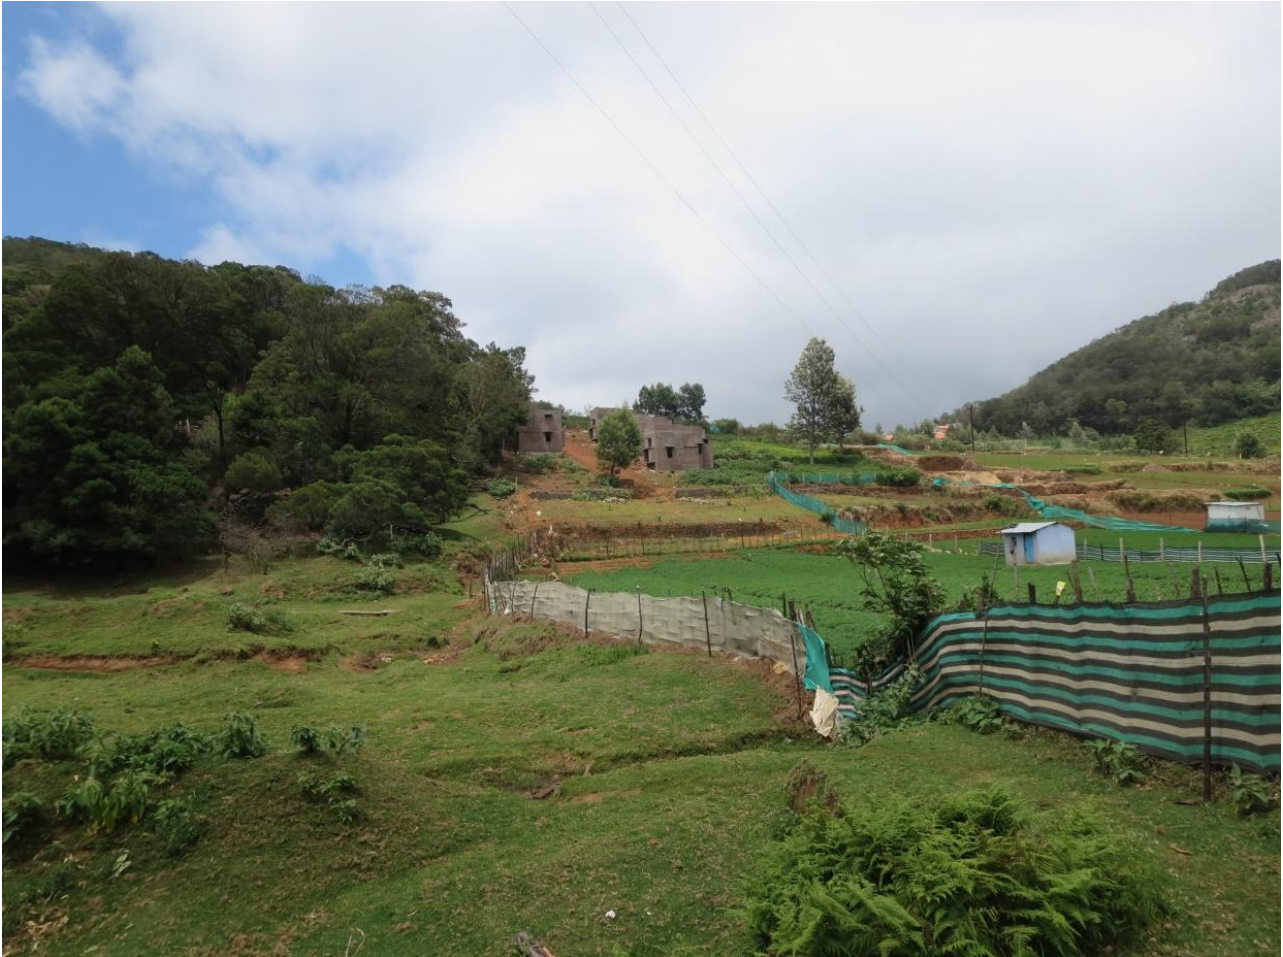
The wetland at Elada is the source of the water to the dam. The wetland is open, small and compact situated at high altitude. The wetland though small is varied. On one end is relatively hard ground - adjacent to the agricultural land. A small stream cuts through this patch of grass leading to the pool. As the pool starts - the wetland plants are seen and the water emerges to the surface. Depth is also seen in this pool. There is a slow flow of water from the stream into this wetland. At one end of the wetland is a drainage channel which is adjacent to the field and perpendicular to the stream.

*Figure 4: Agricultural land separated from the rest of the wetland*

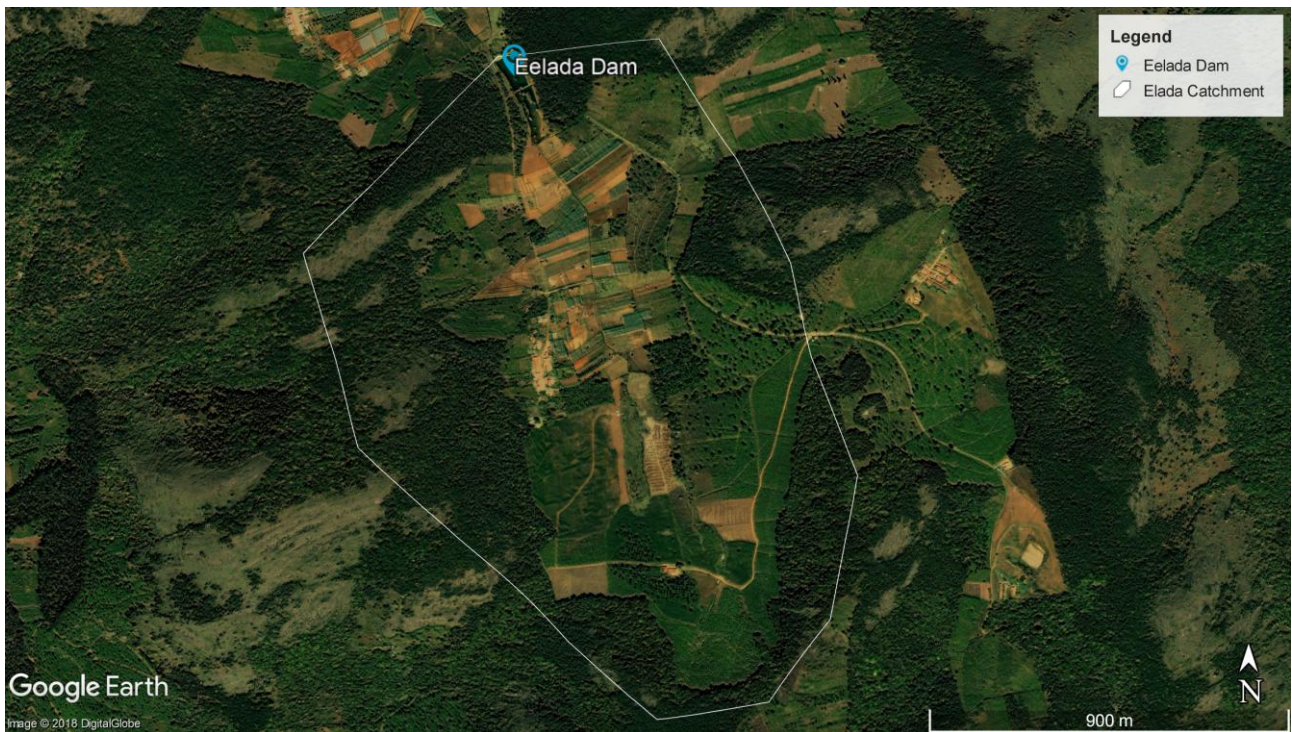
Figure 7: Imagery of the catchment in 2008.

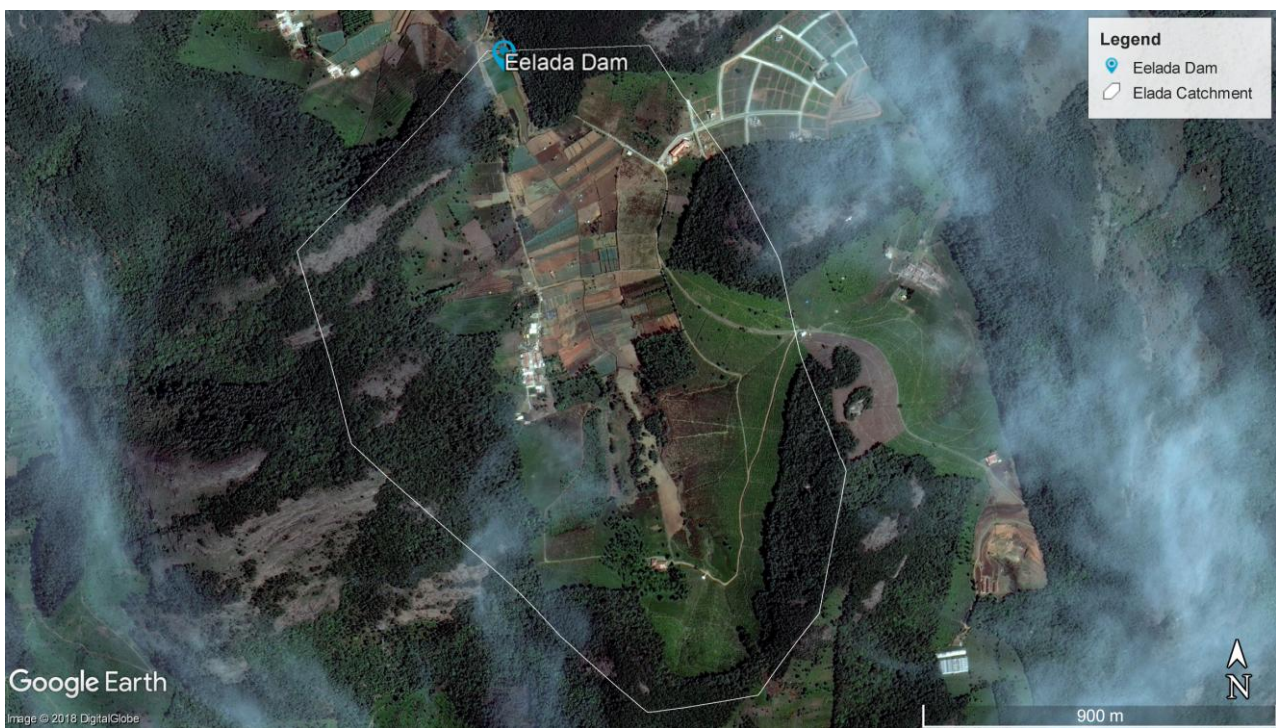
Figure 8: An imagery of the same catchment in 2015.

Changes were observed during the present visit when compared to the earlier visit made in 2006. A motorable road was laid in between the wetland. The poa grass has been uprooted (cut in square shape), which could be for preparing lawns. A cemented check dam has been constructed acting as a storage structure for water. Water from the check dam is being used to wash vehicles. Grazing by cows and goats was observed.

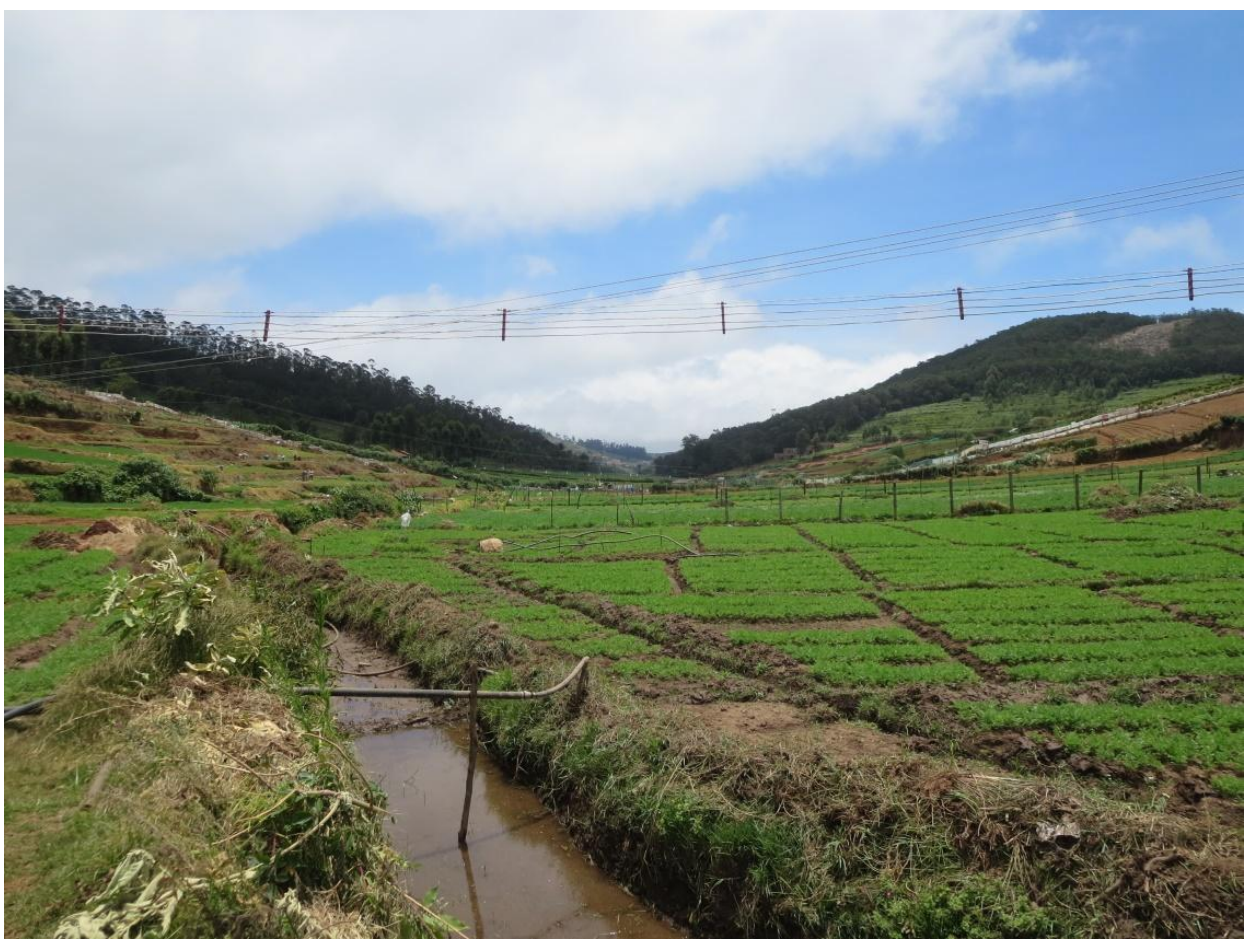
The stream joining the wetland which could also be the main source of water for the wetland comes from a shola patch crisscrossing some fields. The team noticed that water was being pumped from the stream before entering the wetland by agriculturalists close to the wetland which could lead to reduced inflow. Moreover, though no direct discharge of effluent etc. could be seen into the stream or the wetland, a concern is the contamination of the stream water with chemicals and pesticides

*Figure 10: Stream water being used for irrigation in the adjacent fields*

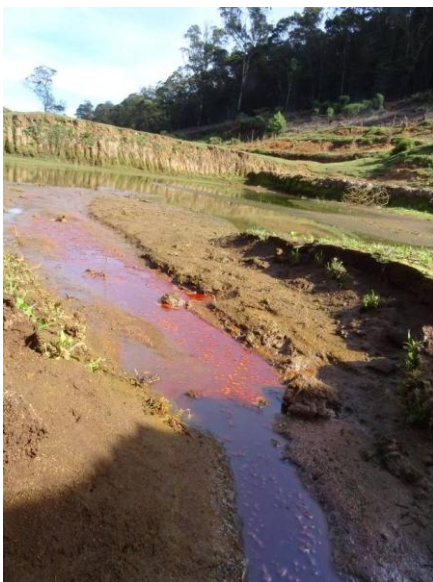
*Figure 11: High iron content in the water*

Seen from the samples, the Iron content in the water keeps increasing as it collects more silt from the weathered materials as the stream runs downstream. The dissolved oxygen falls downstream because of the poor flow of water and stagnation at certain places. The natural flow of water is disrupted by rechanneling the stream around the farm land reducing the rate of flow in the stream. This causes the water to stagnate at certain places and makes way for moss formation. This is seen downstream towards the check dam and thus the dissolved oxygen at this point is significantly lower than the upstream.

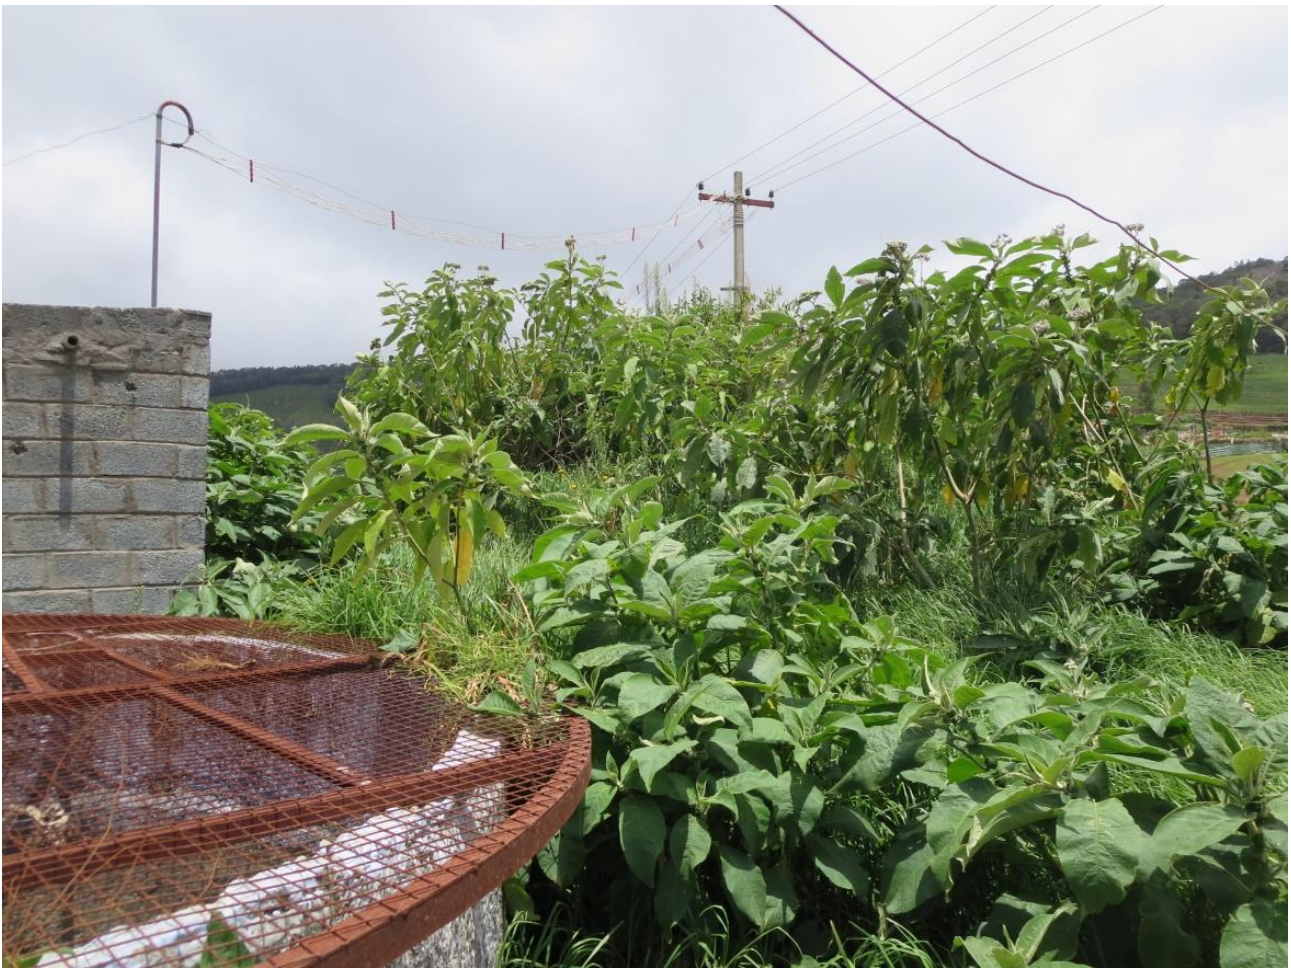
While most of the catchment is taken over by tea plantation, there is a significant tree cover which consists of invasives such as *Eucalyptus* and *Acacia meansii* that make the soil acidic and prevents growth of other native shrubs in the soil. Apart from this there is *Solanum verbascifolium*, an invasive plant lining the wetland area.

*Figure 12: Exotics growing near the water source*

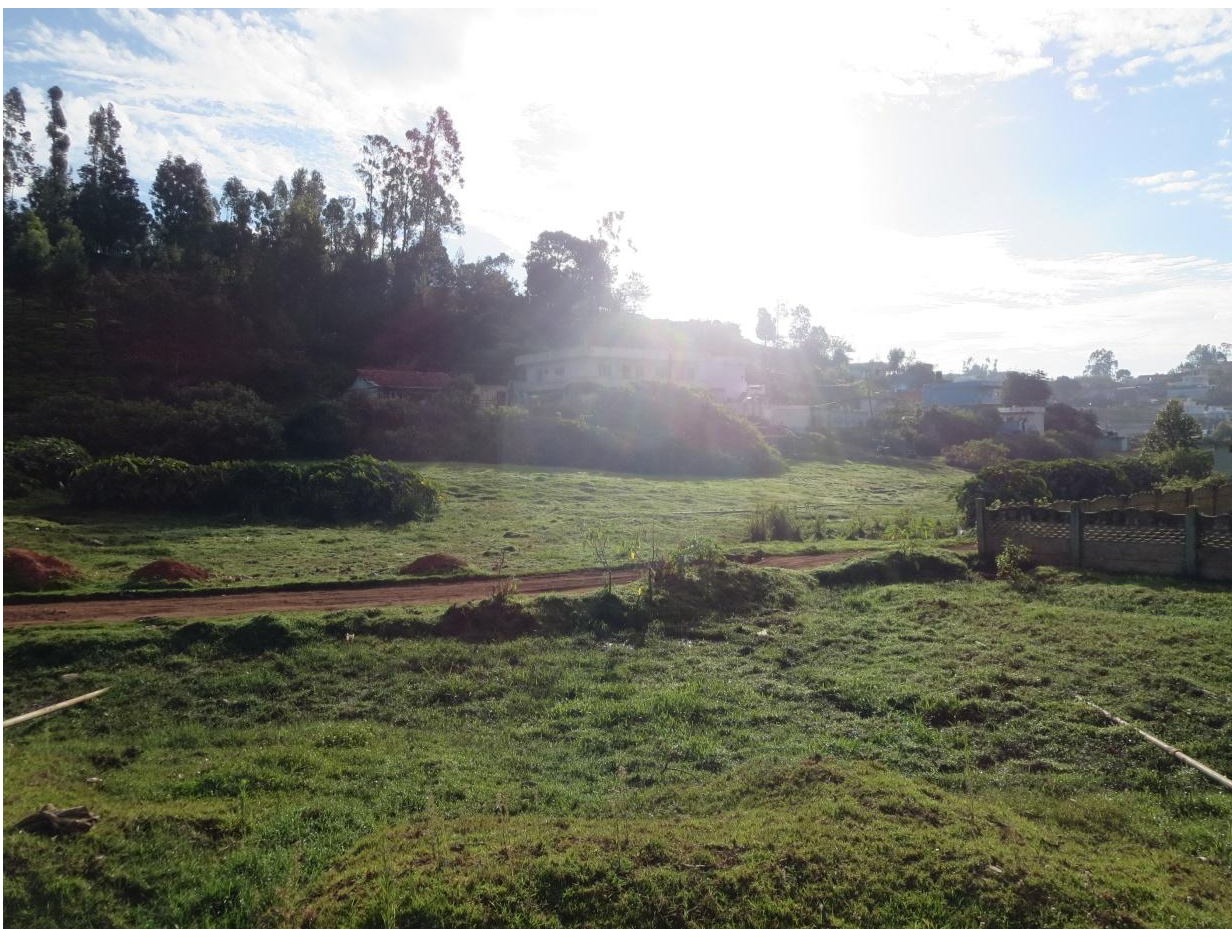
The 7 acre wetland has a stream that starts from the spring to the west that cuts across the wetland and goes downstream to Donnington through the dense neighbourhood and runs further down. The water at the head wetland is cleaner in comparison to the downstream due to the sewage being let out in the downstream. The water from rifle range is used by the immediate neighbourhood and also by the panchayat for supply to Alports area just above the wetland for an hour every alternate day.

Figure 3: Wetland at Rifle range

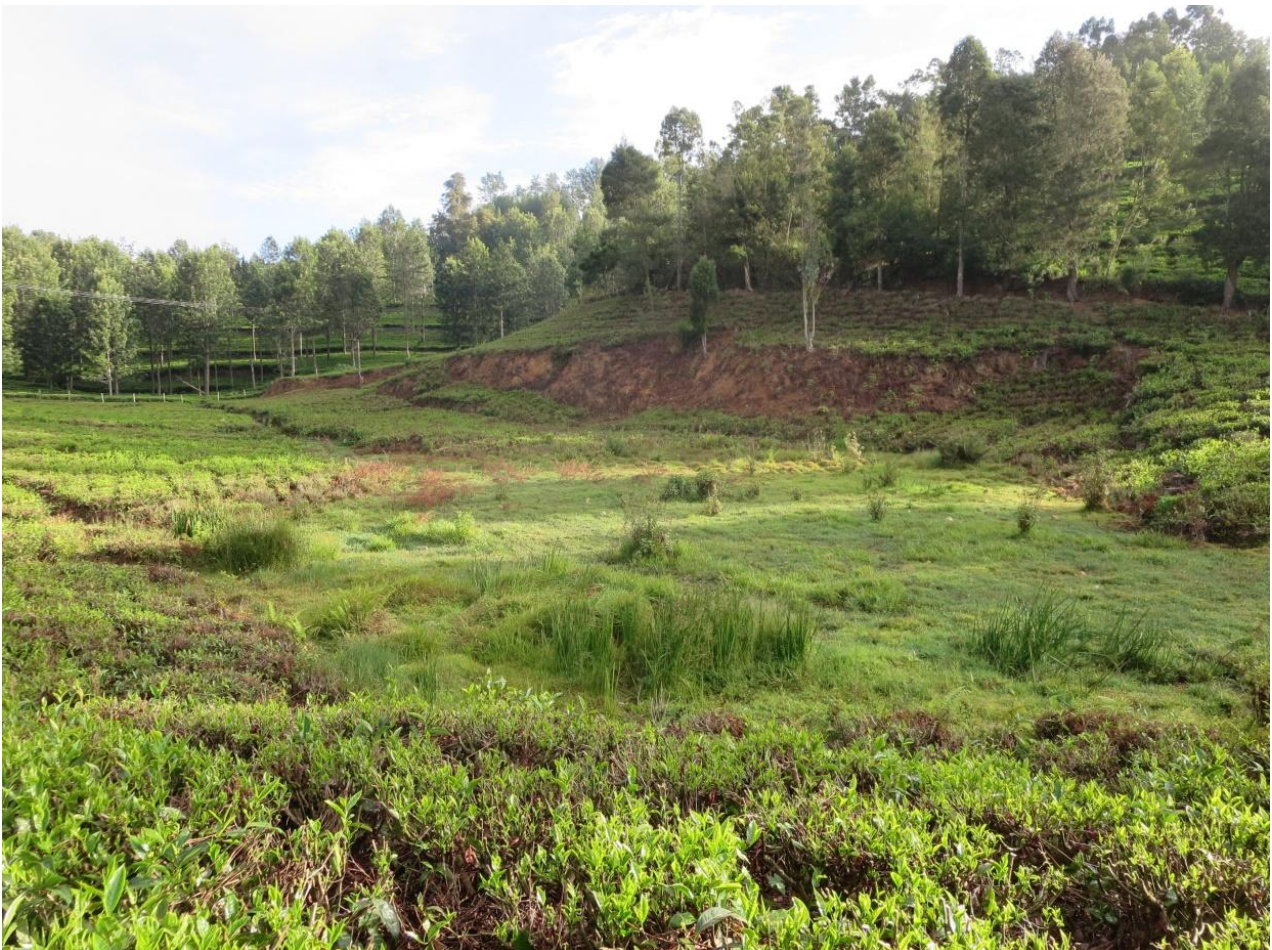
Figure 5: Head wetland at Rifle range

Almost half of the watershed area is occupied by tea plantations (51% of the watershed) that reach down till the wetland itself in the head wetland. Since tea requires a dry landscape to grow in, most of the growth here has failed due to the swampy nature of the wetland. The tea plantations are however found till the ridge of the watershed area.

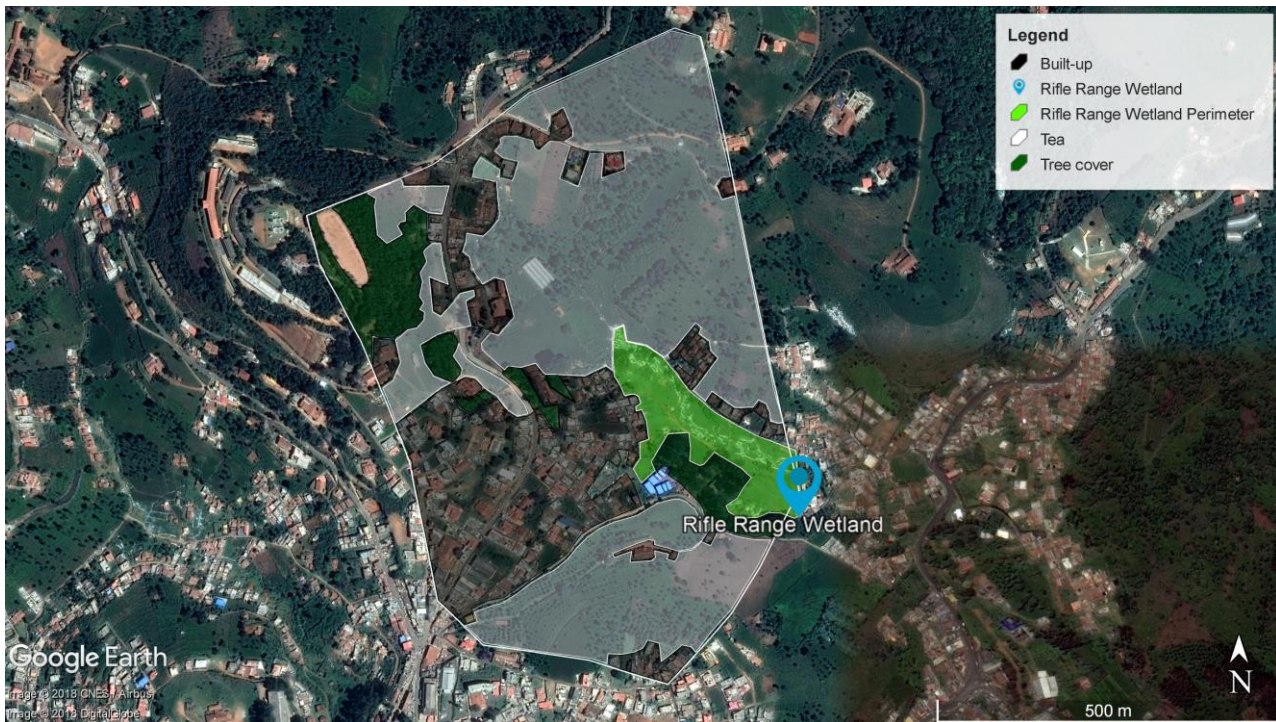
Figure 6: Land cover map of Rifle Range overlaid on Google Earth Image

Though tea occupies most of the watershed, the density of residences in this area is significantly high (27% of the watershed) as compared to the other wetlands that are studied (Elada, Upputhotti and Thalikundah). This is probably due to the close proximity of the wetland to the town centre. While a handful of the current neighbourhood started inhabiting the place around 50 years back, most of the houses were built in the last decade due to the housing demand within the town area irrespective of the dampness due to the wetland. With this came the digging of private wells due to the abundance of water in the locality. Apart from this, the residences also let their domestic waste water into the wetland through pipelines set up by the individual families themselves.

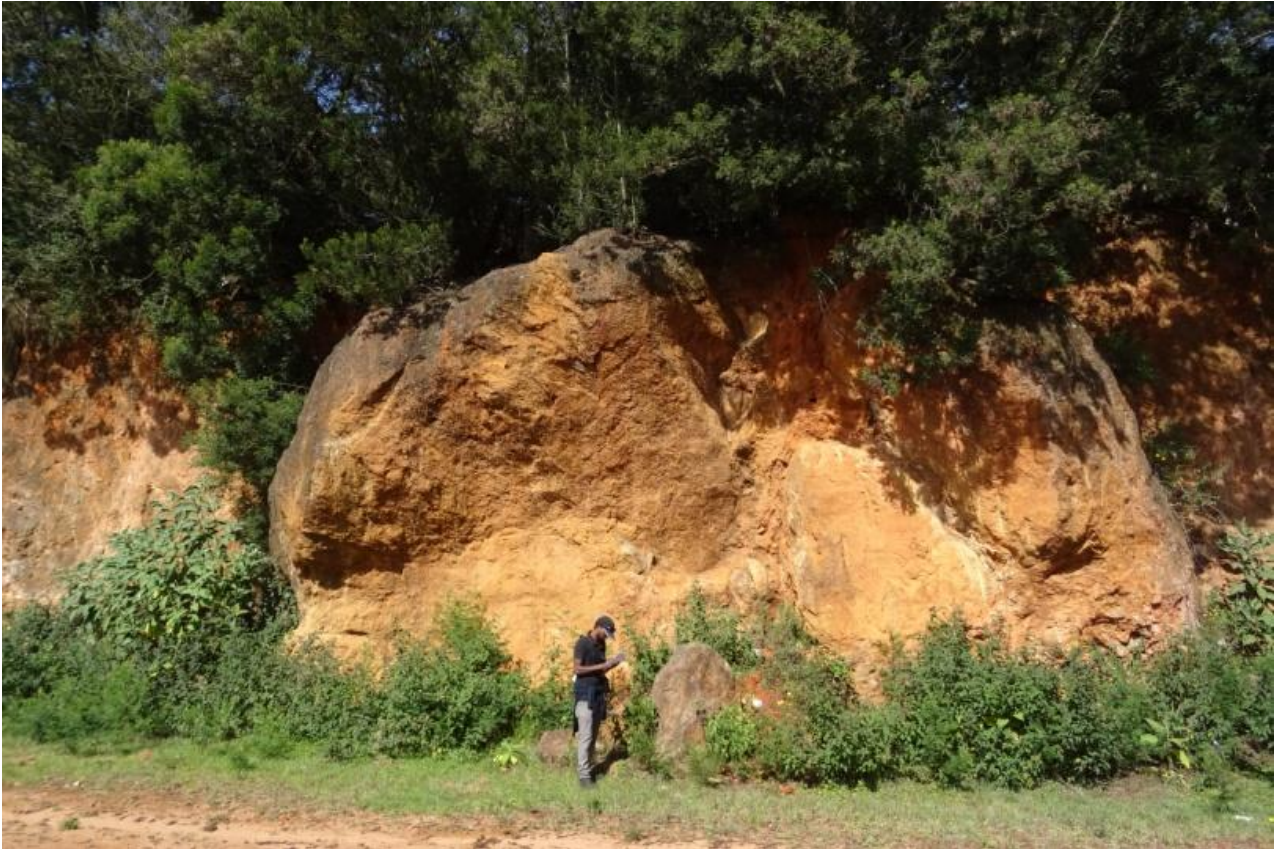
Figure 7: Exposure in Polytechnic ground showing semi weathered layer in the middle surrounded by Regolith

The ground in Shakthi malai next to the polytechnic was the starting point. The regolith or weathered layer goes more than 7 metres deep, the semi weathered rock is seen (refer picture above) in one part of the exposure. There are vertical fractures seen in the semi weathered rock. The process of spheroidal weathering was also seen in the exposure.

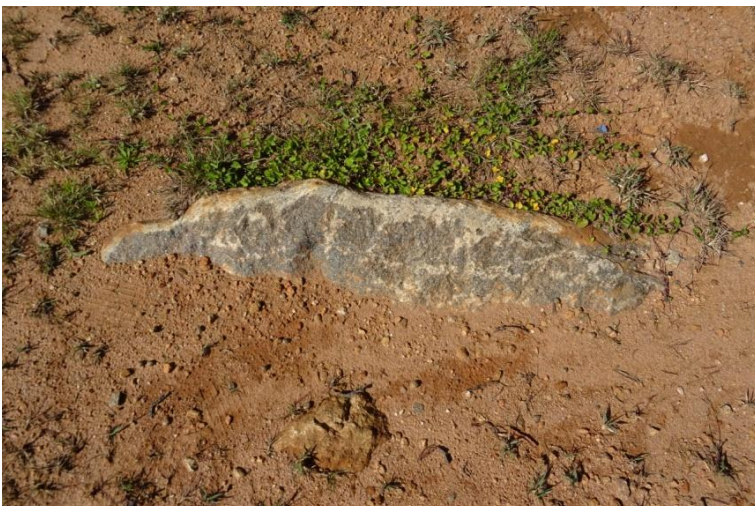
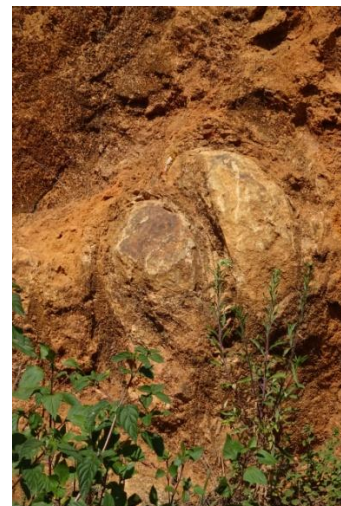
Figure 8: Dyke/Hard rock intrusion seen in Polytechnic ground Figure 9: Spheroidal Weathering

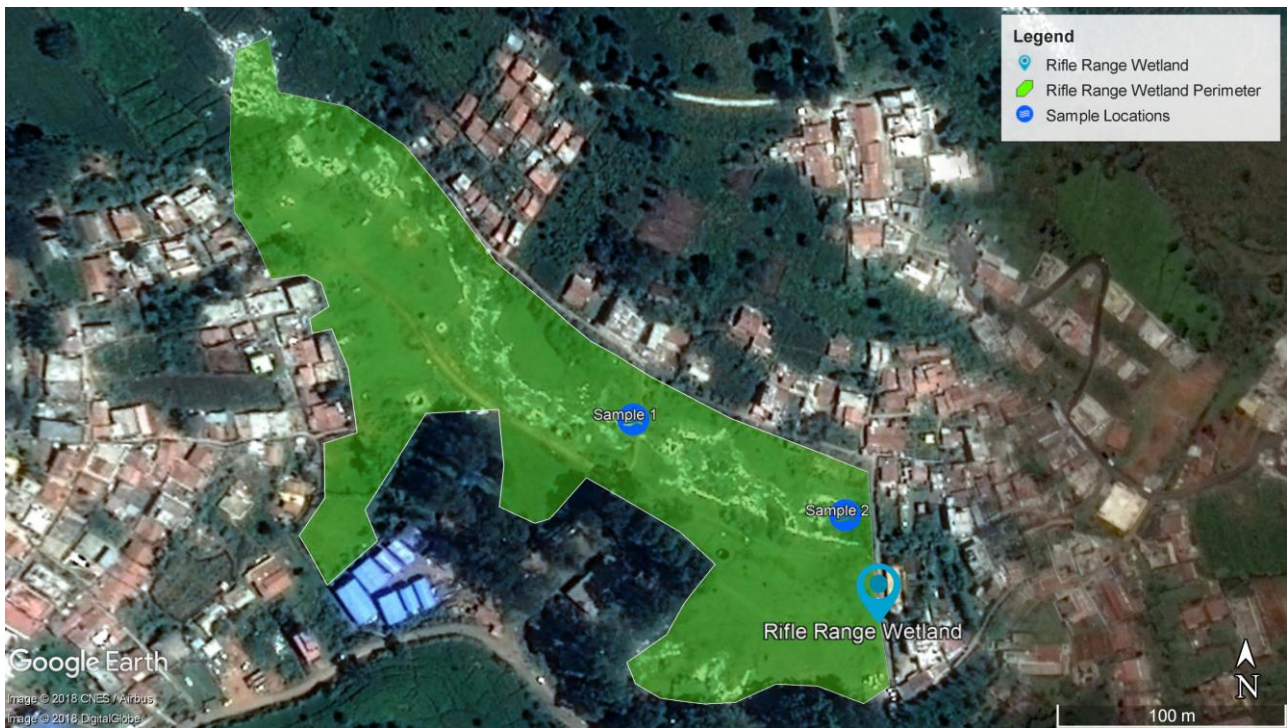
The water sample was taken from two points in the wetland along the stream (marked on the map above); where the stream is intersected by the bridge where a community well is used to draw water for washing clothes and at the end of the wetland. Though the quality of water at both these points is almost the same, there were few differences in terms of the iron content, hardness and coliform in water.

Figure 11: Map showing the location of water sample collection for quality test

The sample from **point 01** was at a very important junction in the wetland where the flow of water in the stream is interrupted by a crossover bridge that leads to the residences built on the catchment area. The water here was clear and odourless and has a higher pH possibly due to the mix of detergents that have high alkalinity. The salt content in this water is within the permissible level for drinking water and so are the electrical conductivity and the total dissolved solids.

There was presence of iron in the water that was evident from the rust orange base and an oily film on top. The iron level in this water is 1mg/l whereas the permissible level is 0.3mg/l. Apart from being an aesthetic problem, the colour does not affect the quality of the water for consumption. Due to lack of open defecation and sewage release into the stream water, there is no Coliform or ammonia present in the water.

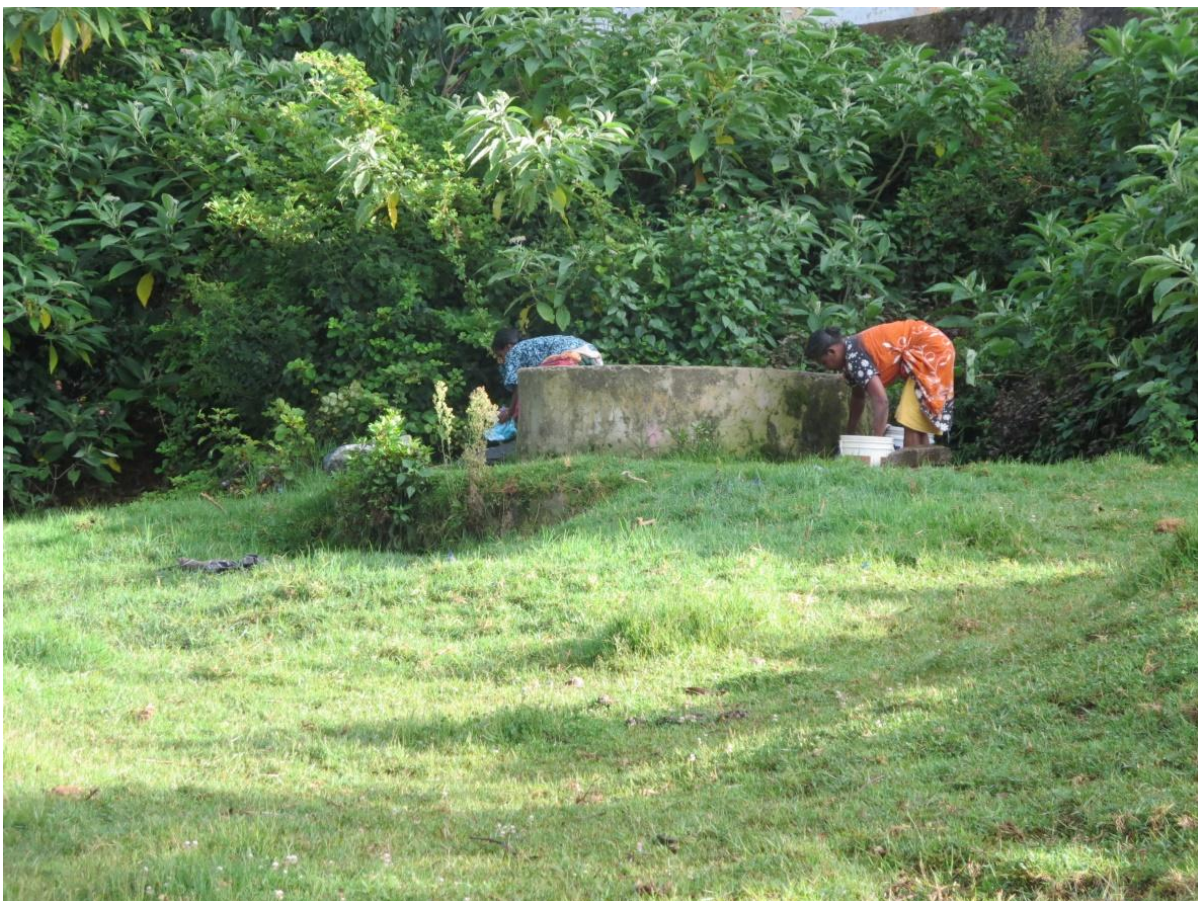
Figure 12: Residents washing clothes near a panchayat well

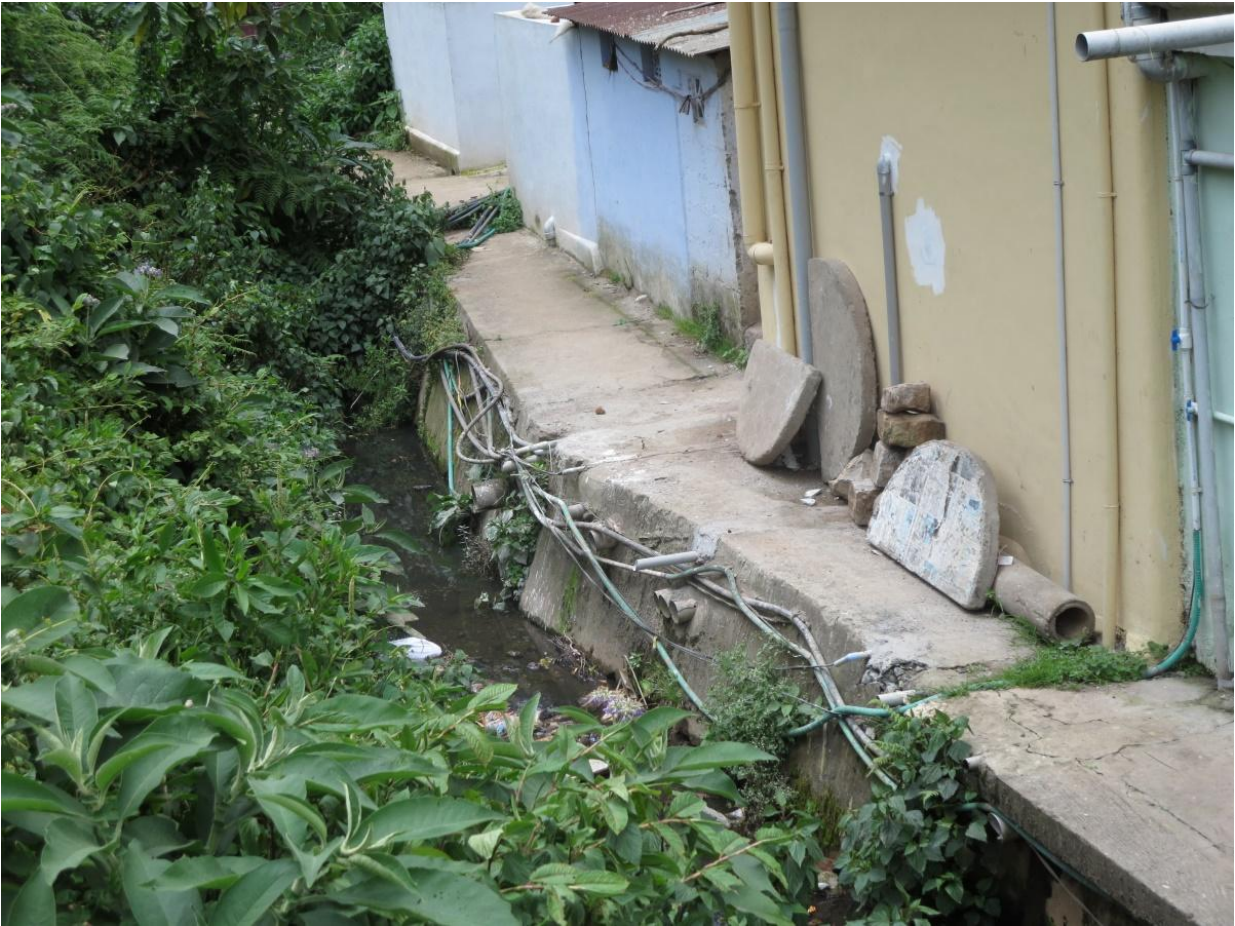
Though the quality of water is within the permissible levels for drinking at the wetland, as the stream travels further down, the water is fully contaminated as the stream collects all the domestic waste from the households and turns into a drainage duct rather than a freshwater stream.

*Figure 13: Sewage being drained into the stream*

11. Downstream, the condition of the stream has to be improved by desilting, trapping sewage outlets from the household and improving the edge conditions of the stream.

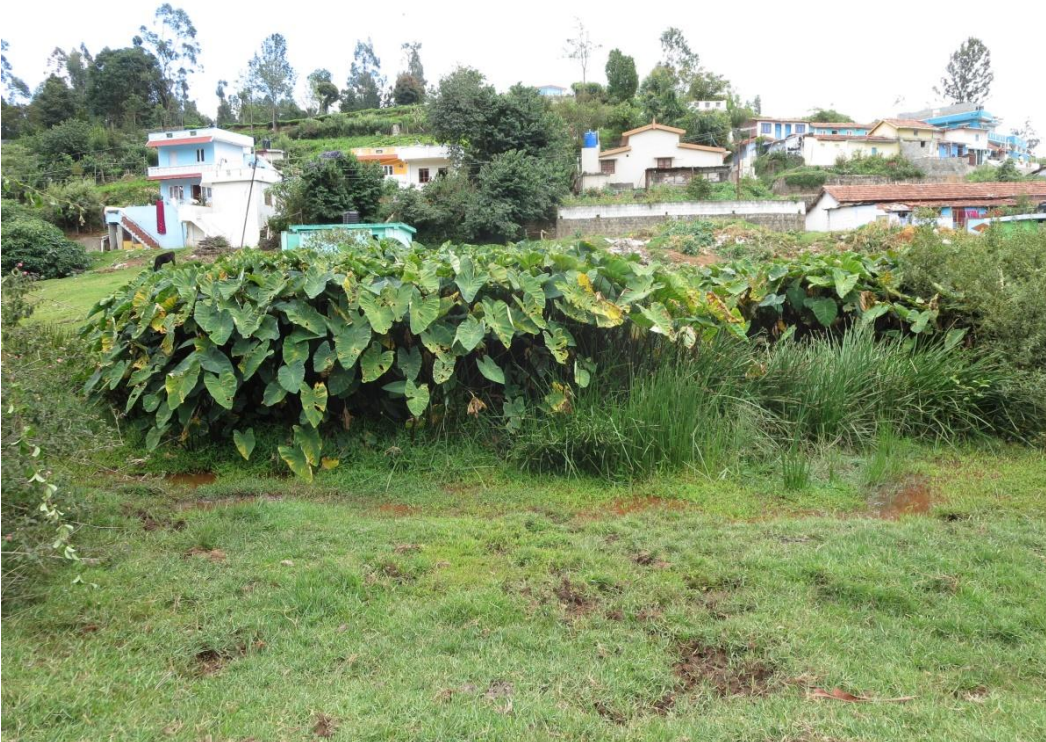
*Figure 14: Dense aquatic plants lining the stream in the wetland*

The wetland at Rifle range houses a number of indigenous wetland species of flora and fauna, whereas exotics are mostly found on the catchment. Amidst the dense residential development, the animals, birds and insects along with the plants help maintain the wetland ecosystem at Rifle range wetland. The terrestrial animals found along the wetland include wild boars, goats, buffalos, monkeys and Cows. The wetland is used as a grazing ground for the nearby household who own cattle as observed. Due to the practice of dumping waste in the wetland by the households, there were a number of boars that eat through the piles of waste.

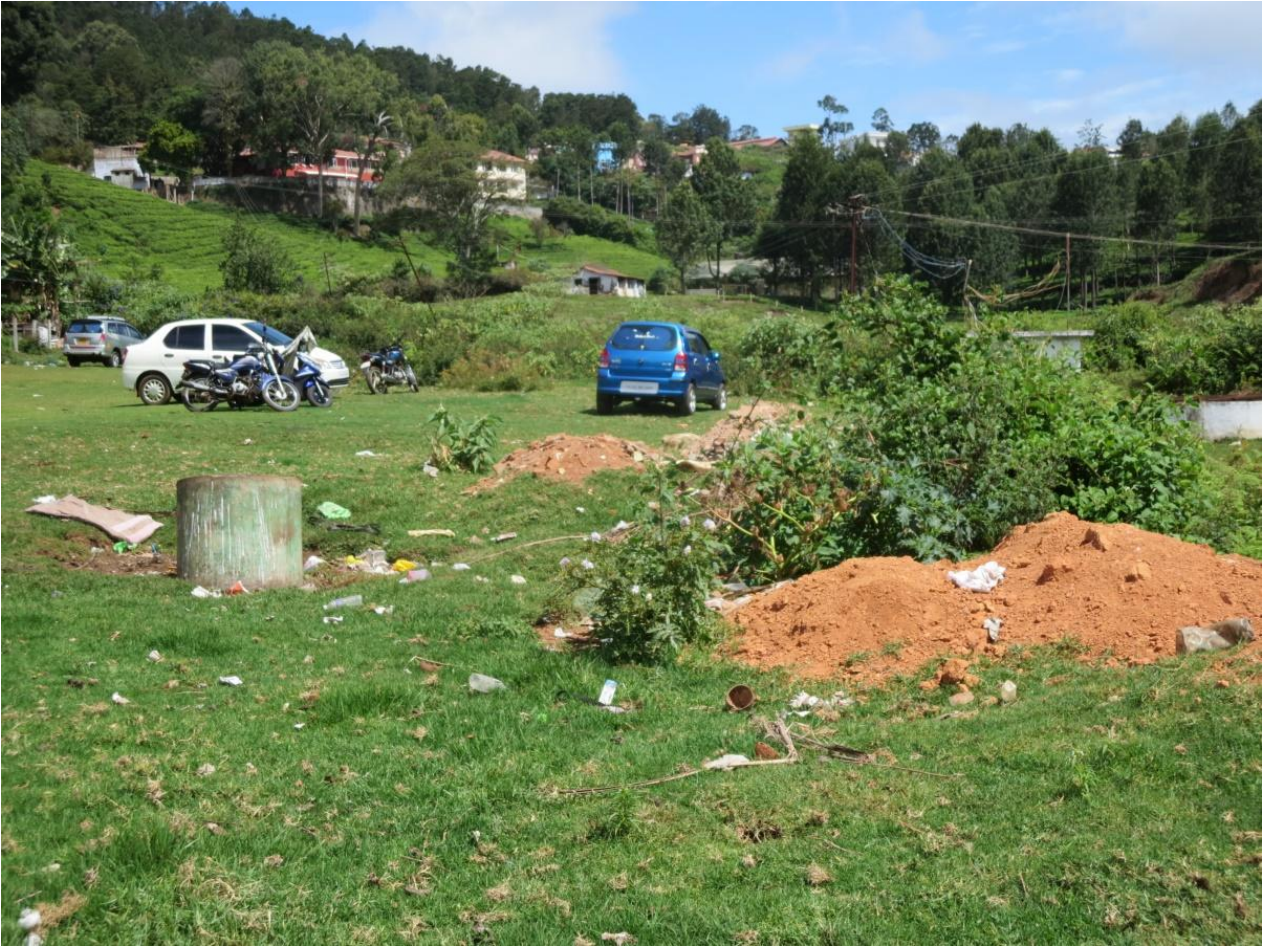
*Figure 15: Wetland being used for parking by the nearby residents*

10. In order for these measures to sustain over a period of time, the wetland has to be fenced in certain critical areas and areas of intervention. Movement through the wetland should also be restricted and regulated to avoid damage due to human intervention.

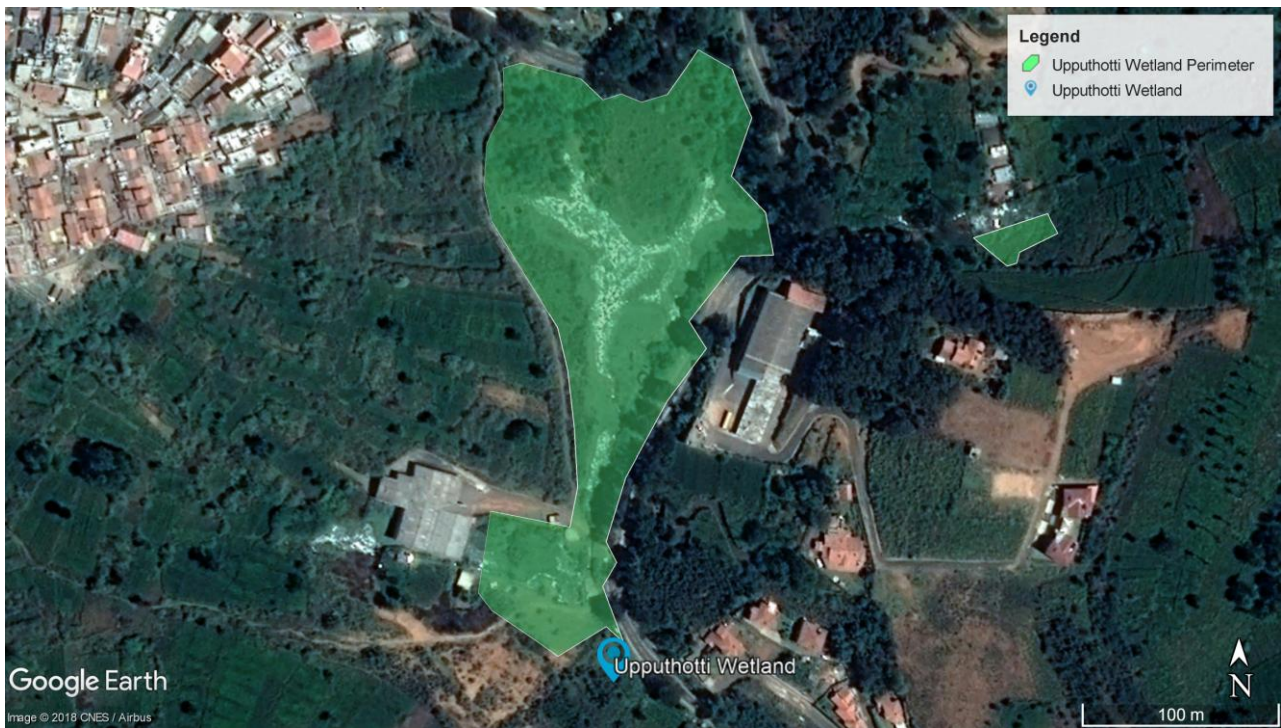
*Figure 2: Head wetland at Upputhotti*

The head wetland is of area 0.25 acres and has a rectangular profile. This part of the wetland is at two levels separated by a path that leads to 3 houses in the catchment. Along its catchment, the wetland here is surrounded by tea plantations. We surmise that a spring may have existed given the presence of a temple north of the wetland. It is a common practice among the locals to conserve the springs by building a temple marking its significance as one of the life supporters. The water runs off from this wetland, passes through the tea plantations and reaches the main wetland.
