# WETLANDS OF THE NILGIRIS

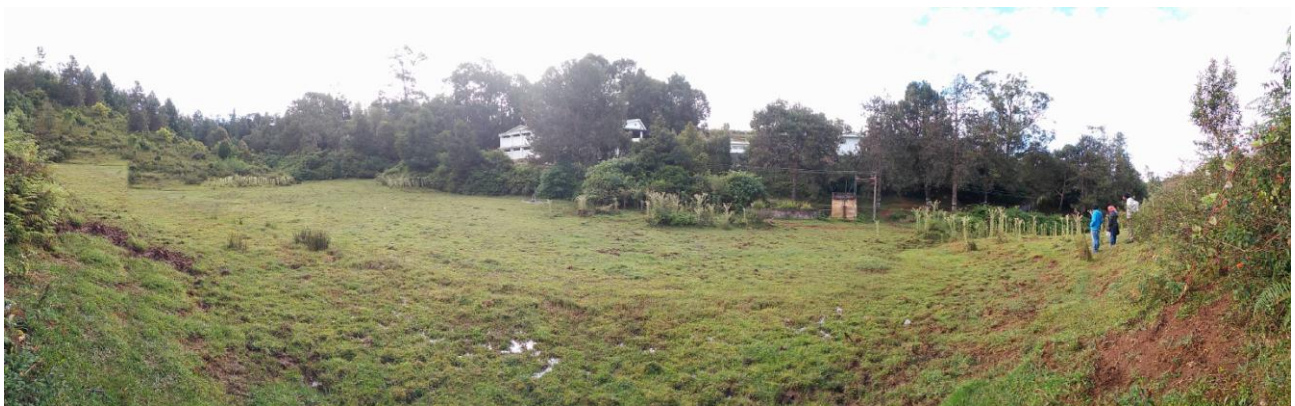
*Figure 3: Upputhotti Wetland*

The main wetland is a triangular piece of land of area 2.12 acres with its broader end in the north and tapers towards the south. The wetland is home to a number of indigenous plant varieties that help maintain the wetland ecosystem along with a number of birds, animals, bees and other insects. The wetland is relatively untouched except for a couple of municipality dug wells. The catchment area is taken over by the exotic and invasive varieties of plants till the brim of the depression in addition to a substantial amount of tea cultivation on the slope from the head wetland. Apart from this, there are a couple of industrial buildings (processing unit and warehouse) on the catchment.

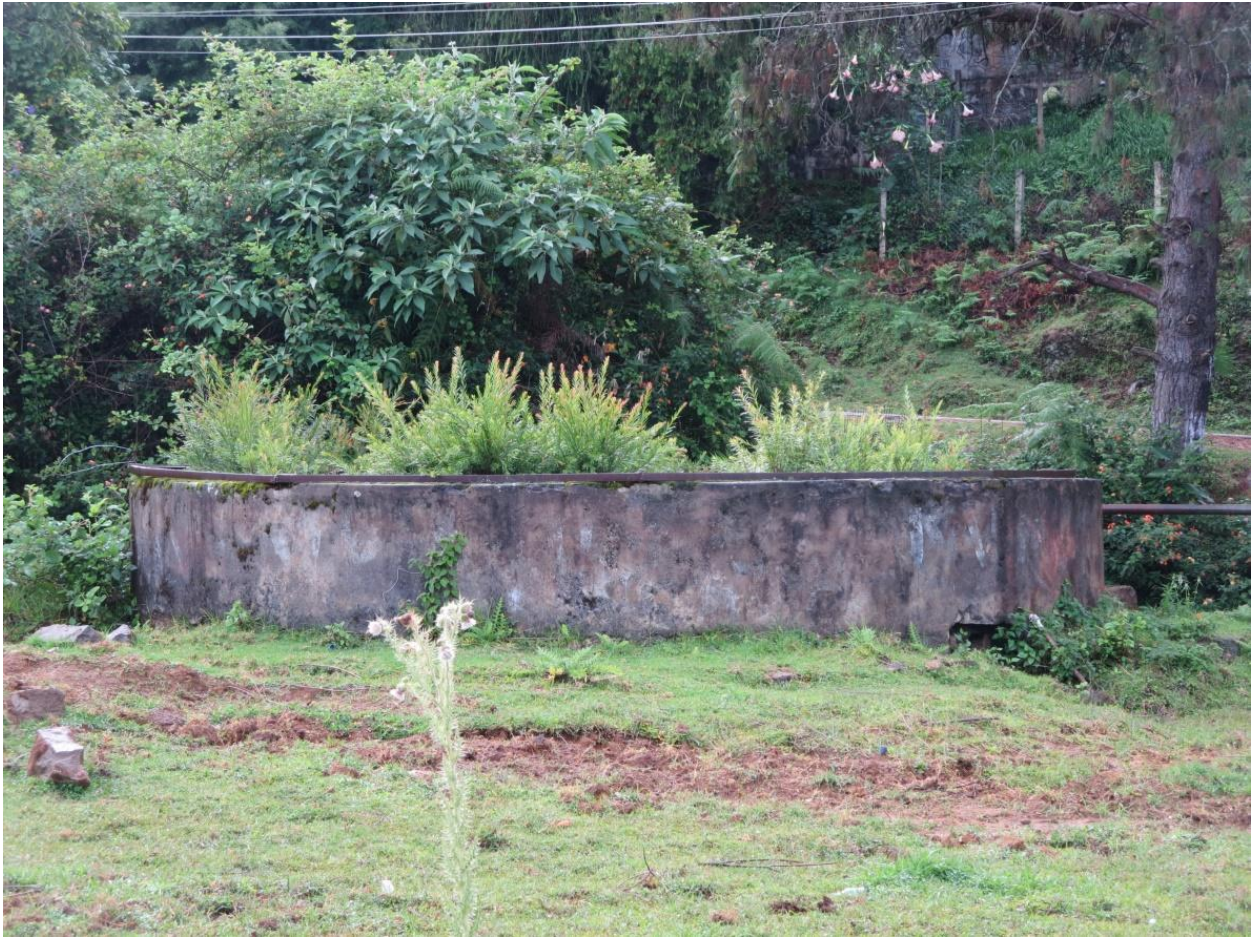
*Figure 4: Panchayat well at Upputhotti from which 6500 litres of water is drawn everyday*

Every day, 32,500 (5x6500 litres) litres of water is taken from one of the wells) in the wetland by the Coonoor Municipality to serve certain resorts, schools and hospitals in the locality. Apart from this the municipality also draws a few thousand litres of water from the collection tank that is built south of the wetland.

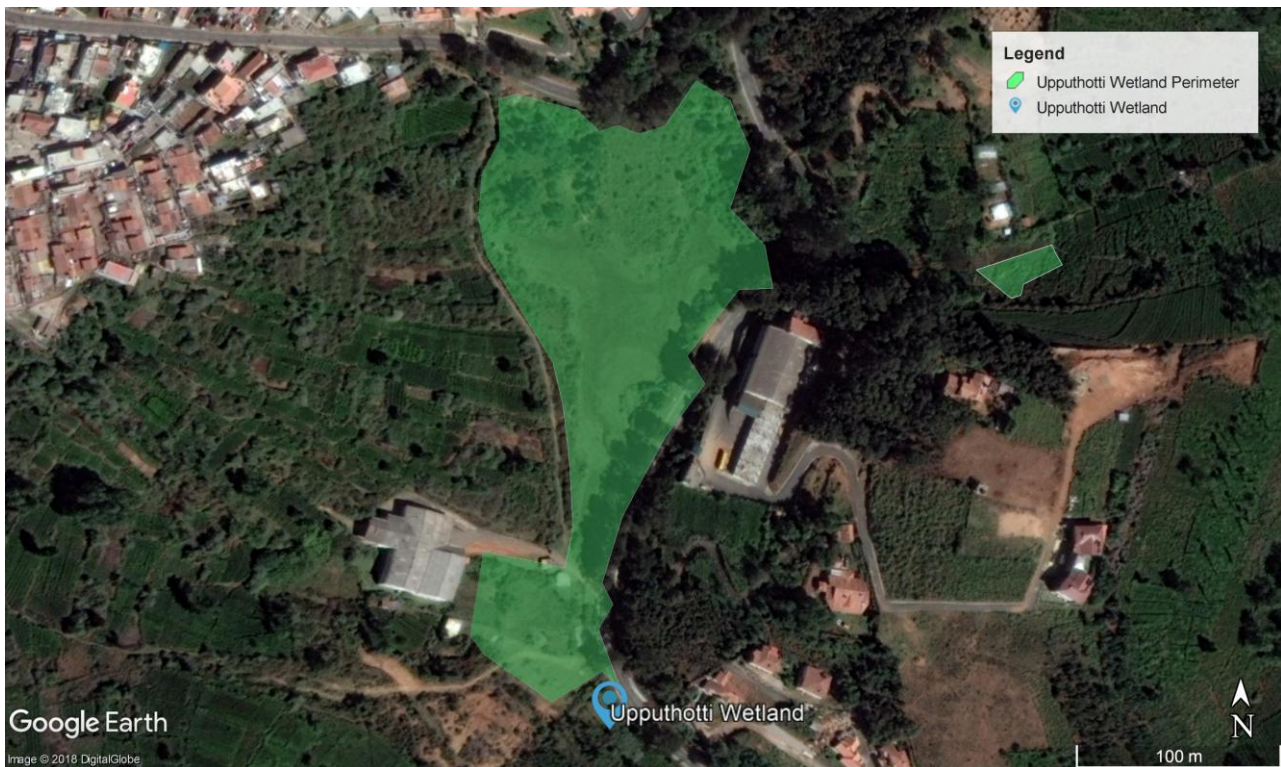
Figure 8: An imagery of the catchment in 2017.

To the north of the wetland, a part of Yedapalli village sits on the catchment area. In addition to the north of the wetland, there are a couple of industrial buildings to the east and south of the wetland which together constitute 10% of the overall catchment area. The houses in the villages depend on the wetland for its water and over extraction in these villages would again affect the health of the wetland.

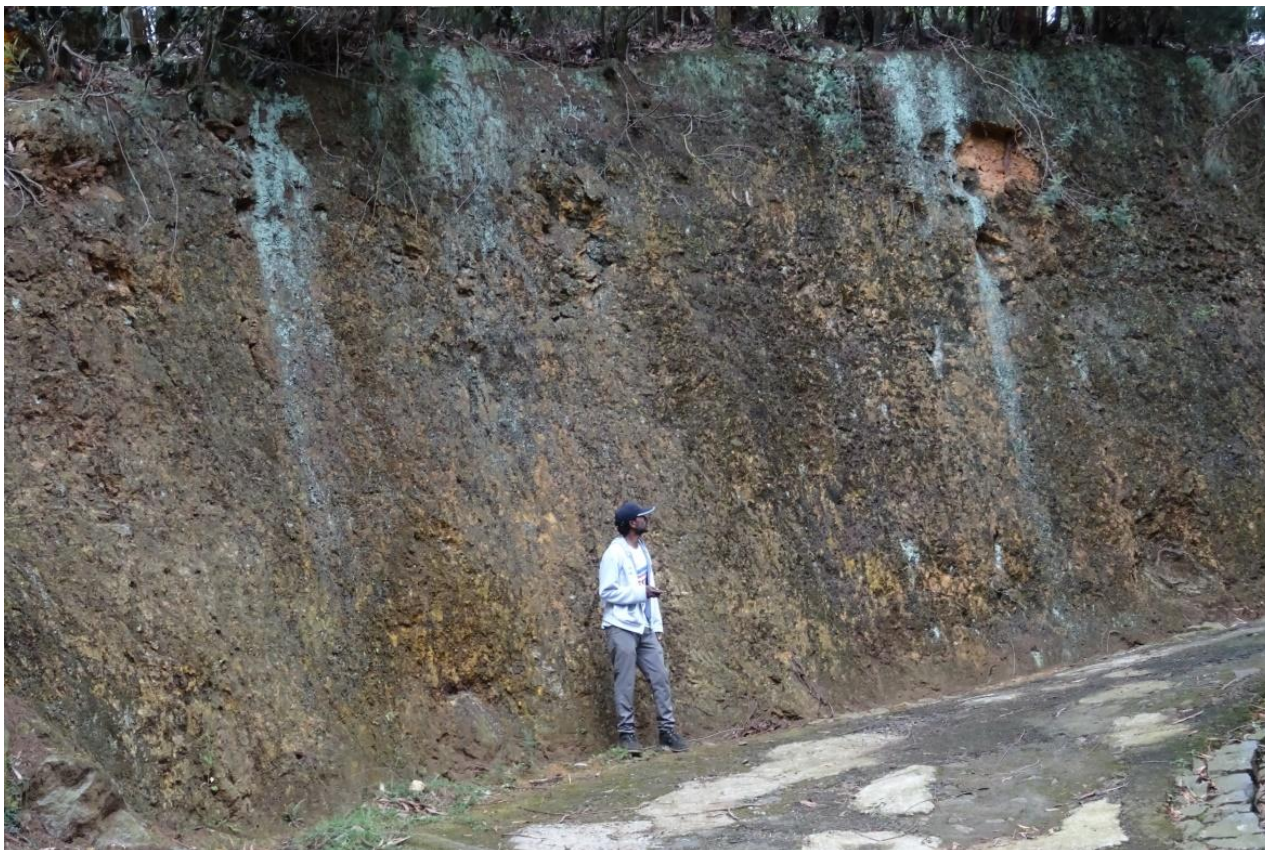
exceeding rock strength. The bedrocks are found at 2.5m below the weathered layer with horizontal fissures.

Figure 9: Rock outcrop seen near the head wetland

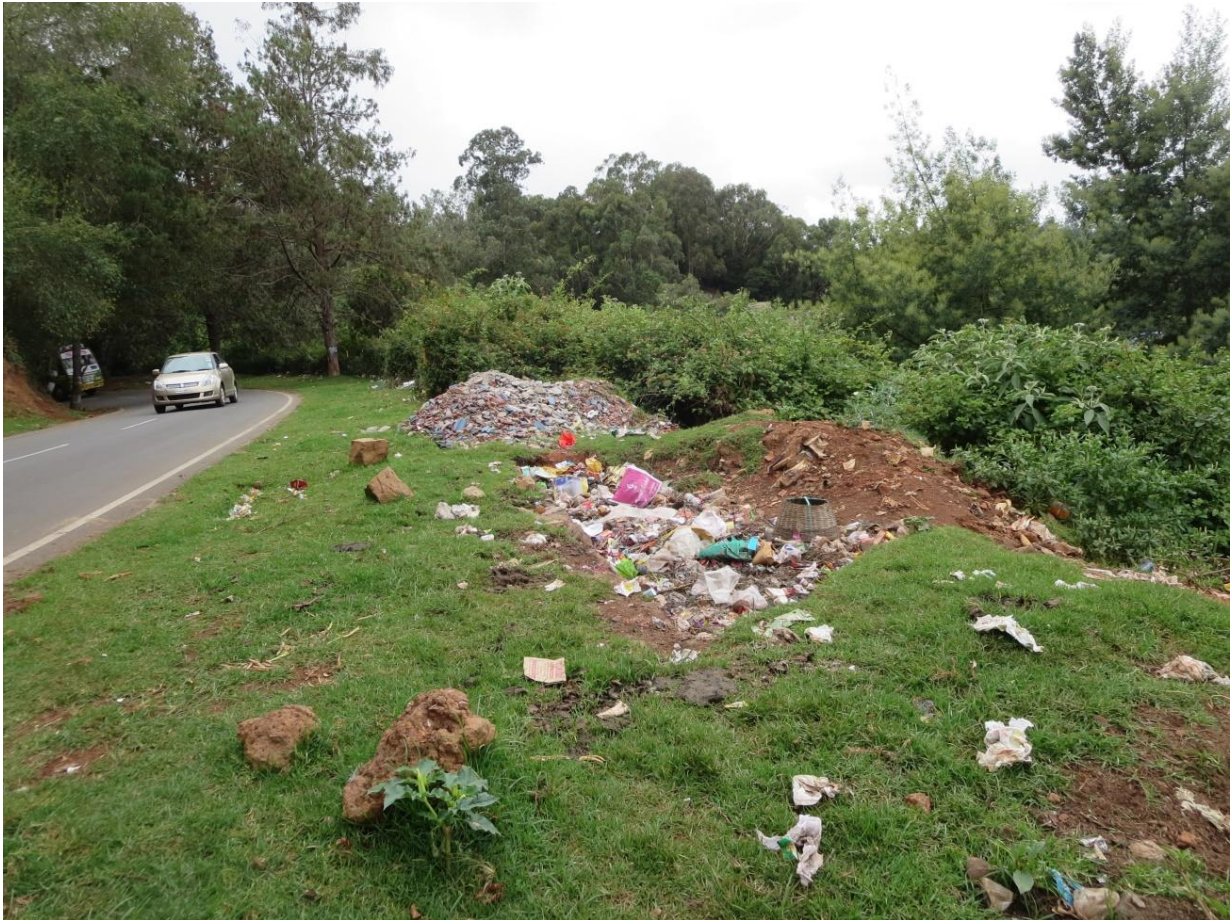
*Figure 13: Waste being dumped on the catchment adjacent to the main road*

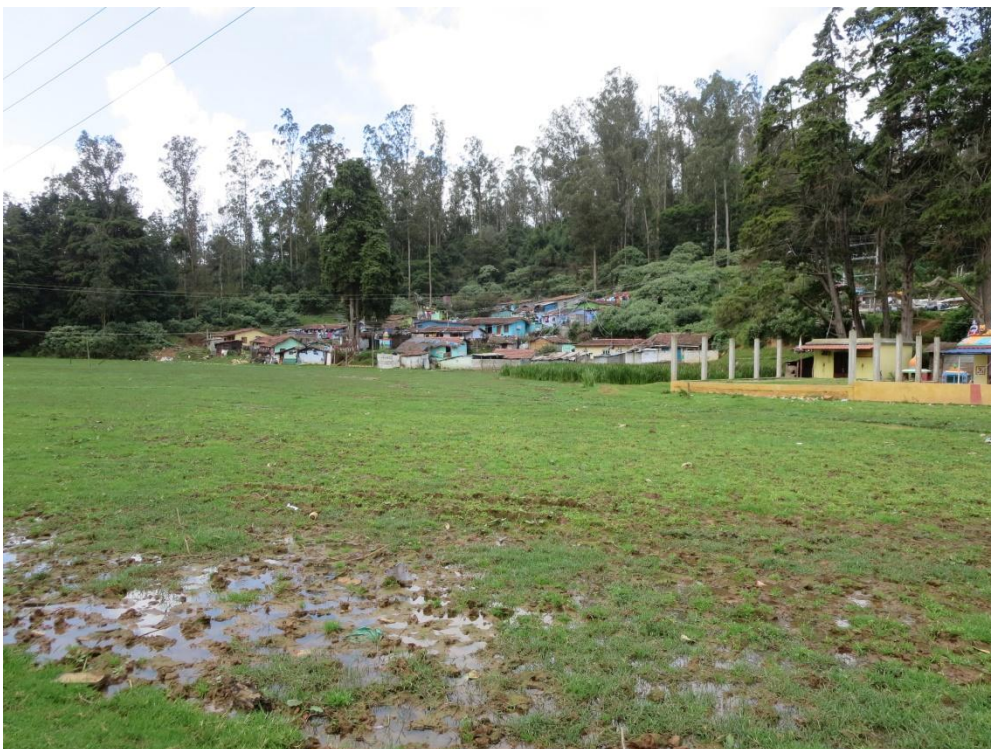
*Figure 4: Colonies developed along the wetland*

The wetland is surrounded by a number of communities that have made settlements in the locality by mid-20th century when Hindustan Photo Film Manufacturing Company (HPF) was set up in

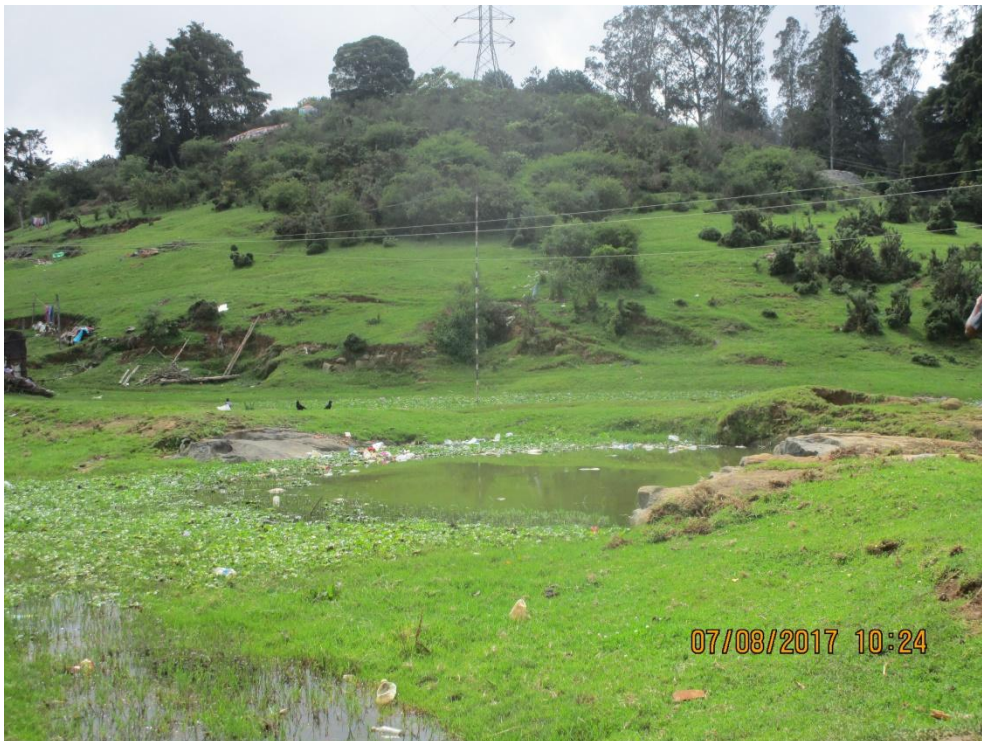
Figure7: Wetland at Thalaikundha with exotics around

The largest area in the catchment is occupied by tree cover (69% of the catchment area). The species found here are mostly exotics such as Cypruss, eucalyptus, acacia etc, with remnants of native species such as Mahonia, Melaleuca and Rhododendron. Over the period of 10 years (evident from the satellite imagery) the tree cover has spread over to a great extent. There could be two reasons for this spread; the exotics such as acacia are better capable of spreading and deliberate plantation by the forest department to increase the tree cover in the area.

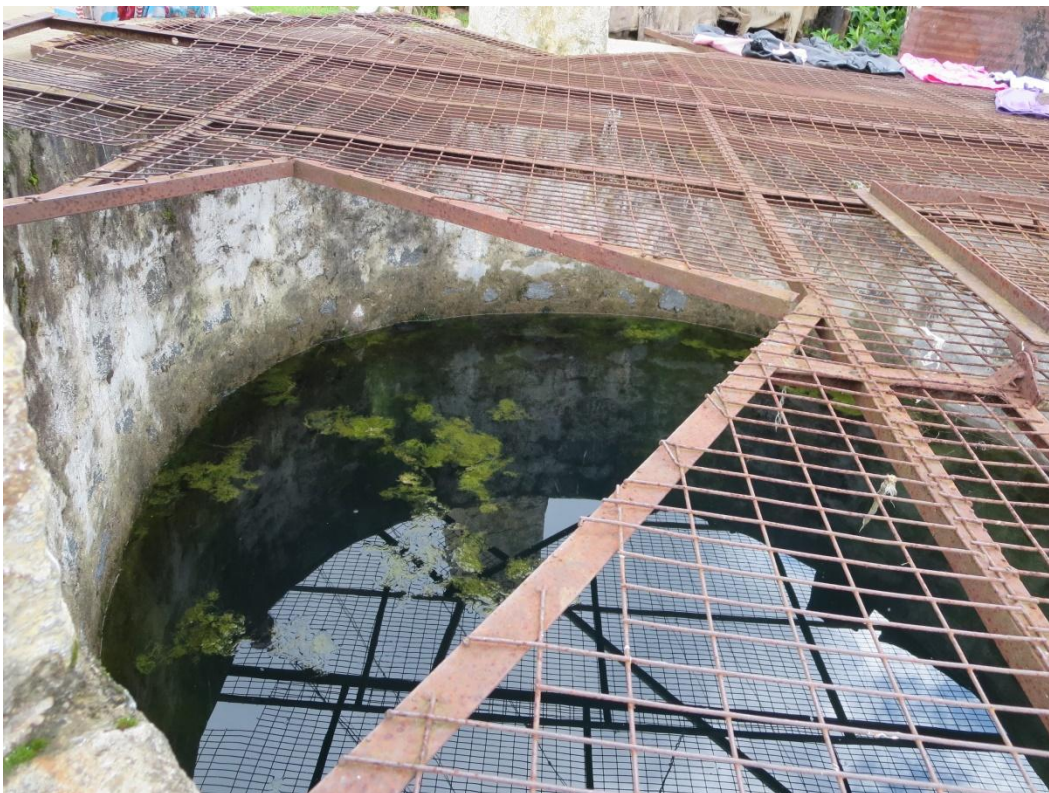
Near the head wetland, there is Indira Nagar, a colony of 15 houses that is built on the brim of the wetland and they share a community well for drinking water and other domestic use. The water level in the well is at the level of the wetland itself but highly infested by moss. The culvert that carries excess water from one side of the road to another under the bridge is fully blocked due to waste and silt deposit. This causes the wetland water to clog during monsoons as there is no escape. This poses a huge threat to the hygiene in the neighbourhood. As told by the residents, there have been cases of dengue in the colony due to the stagnation of water in the area.

*Figure 11: The community well used by the residents of Indira Nagar*

The water was clear with no bad odour and a permissible pH level of 7 which is ideal for drinking water. The total dissolved solids in this water are 720ppm whereas the permissible level is below

500ppm. This, along with the high Sodium Chloride level causes the water to be salty. The electrical conductivity therefore is within the permissible limit but higher than the stream water due to high salinity. This could also be due to the high salinity of water as it contributes to some of the ions. High TDS content shows the interaction of water with salts in the aquifer leading to corrosion, and may cause gastro intestinal irritation.

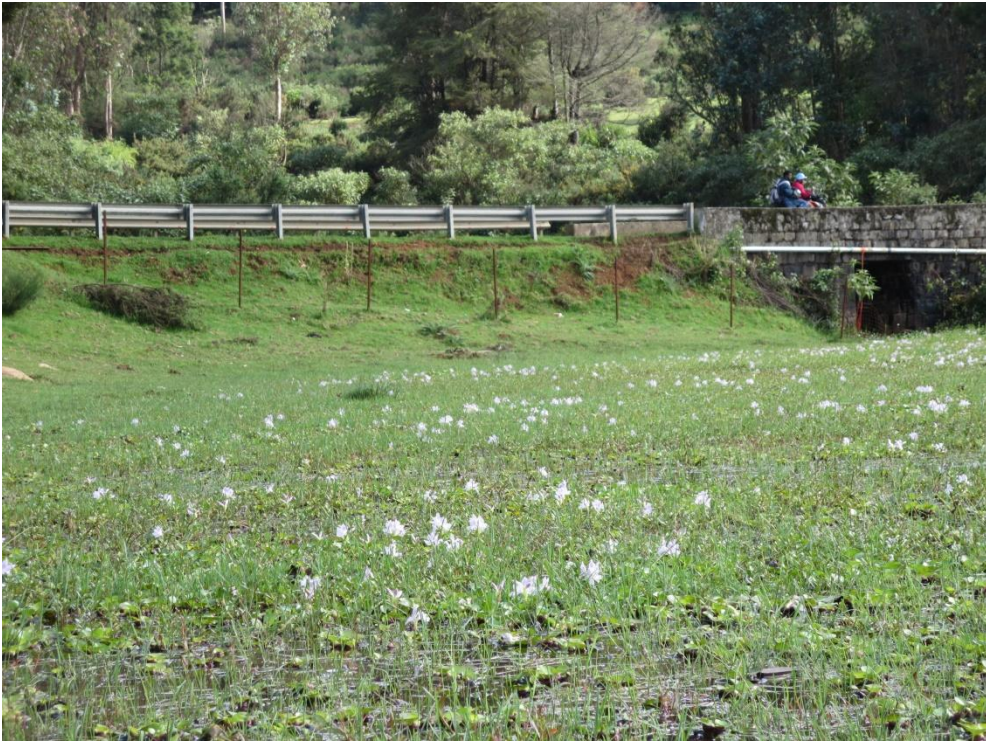
There were a lot of aquatic plants in the wetland one of which is the invasive, *Eichhornia crassipes* (*water hyacinth*). Most part of the standing water in the wetland is covered by the Hyacinth which outside its native region, the Amazon basin, is considered a threat to the freshwater ecosystem. By covering the surface of the water, it cuts off sunlight for the water, obstructs water flow and thereby starves water of oxygen. Since the presence of oxygen is necessary for water to purify itself, the quality of water in the locality is highly compromised. Apart from this, there are also other aquatics such as *Myriophyllum aquaticum*, *Alternanthera*, and mosses that are considered invasive too, clogging waterways.

*Figure 12: Water Hyacinth, an invasive has taken over the surface of the water*

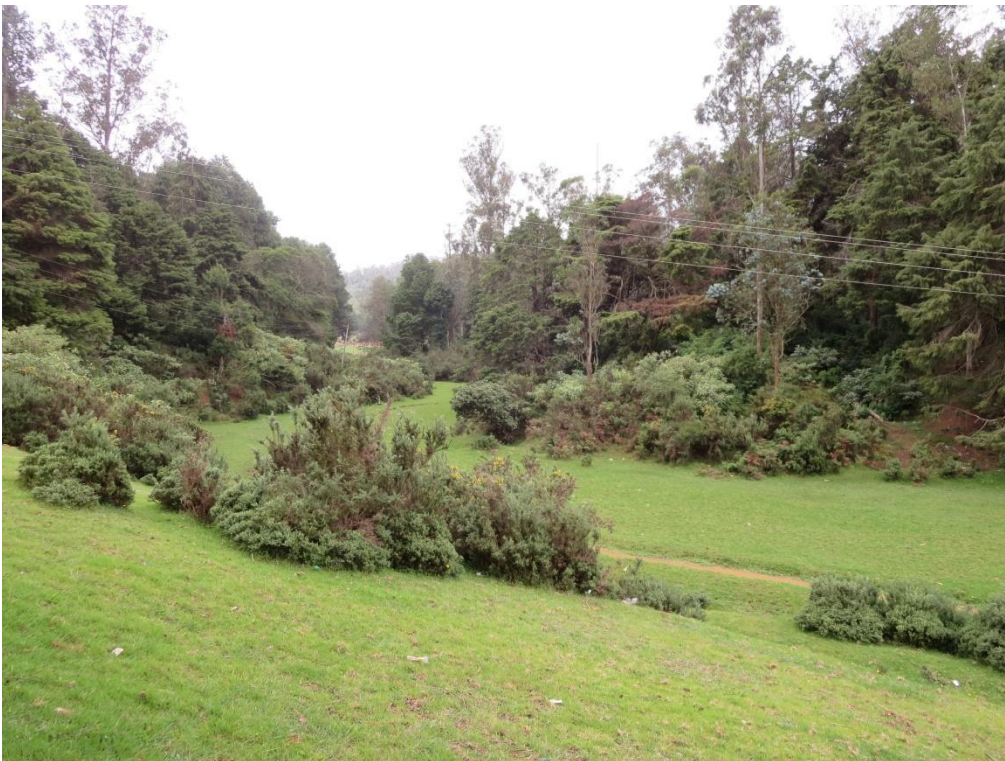
*Figure 13: Invasive species such as Cuprusses, Eucalytus and Wattle have taken over the wetland*
