WETLANDS OF THE NILGIRIS

WORKING AREA:

WETLAND SURVEY IN 2006:

SURVEY METHODOLOGY 2016-17:

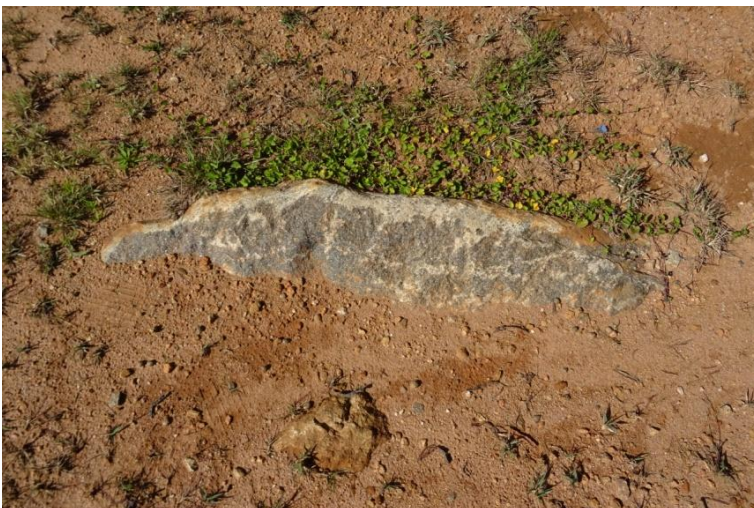
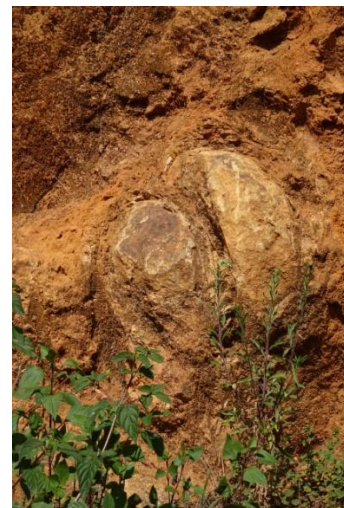
Figure 8: Dyke/Hard rock intrusion seen in Polytechnic ground Figure 9: Spheroidal Weathering

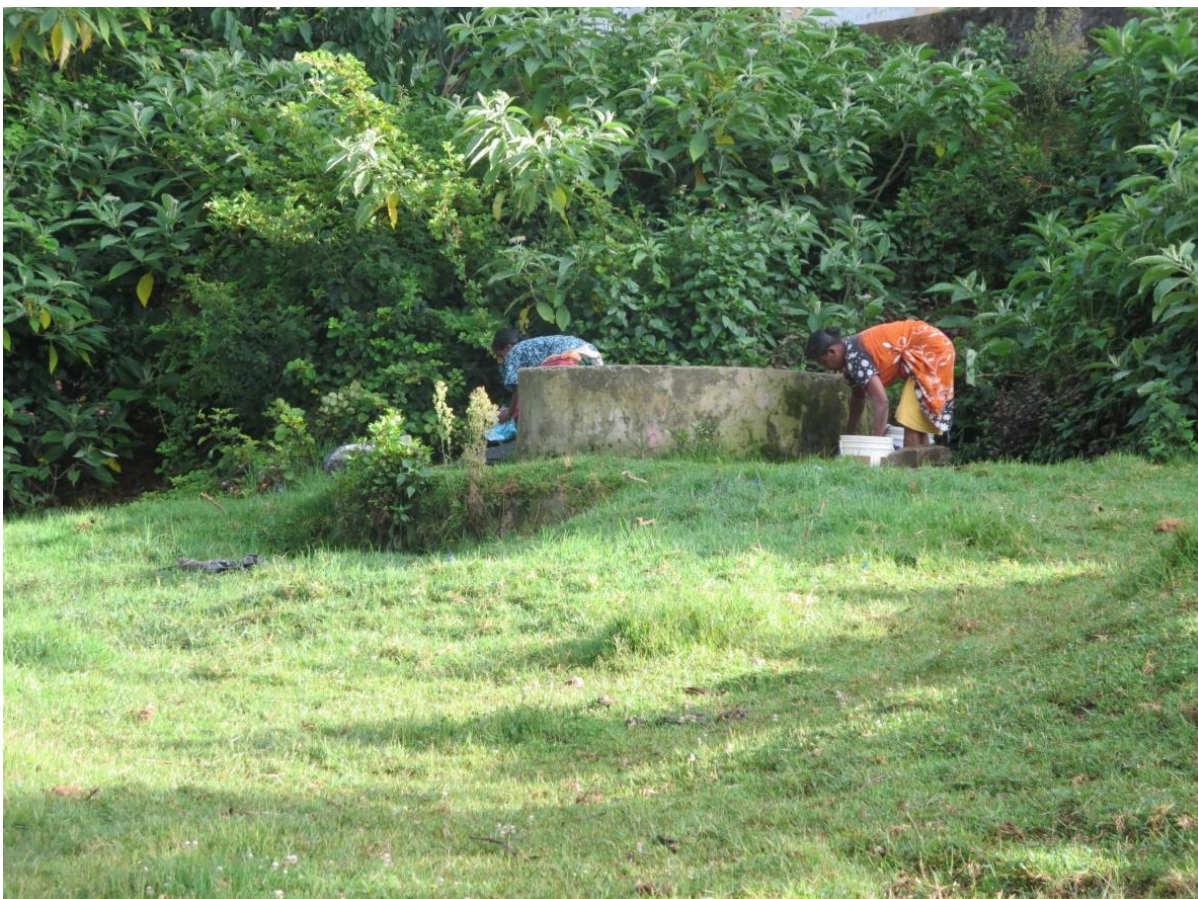
Figure 12: Residents washing clothes near a panchayat well

There was presence of iron in the water that was evident from the rust orange base and an oily film on top. The iron level in this water is 1mg/l whereas the permissible level is 0.3mg/l. Apart from being an aesthetic problem, the colour does not affect the quality of the water for consumption. Due to lack of open defecation and sewage release into the stream water, there is no Coliform or ammonia present in the water.

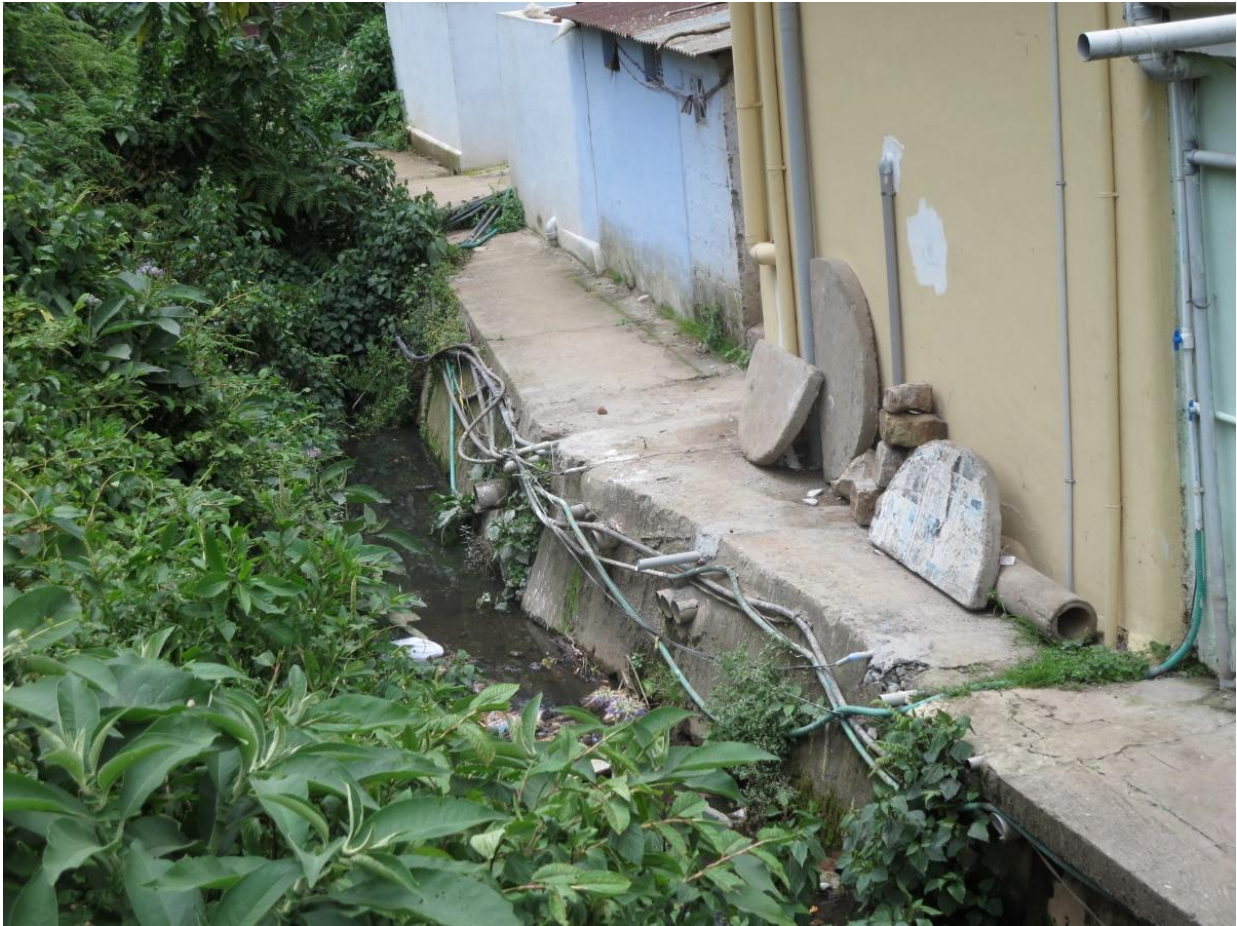
Though the quality of water is within the permissible levels for drinking at the wetland, as the stream travels further down, the water is fully contaminated as the stream collects all the domestic waste from the households and turns into a drainage duct rather than a freshwater stream.

Figure 13: Sewage being drained into the stream

11. Downstream, the condition of the stream has to be improved by desilting, trapping sewage outlets from the household and improving the edge conditions of the stream.

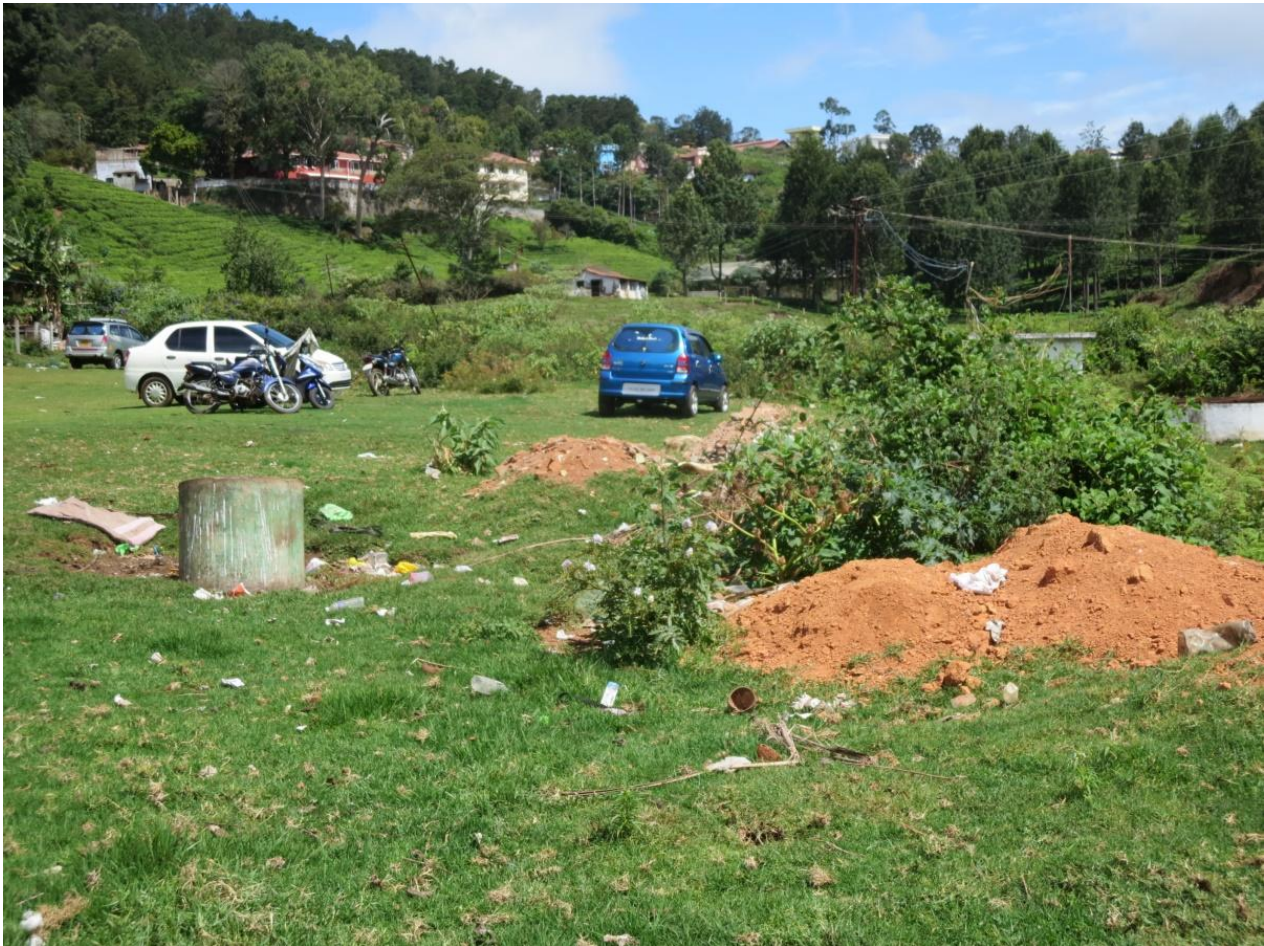
Residents of the neighbourhood are the only stakeholders that can have a direct, yet far reaching effect in terms of conserving the wetland. While the older residents are aware of the wetland characteristics as they have been coexisting with the wetland for generations, the newer residents are unaware of the situation as it doesn't affect their livelihood directly. The town panchayat (local government body), the secondary stakeholder, is under pressure to supply the town with water, supplying from water surplus areas to water deficit areas within the town, leaving the wetland in disarray. There is competing pressure on the wetland from all the stakeholders, by constant digging of wells, encroachment of the wetland for parking and ad hoc measures to control flooding and drought which leads to the ecological degradation of the wetland.

Figure 15: Wetland being used for parking by the nearby residents

10. In order for these measures to sustain over a period of time, the wetland has to be fenced in certain critical areas and areas of intervention. Movement through the wetland should also be restricted and regulated to avoid damage due to human intervention.

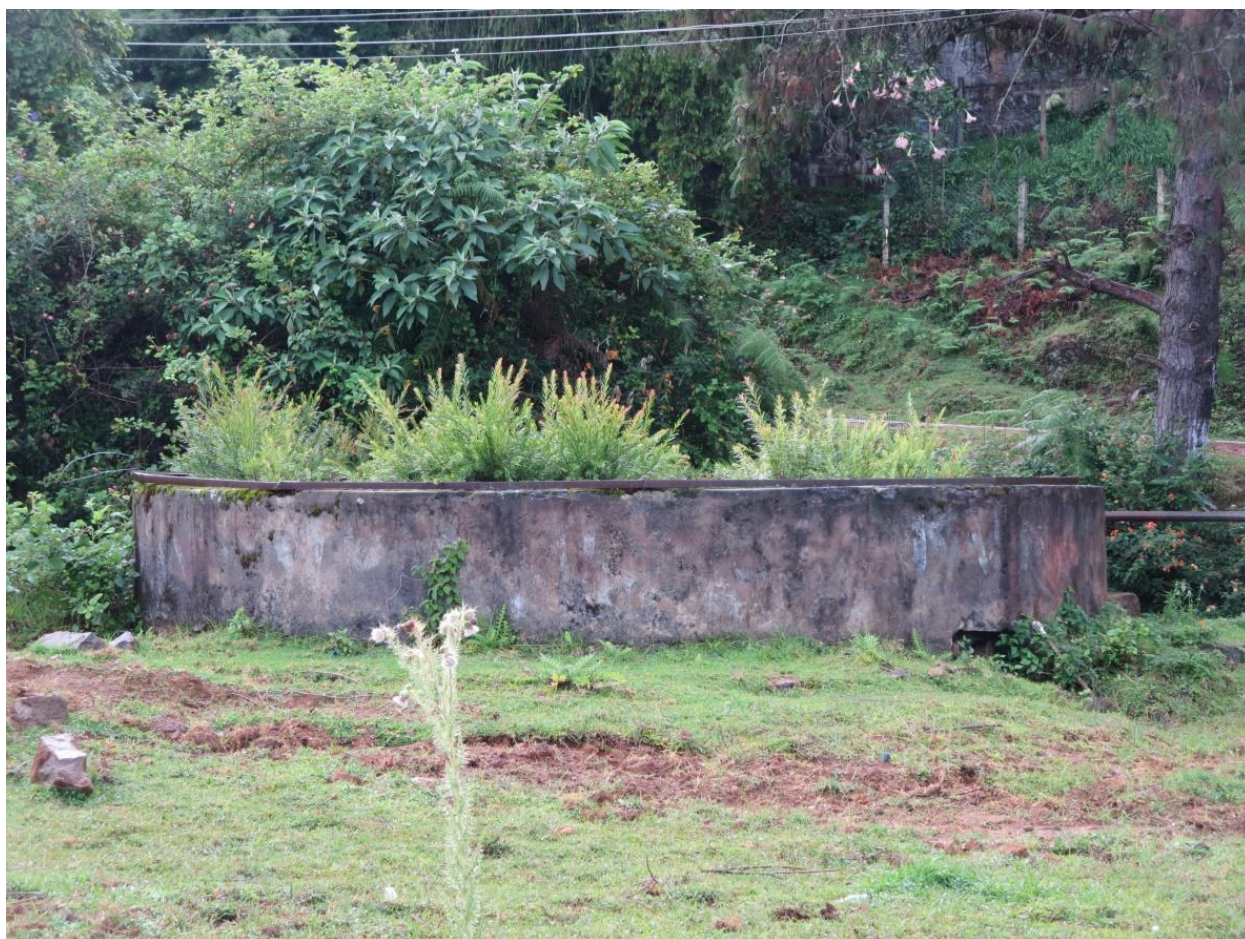
Figure 4: Panchayat well at Upputhotti from which 6500 litres of water is drawn everyday

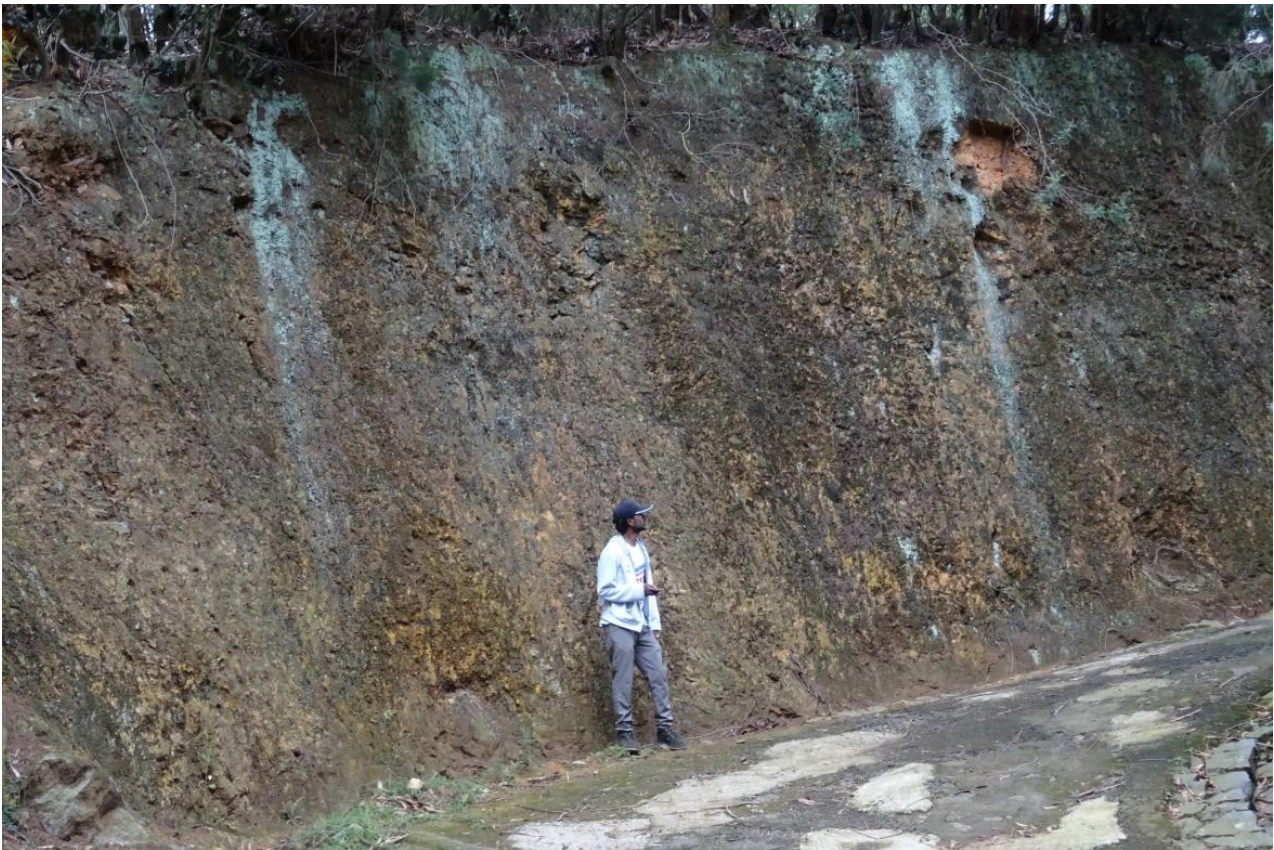
exceeding rock strength. The bedrocks are found at 2.5m below the weathered layer with horizontal fissures.

Figure 9: Rock outcrop seen near the head wetland

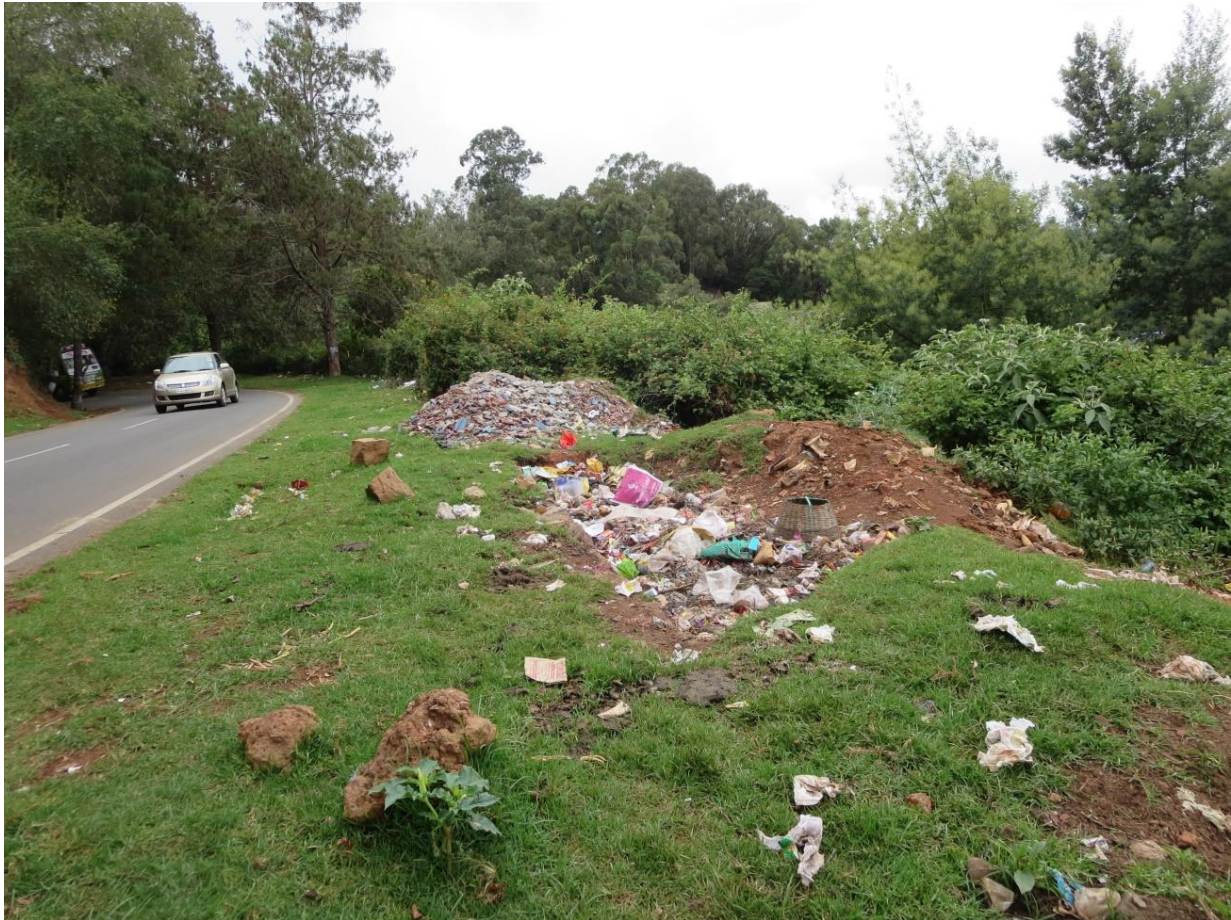
Figure 13: Waste being dumped on the catchment adjacent to the main road

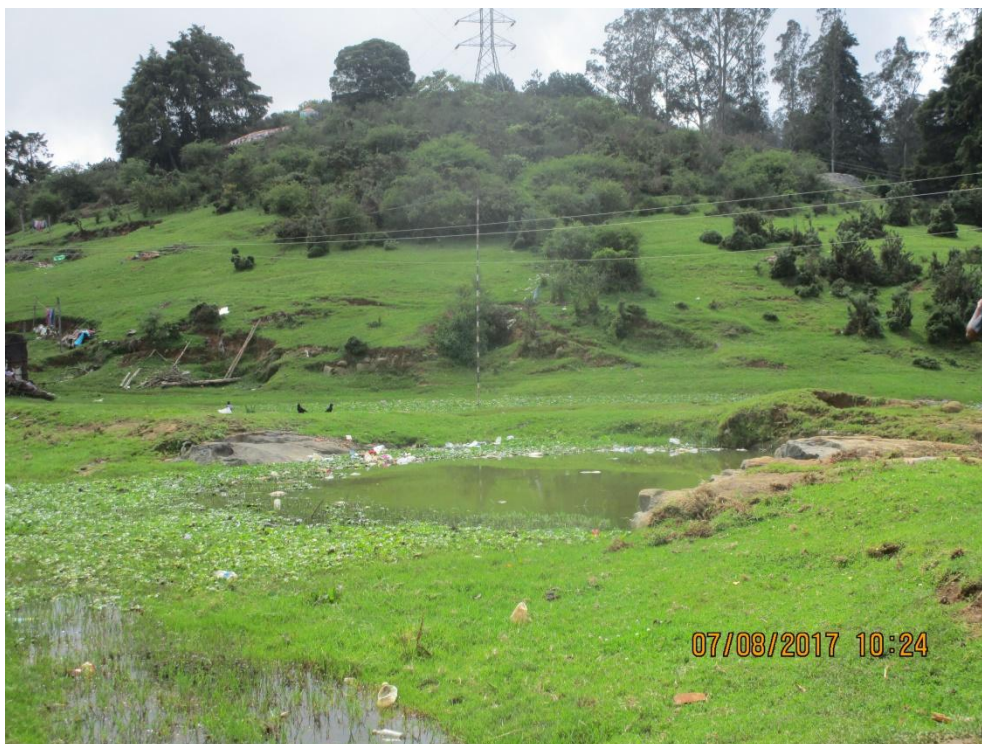
Figure7: Wetland at Thalaikundha with exotics around

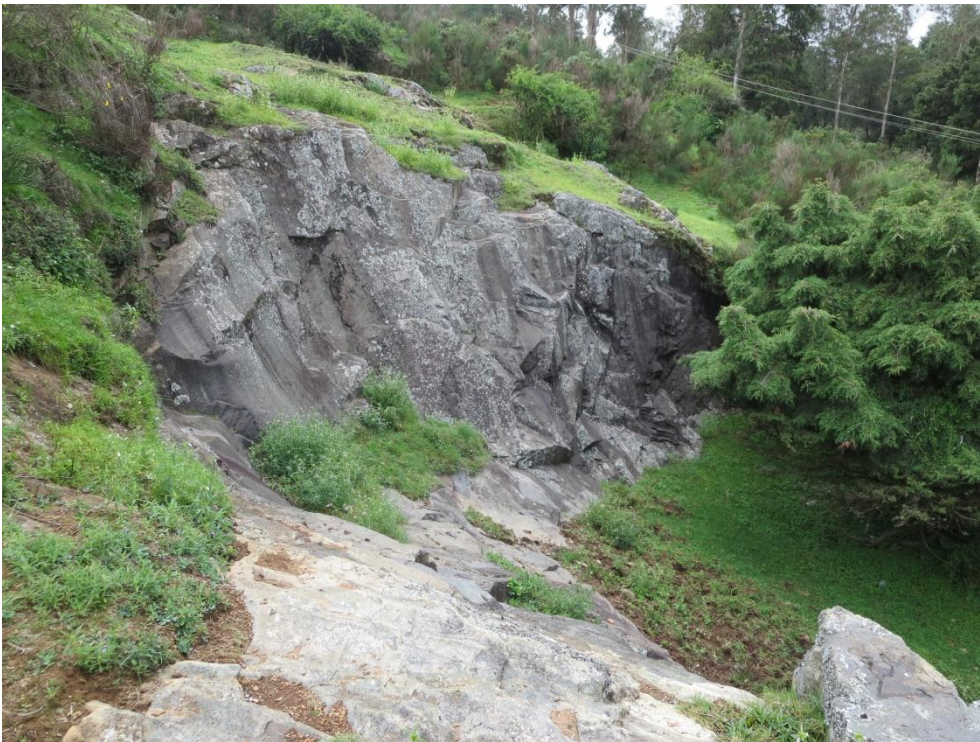
Figure 10: Rock outcrops in the catchment

Apart from this, various rock fractures were observed indicating the direction of movement of water at four different points. The rock at this point was made of Quartzite with granite veins.

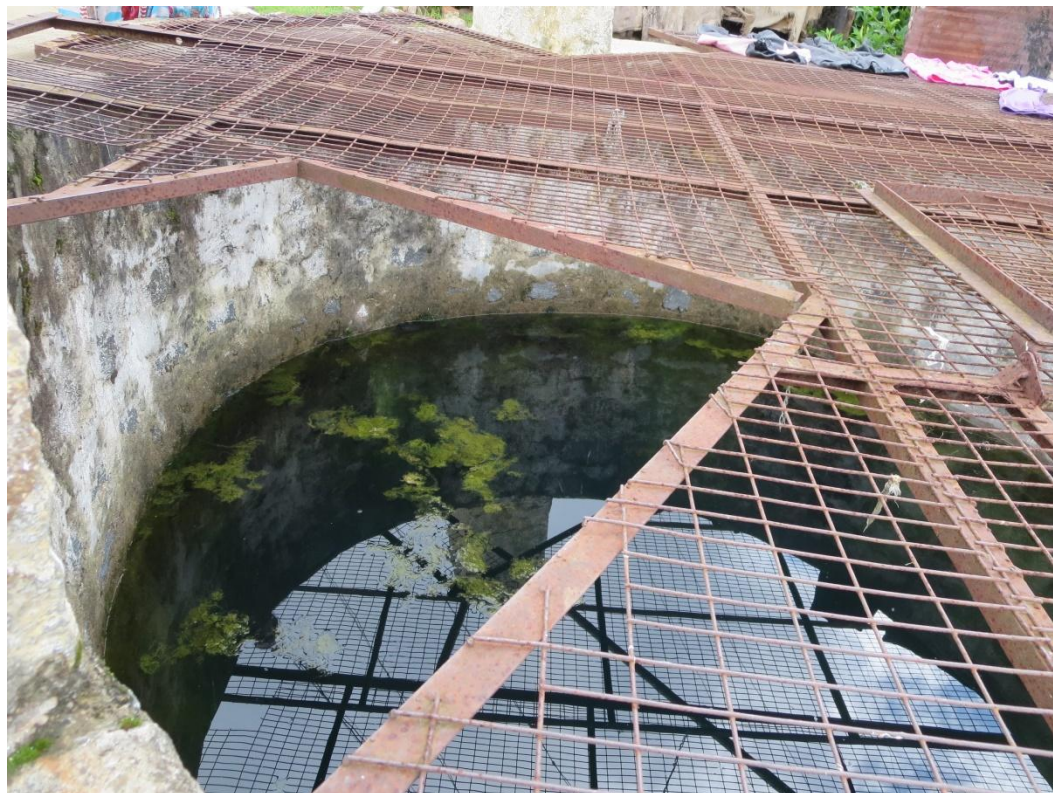
Near the head wetland, there is Indira Nagar, a colony of 15 houses that is built on the brim of the wetland and they share a community well for drinking water and other domestic use. The water level in the well is at the level of the wetland itself but highly infested by moss. The culvert that carries excess water from one side of the road to another under the bridge is fully blocked due to waste and silt deposit. This causes the wetland water to clog during monsoons as there is no escape. This poses a huge threat to the hygiene in the neighbourhood. As told by the residents, there have been cases of dengue in the colony due to the stagnation of water in the area.

Figure 11: The community well used by the residents of Indira Nagar

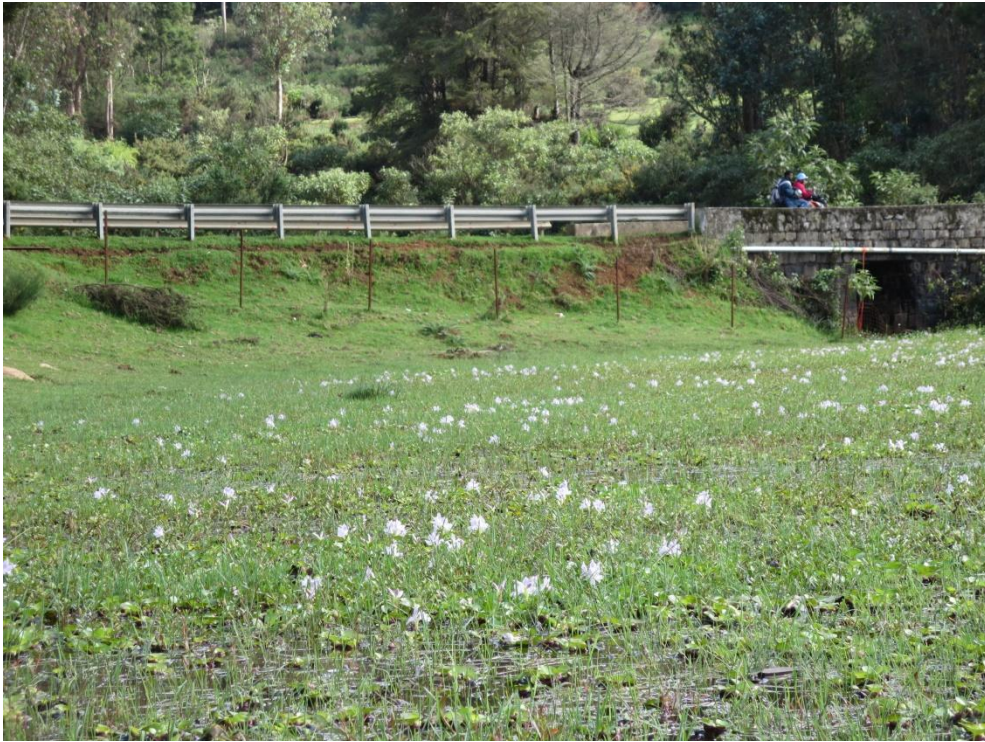
There were a lot of aquatic plants in the wetland one of which is the invasive, *Eichhornia crassipes* (water hyacinth). Most part of the standing water in the wetland is covered by the Hyacinth which outside its native region, the Amazon basin, is considered a threat to the freshwater ecosystem. By covering the surface of the water, it cuts off sunlight for the water, obstructs water flow and thereby starves water of oxygen. Since the presence of oxygen is necessary for water to purify itself, the quality of water in the locality is highly compromised. Apart from this, there are also other aquatics such as *Myriophyllum aquaticum*, *Alternanthera*, and mosses that are considered invasive too, clogging waterways.

Figure 12: Water Hyacinth, an invasive has taken over the surface of the water

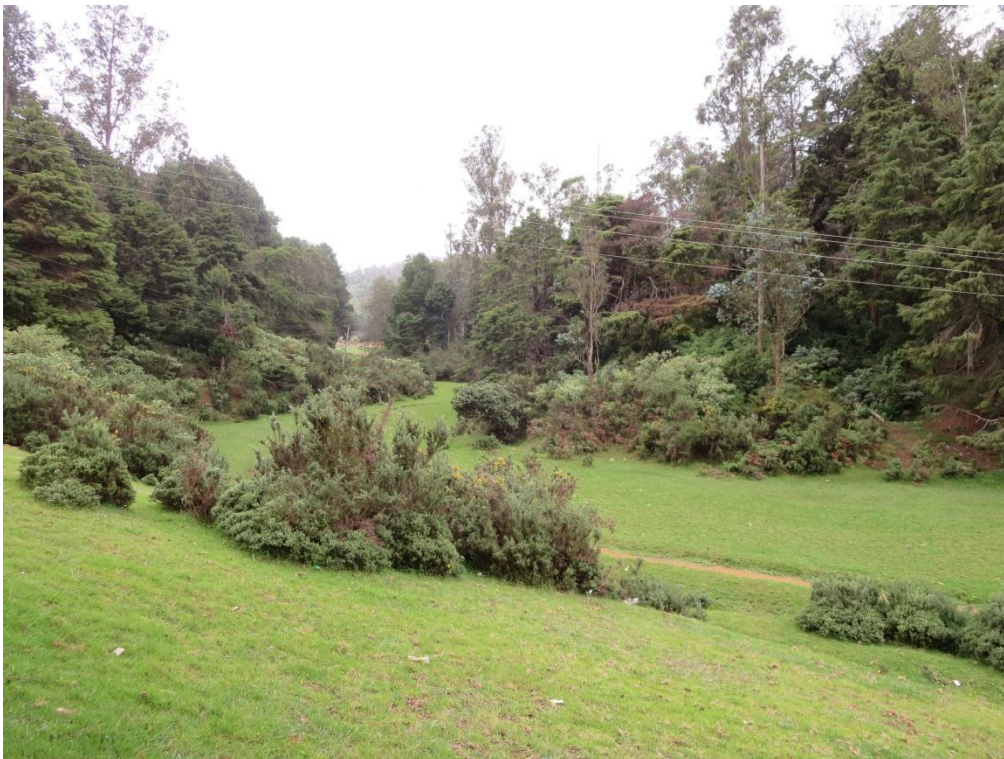
Figure 13: Invasive species such as Cupresses, Eucalytus and Wattle have taken over the wetland
