CASE STUDY 2: RIFLE RANGE Wetland

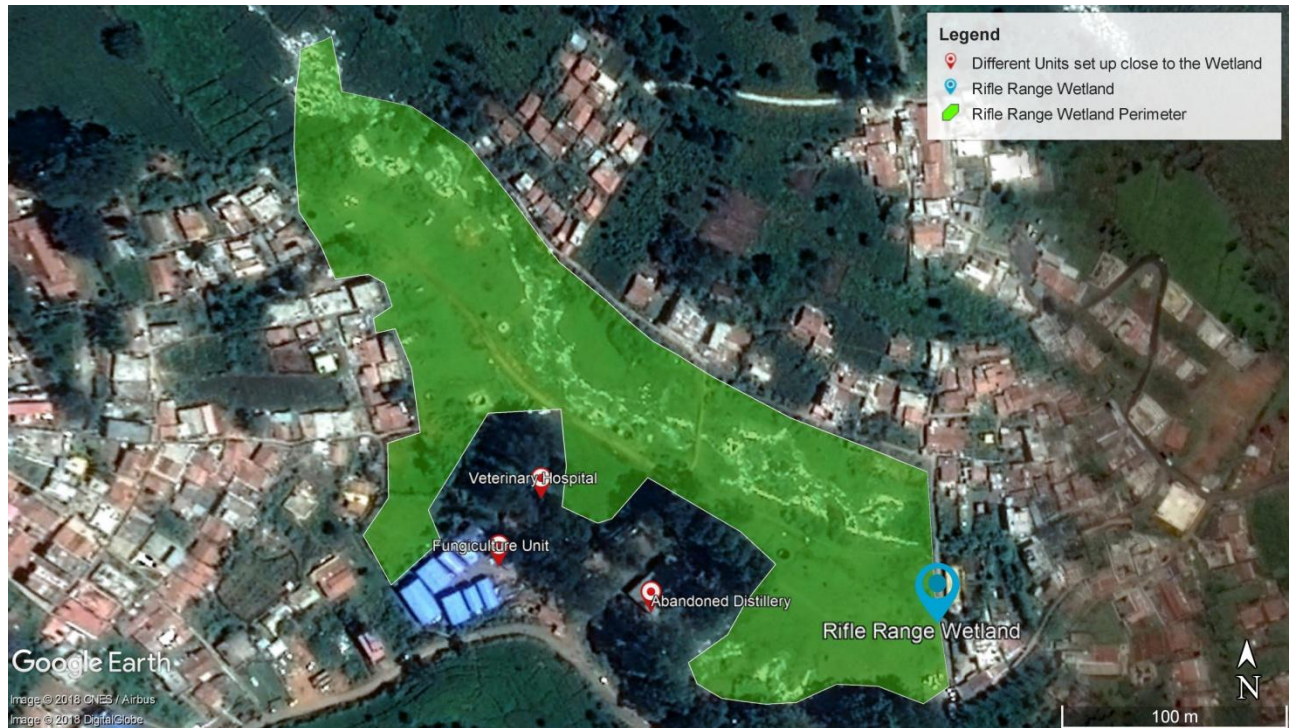
Figure 2: Context map of Rifle range

The wetland is located at one of the prime residential areas within Kotagiri and it has a varied land use around it. Apart from the dense residences on the immediate catchment, there is also a Veterinary hospital, Fungiculture unit (edible mushrooms) and an abandoned distillery. There are six wells that were dug by the panchayat but only three of them are in use at the time of the study. The wetland at rifle range is one of the biggest among all the wetlands that are being studied in detail.

The 7 acre wetland has a stream that starts from the spring to the west that cuts across the wetland and goes downstream to Donnington through the dense neighbourhood and runs further down. The water at the head wetland is cleaner in comparison to the downstream due to the sewage being let out in the downstream. The water from rifle range is used by the immediate neighbourhood and also by the panchayat for supply to Alports area just above the wetland for an hour every alternate day.

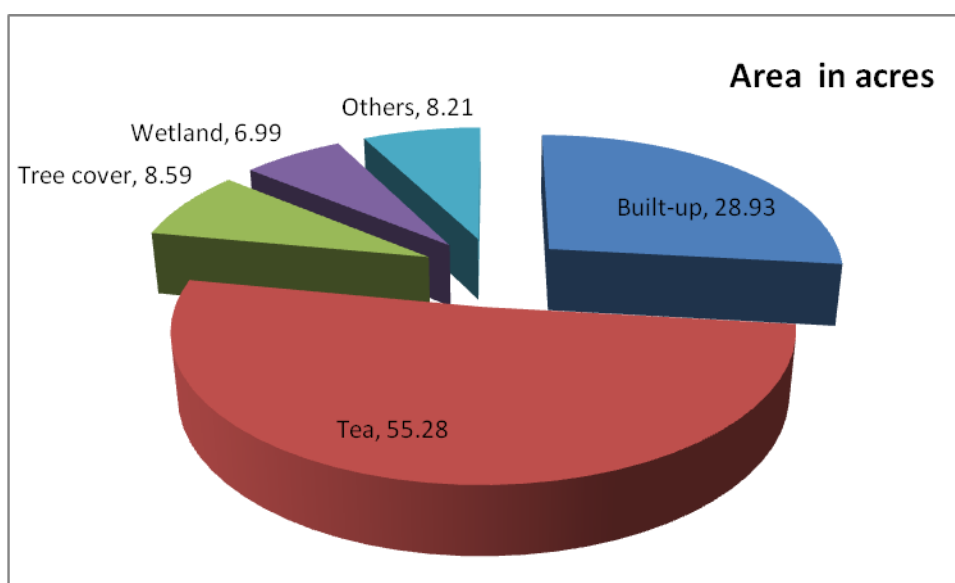
Figure 4: Proportion of the different land uses

Name	Area (acres)
Built-up	28.93
Tea	55.28
Tree cover	8.59
Wetland	6.99
Miscellaneous	8.21
Total	108

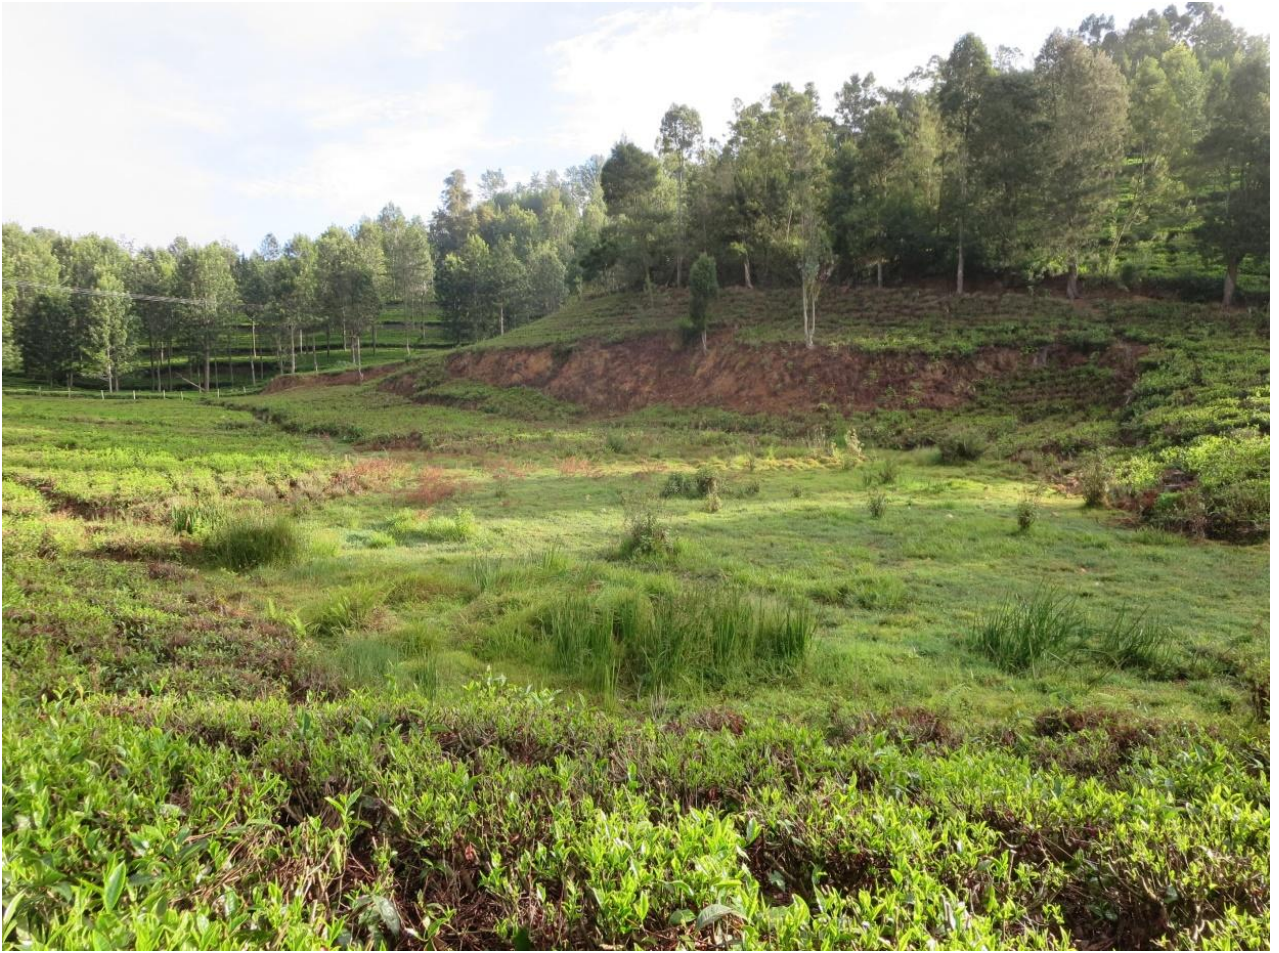
Figure 5: Head wetland at Rifle range

Almost half of the watershed area is occupied by tea plantations (51% of the watershed) that reach down till the wetland itself in the head wetland. Since tea requires a dry landscape to grow in, most of the growth here has failed due to the swampy nature of the wetland. The tea plantations are however found till the ridge of the watershed area.

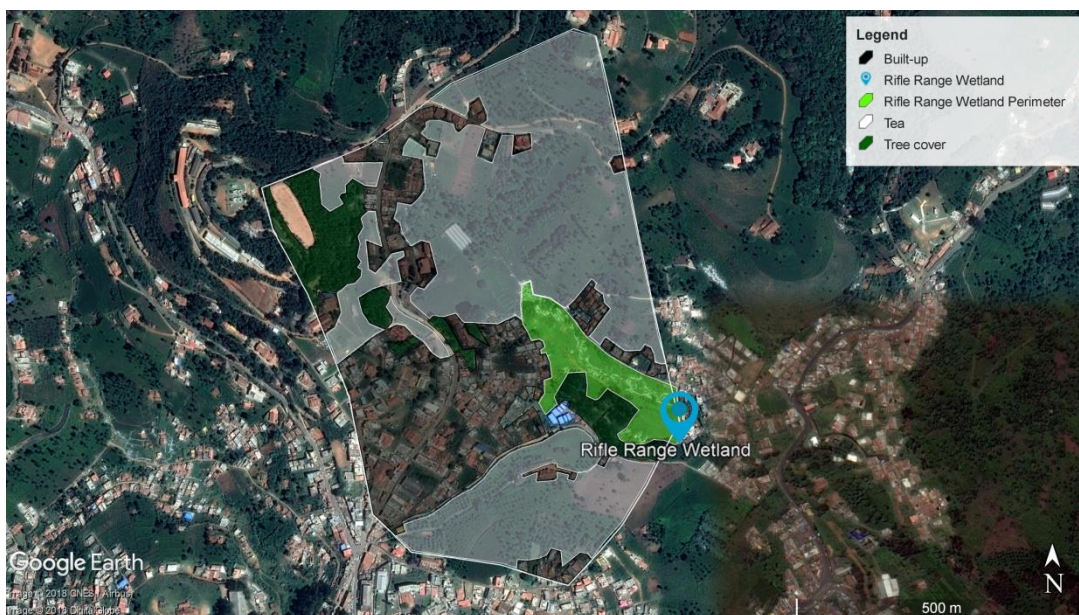
Figure 6: Land cover map of Rifle Range overlaid on Google Earth Image

Though tea occupies most of the watershed, the density of residences in this area is significantly high (27% of the watershed) as compared to the other wetlands that are studied (Elada, Upputhotti and Thalikulandah). This is probably due to the close proximity of the wetland to the town centre. While a handful of the current neighbourhood started inhabiting the place around 50 years back, most of the houses were built in the last decade due to the housing demand within the town area irrespective of the dampness due to the wetland. With this came the digging of private wells due to the abundance of water in the locality. Apart from this, the residences also let their domestic waste water into the wetland through pipelines set up by the individual families themselves.

Apart from this, there is very minimal tree cover left in the area due to dense built up in the locality. The wetland hardly covers 6% of the overall watershed due to the encroachment of houses and other buildings in the area. However, most part of the wetland is dry due to over extraction in the recent past.

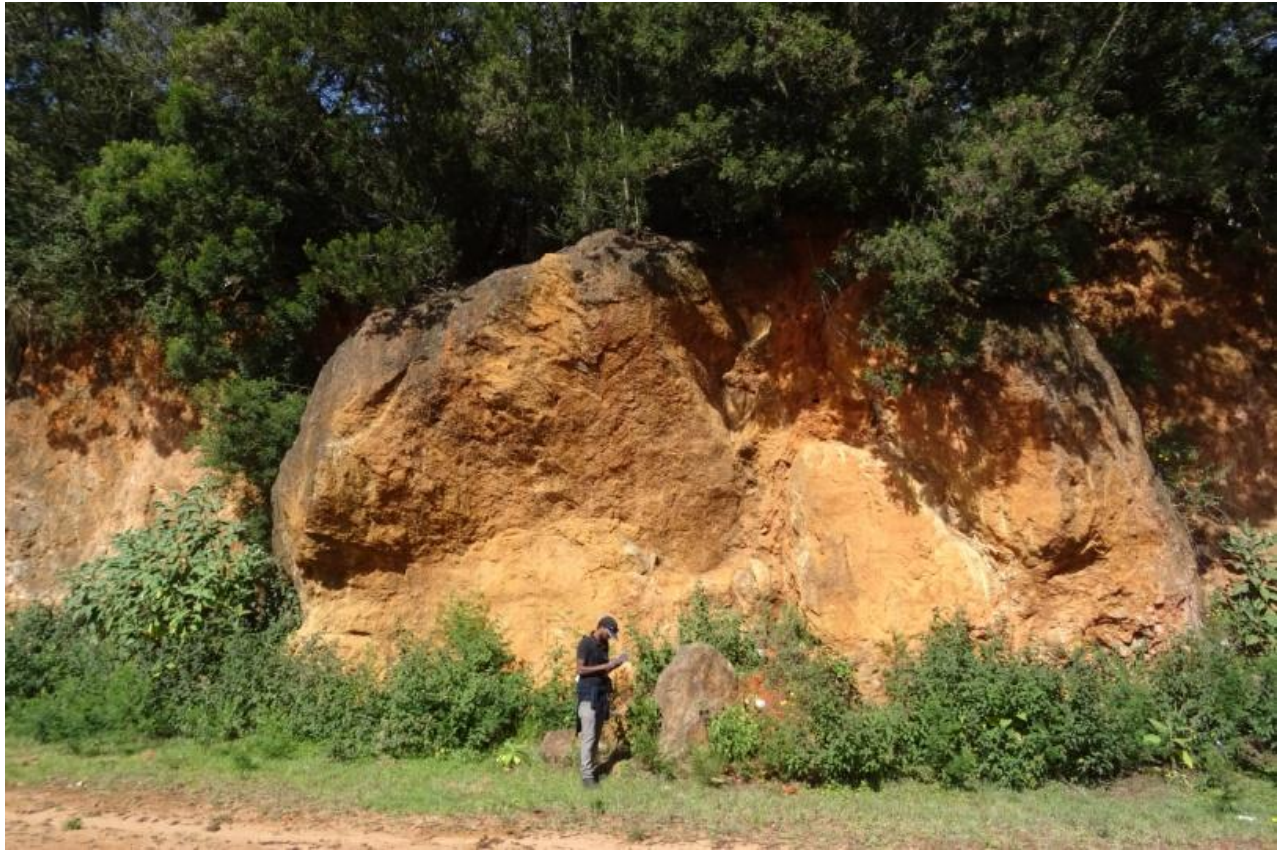
Figure 7: Exposure in Polytechnic ground showing semi weathered layer in the middle surrounded by Regolith

The ground in Shakthi malai next to the polytechnic was the starting point. The regolith or weathered layer goes more than 7 metres deep, the semi weathered rock is seen (refer picture above) in one part of the exposure. There are vertical fractures seen in the semi weathered rock. The process of spheroidal weathering was also seen in the exposure.

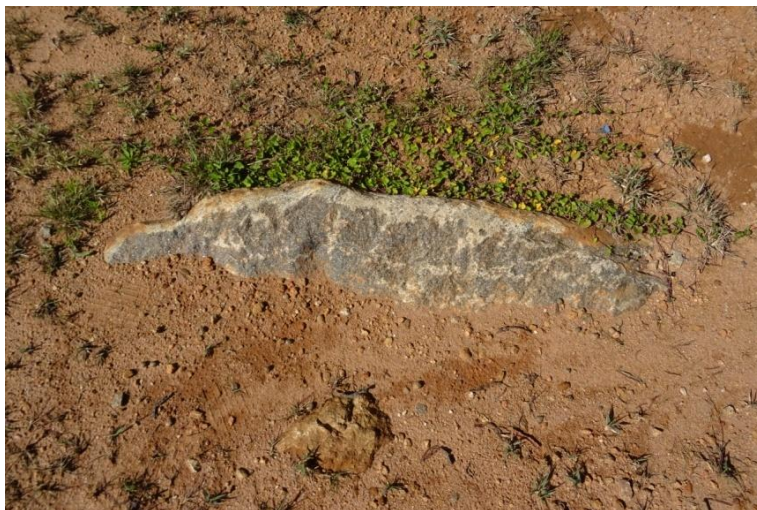
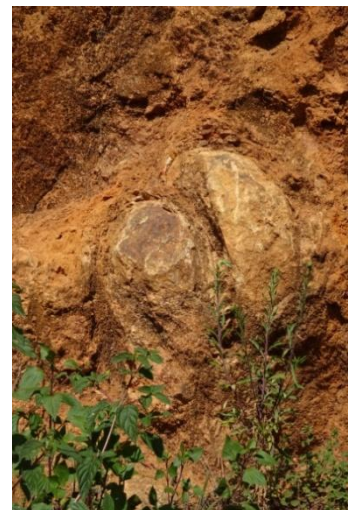
Figure 8: Dyke/Hard rock intrusion seen in Polytechnic ground Figure 9: Spheroidal Weathering

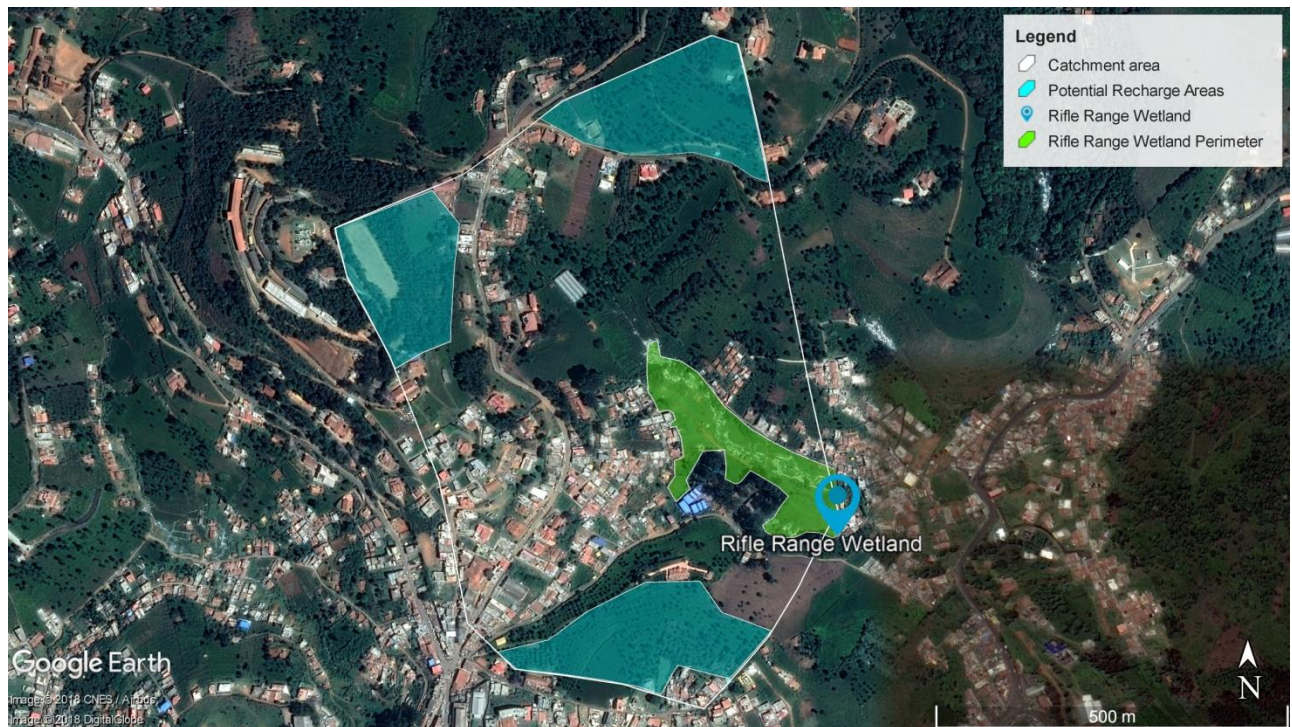
The important aquifer for the wetland is the weathered unconfined layer which stores and transmits water to the wetland. There are two major drainages feeding the wetland, one starting from the left flank (West) which brings water mixed with sewage from the dense habitations in Ramchand area, and the other drainage forming from the right flank (NNE) from below Windygap area in club road. The drainage from the right flank also has a depression spring close to the valley which feeds the wetland. The soil in the wetland is clayey type which helps in holding the water above ground level. The movement of ground water is much slower in the clayey sediment.

Figure 10: Potential recharge areas of Rifle Range wetland is shown in the map.

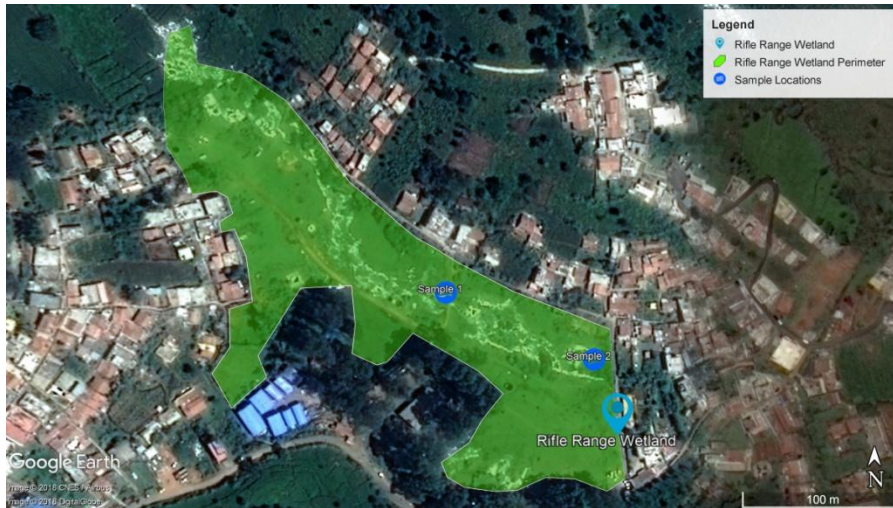
The water sample was taken from two points in the wetland along the stream (marked on the map above); where the stream is intersected by the bridge where a community well is used to draw water for washing clothes and at the end of the wetland. Though the quality of water at both these points is almost the same, there were few differences in terms of the iron content, hardness and coliform in water.

Figure 11: Map showing the location of water sample collection for quality test

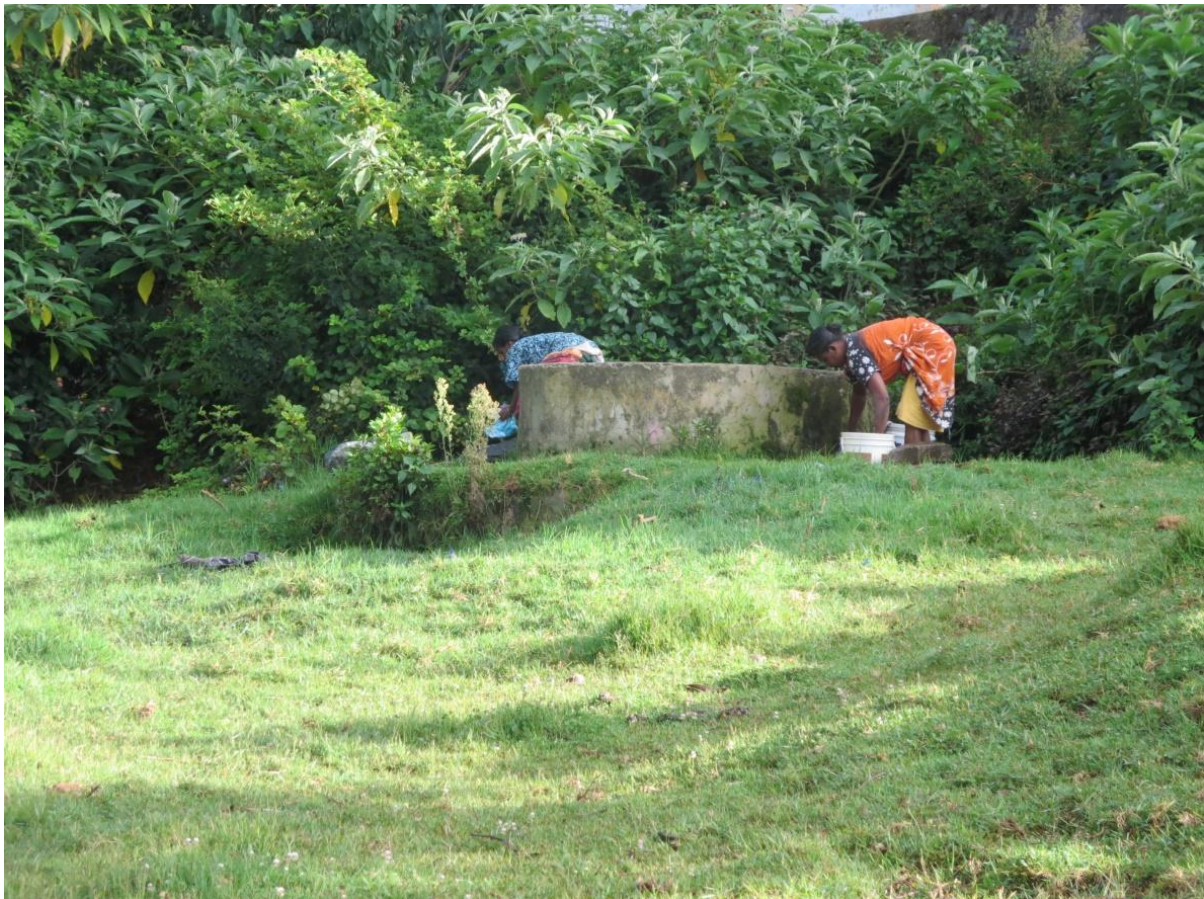
The sample from **point 01** was at a very important junction in the wetland where the flow of water in the stream is interrupted by a crossover bridge that leads to the residences built on the catchment area. The water here was clear and odourless and has a higher pH possibly due to the mix of detergents that have high alkalinity. The salt content in this water is within the permissible level for drinking water and so are the electrical conductivity and the total dissolved solids.

Figure 12: Residents washing clothes near a panchayat well

There was presence of iron in the water that was evident from the rust orange base and an oily film on top. The iron level in this water is 1mg/l whereas the permissible level is 0.3mg/l. Apart from being an aesthetic problem, the colour does not affect the quality of the water for consumption. Due to lack of open defecation and sewage release into the stream water, there is no Coliform or ammonia present in the water.

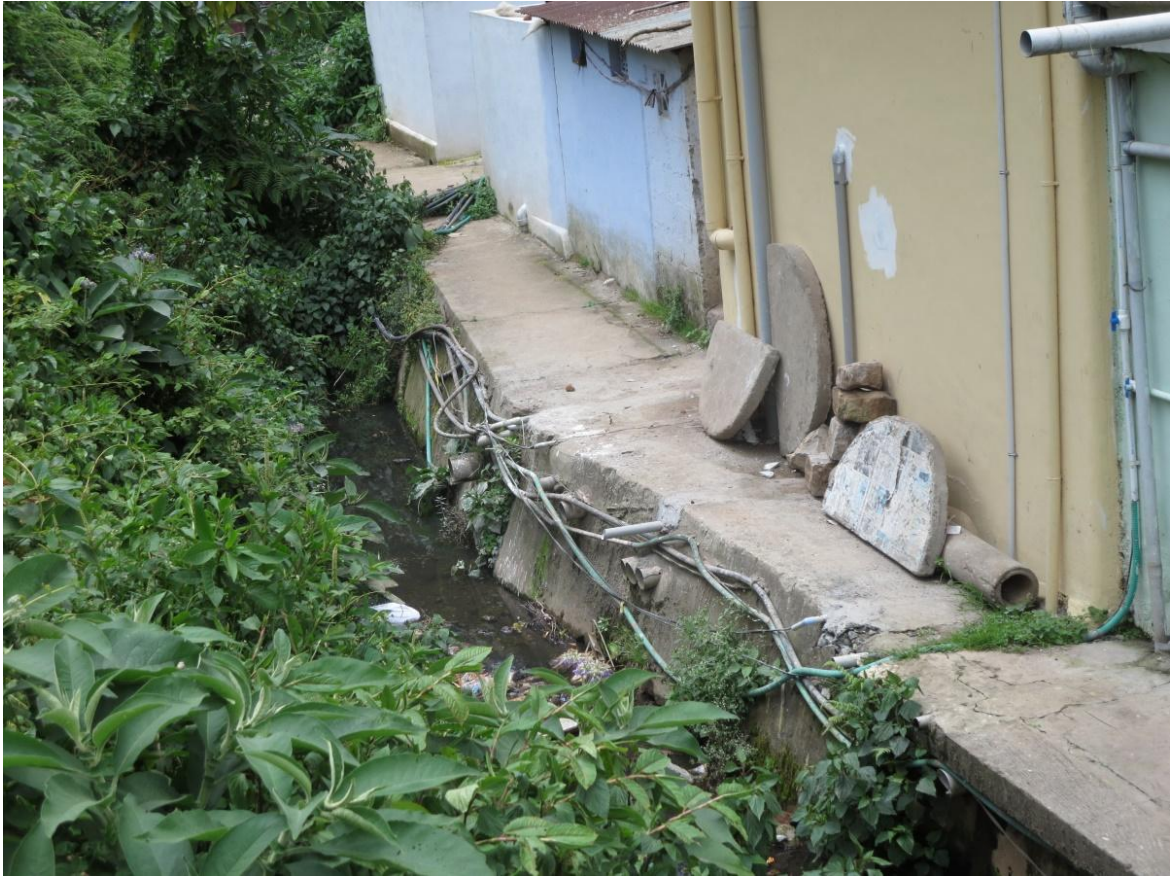
Though the quality of water is within the permissible levels for drinking at the wetland, as the stream travels further down, the water is fully contaminated as the stream collects all the domestic waste from the households and turns into a drainage duct rather than a freshwater stream.

Figure 13: Sewage being drained into the stream

11. Downstream, the condition of the stream has to be improved by desilting, trapping sewage outlets from the household and improving the edge conditions of the stream.

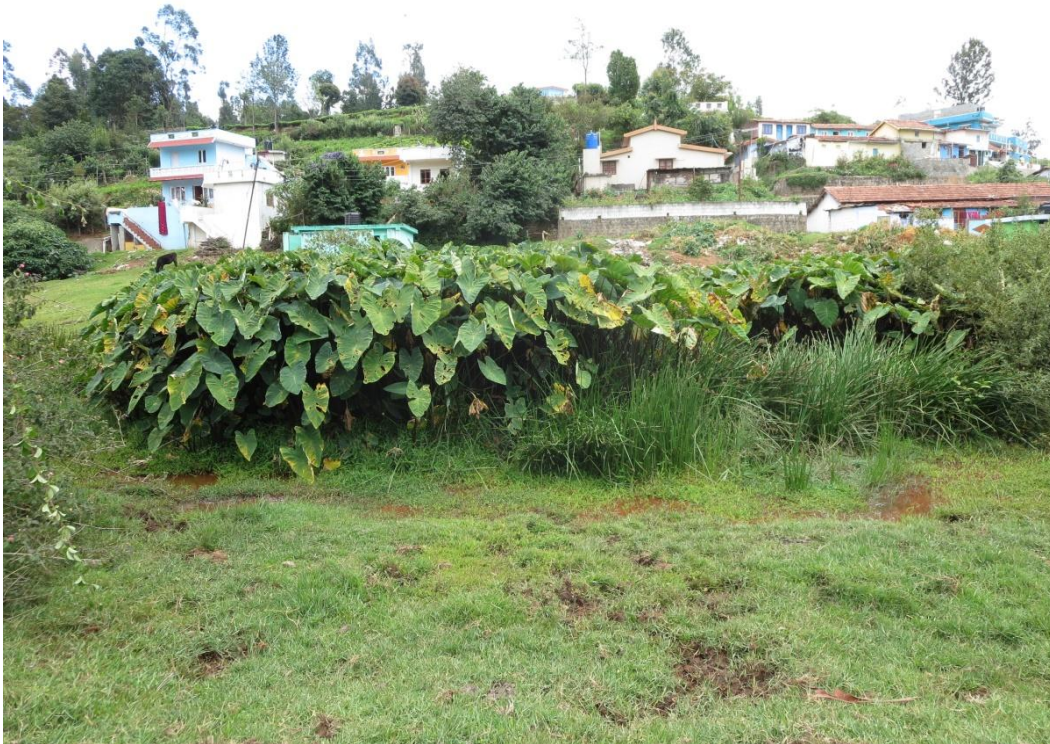
Figure 14: Dense aquatic plants lining the stream in the wetland

At the depression, where the stream runs, the landscape is dominated by *Arum*, *Isachne*, *Scripus* and *Ludwigia* which are native aquatic plants that play a major role in retaining water in the stream and in improving the quality of water as it runs downstream. Apart from that the dried up patches are taken over by a mix of both native and exotic grasses. Lining the wetland towards the south is *Eucalyptus* that was first introduced by United Breweries Ltd in early 20th century to make the marshy land suitable for construction.

9. In the wetland, a **buffer on the either side of the stream** must be maintained in order to allow for the aquatic plants to thrive and further help in water retention and purification.

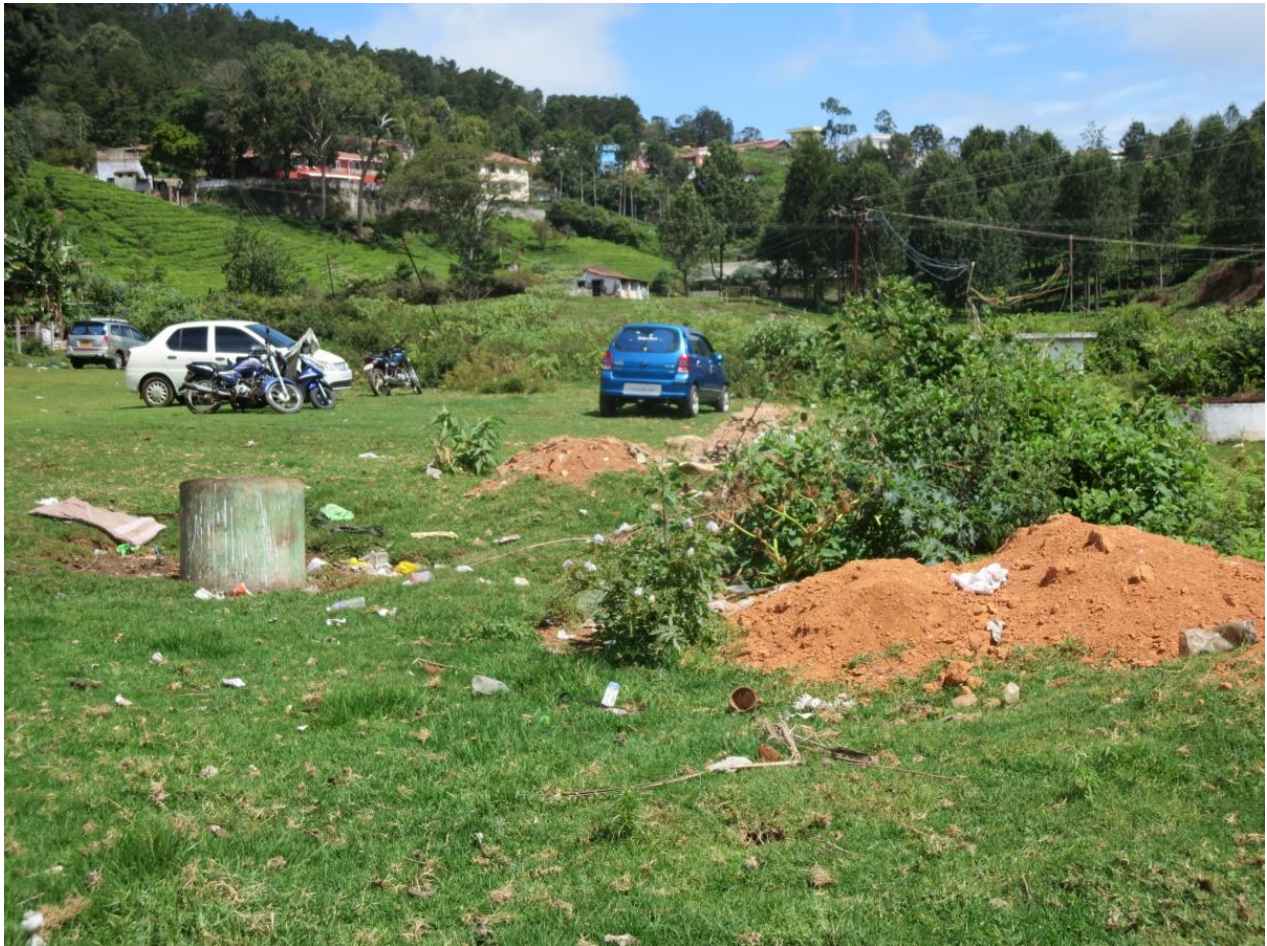
Residents of the neighbourhood are the only stakeholders that can have a direct, yet far reaching effect in terms of conserving the wetland. While the older residents are aware of the wetland characteristics as they have been coexisting with the wetland for generations, the newer residents are unaware of the situation as it doesn't affect their livelihood directly. The town panchayat (local government body), the secondary stakeholder, is under pressure to supply the town with water, supplying from water surplus areas to water deficit areas within the town, leaving the wetland in disarray. There is competing pressure on the wetland from all the stakeholders, by constant digging of wells, encroachment of the wetland for parking and

Figure 15: Wetland being used for parking by the nearby residents

10. In order for these measures to sustain over a period of time, the wetland has to be fenced in certain critical areas and areas of intervention. Movement through the wetland should also be restricted and regulated to avoid damage due to human intervention.
