## Need and Urgency of Landslide Risk Planning for Nilgiri District, Tamil Nadu State, India

### ABSTRACT

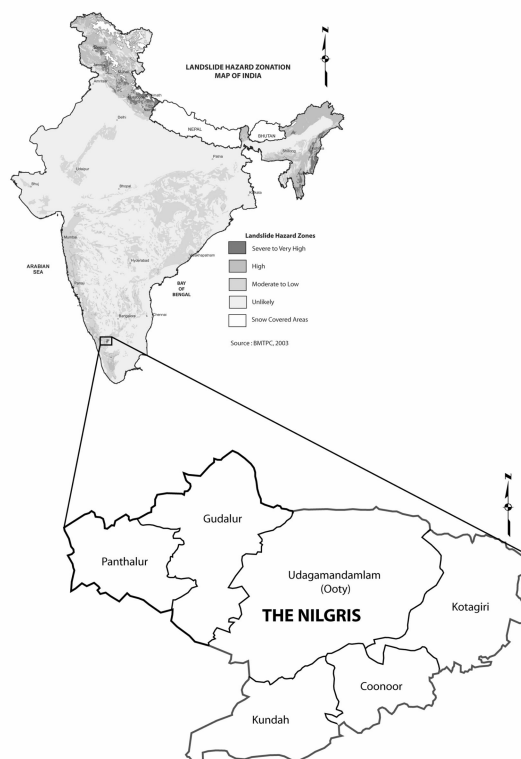
Figure 1. Map showing the location of the study area in the Landslide Hazard Zonation Map of India

Nilgiri is hilly district with an area of 2500 sq. kms and is situated in the northwestern part of Tamil Nadu state. It is bordered by the states of Karnataka in the north, Kerala in the west and south and by the districts Erode and Coimbatore of Tamil Nadu in the north east respectively. Ootacamund (udagamandalam) is the district head quarters (Figure 1). The total population of the district is 762141 as per the Census 2001.
