*HYDROGEOLOGICAL SURVEY IN ARACODE, COONOOR, OOTY AND
SIGUR REGIONS OF THE NILGIRI DISTRICT, TAMIL NADU*

Hydrogeological survey in Aracode, Coonoor, Ooty and Sigur regions of the Nilgiri district, Tamil Nadu

Technical Report Number: ACWA/Hydro/2017/H60

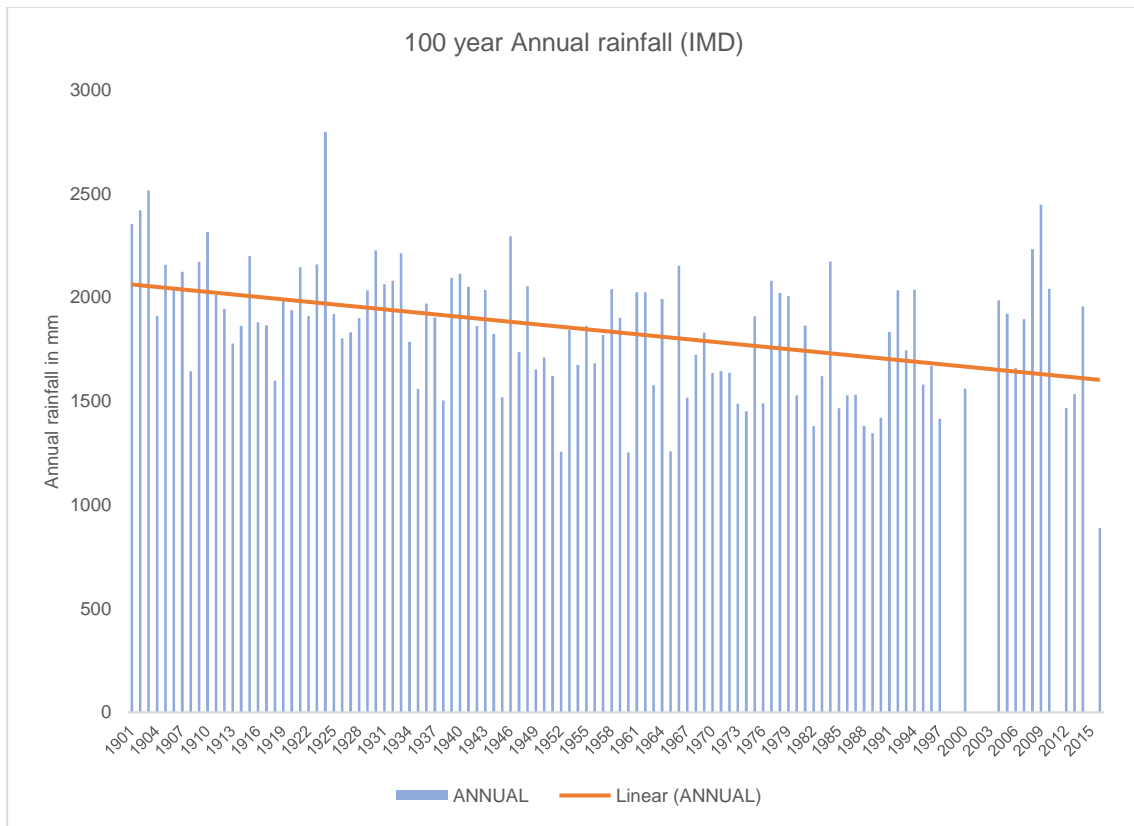
Figure 1: 110 years of district level annual rainfall trend depicting a sharp decline (IMD, 2012)

Secondary data analysis from various sources was carried out in order to understand the regional groundwater scenario and groundwater dependency in the Nilgiris. According to the Indian Meteorological Department (IMD), the district's average annual rainfall is 1846.5mm (IMD, 2012). A seasonal rainfall analysis for 110 years between 1901 and 2016 shows that the region receives bimodal rainfall between June to September (56%) and from the returning monsoon from October to December (27%). A long term trend of the annual rainfall shows that rainfall is steeply declining over the years (Figure 1). The decline is sharpest between January and September but the period from October to December is showing a gradual rise (Figure 2).

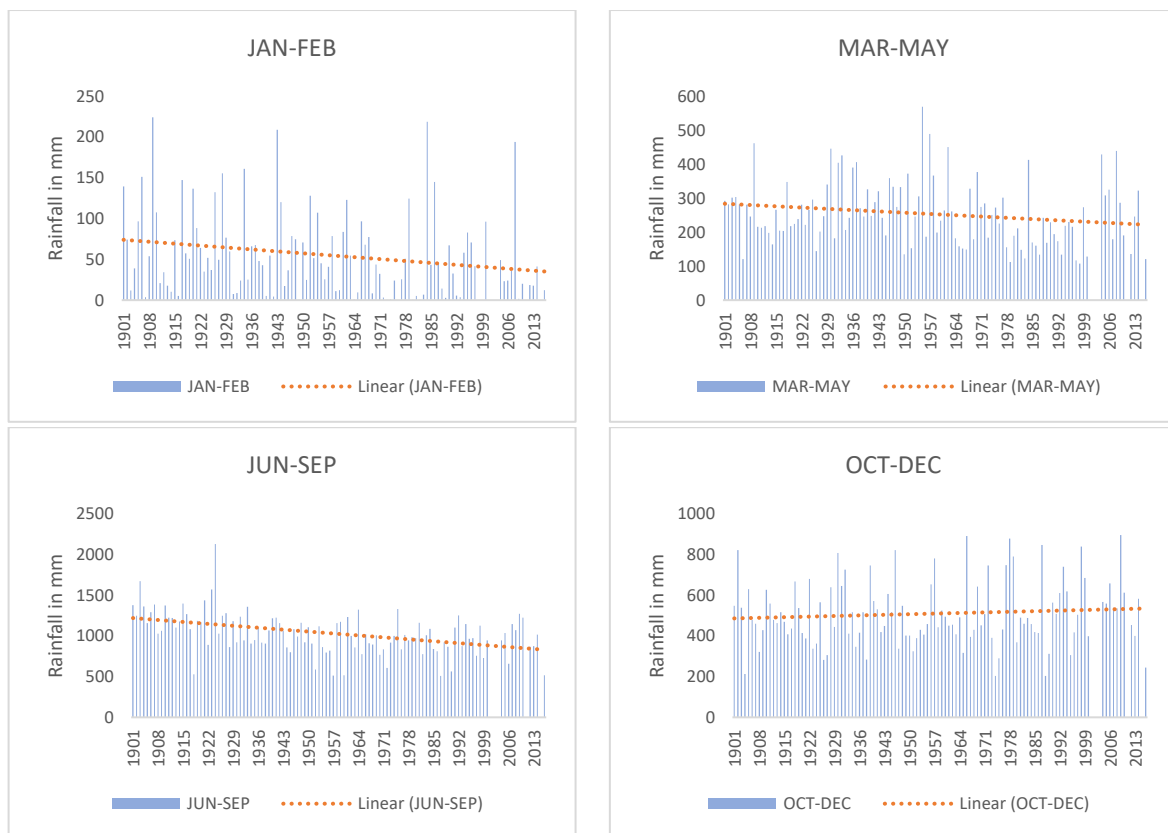
Figure 2: 110 years of district level seasonal rainfall analysis depicting declining rainfall between January to September and increasing trend from October to December

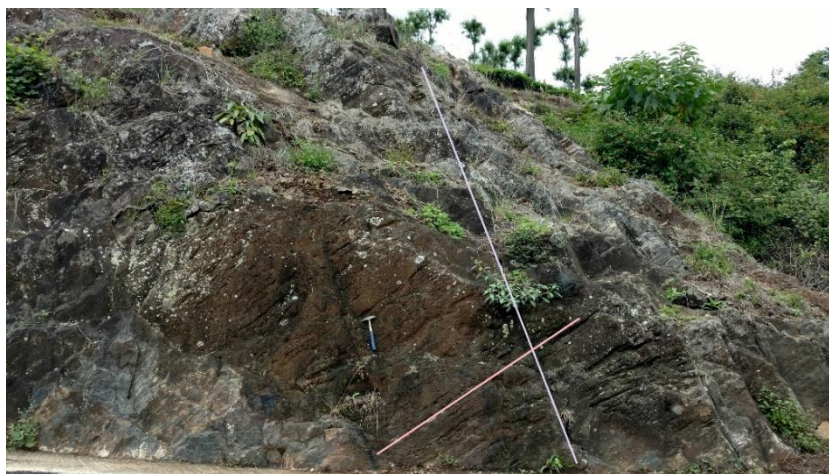
Photo 1: Road cut exposure of charnockite exhibiting dipping foliation and fractures

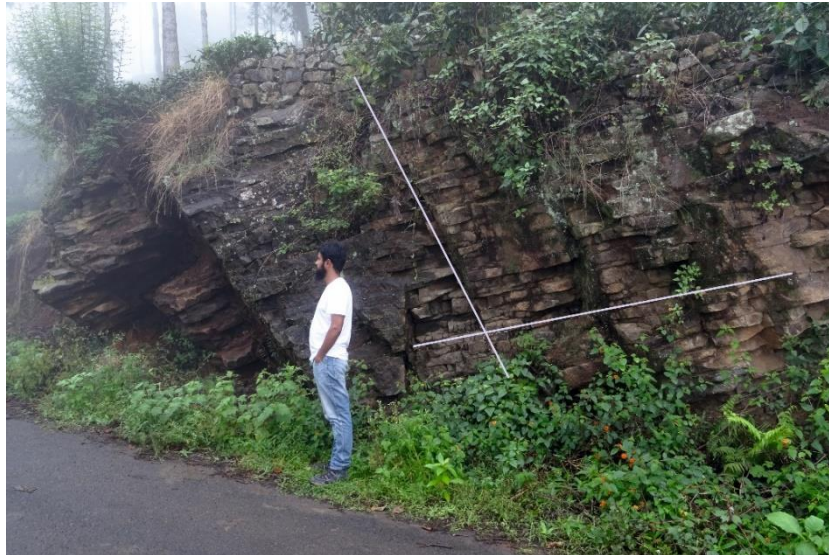
Photo 2: A charnockite or gneiss roadside outcrop showing two sets of fractures; several nearly horizontal and a few high angle dipping fractures

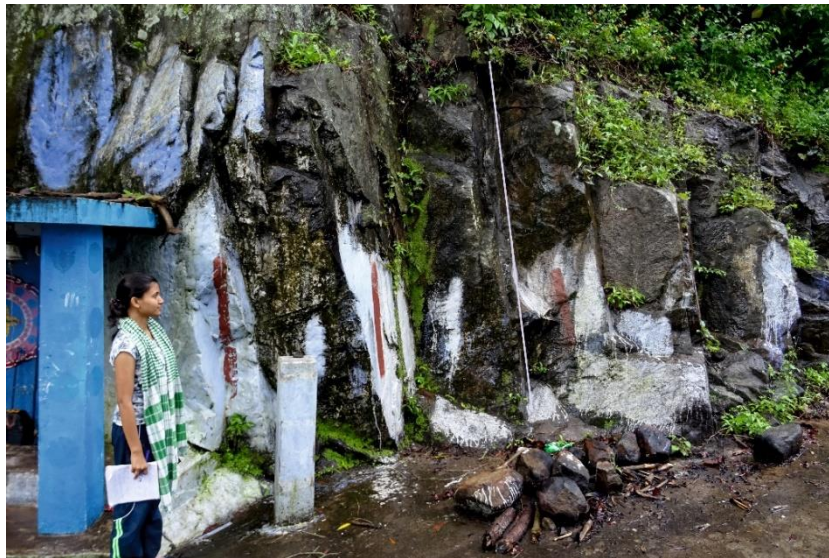
Photo 3: Near vertical fractures without any openings in charnockite (Photo courtesy – Keystone Foundation)

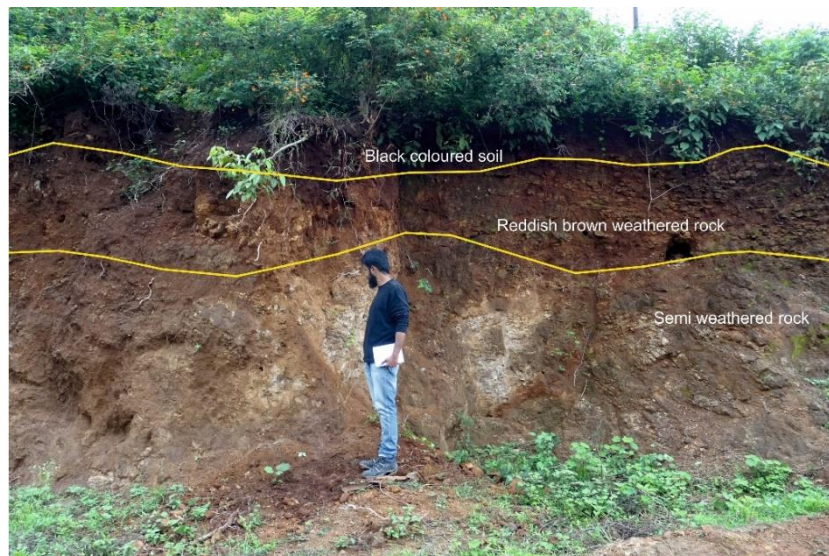
Photo 4: A cross sectional profile revealing the different degrees of weathering - top black coloured soil underlain by reddish-brown weathered rock which overlies a semi-weathered rock

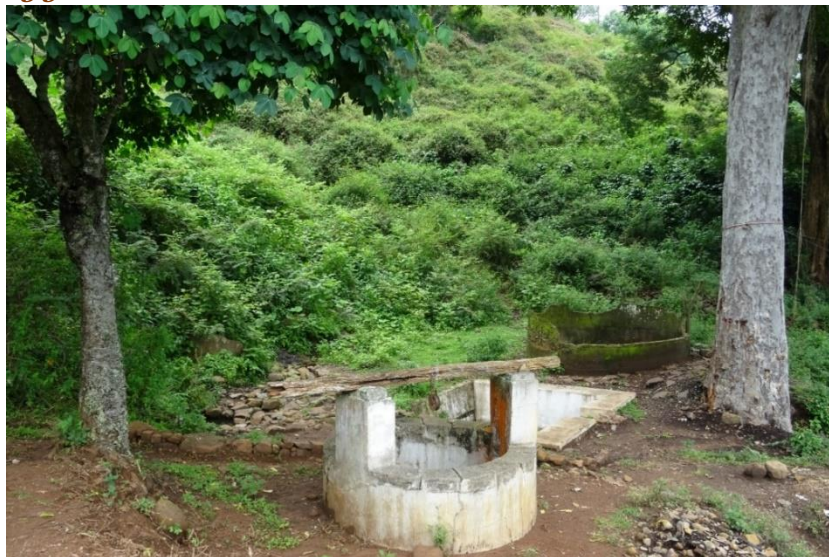
*Photo 5: Two small perennial depression springs whose water is collected in a small collection box (located between the two wells) provides drinking water to Kokode village. The two old wells are also perennial and are used for domestic and drinking purposes by two other villages. Effectively, a spring box and two wells tap the same springs in this case
(Photo courtesy – Keystone Foundation)*

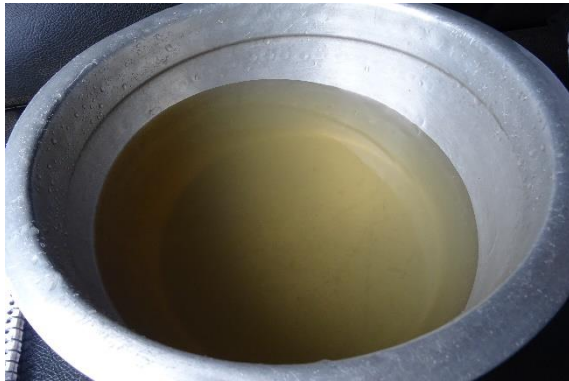
Photo 6a: Colour of rain water remained unchanged after emersion of guava leaves

The in-situ water quality analysis of one hand pump located in the Garikyur village shows that values for salinity, TDS and EC are twice as high as that detected for spring water. Along with this, a qualitative method of testing iron which involves immersing crushed guava leaves into the sample (knowledge passed down by Mohammed Murtaza from Supaul district, Bihar) was carried out on two samples. Change in colour of the sample from light pink to shades of purple indicates increasing levels of iron contamination. One rain water sample and the other from a hand pump showed that the colour of rain water sample remained unchanged (Photo 6a) while the hand pump water sample turned into a shade of

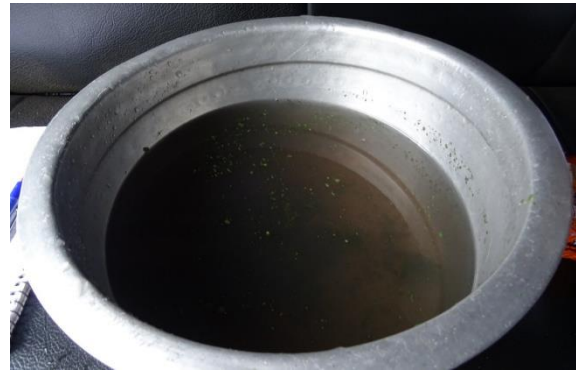
Photo 6b: Deep purple colour od sample indicating presence of iron in water collected from a hand pump located in Garikyur village.

purple indicating the presence of iron (Photo 6b). Also despite the fact that the springs do not show presence of bacteria, the region is vulnerable to contamination due to the close proximity of villages and practice of open defecation.

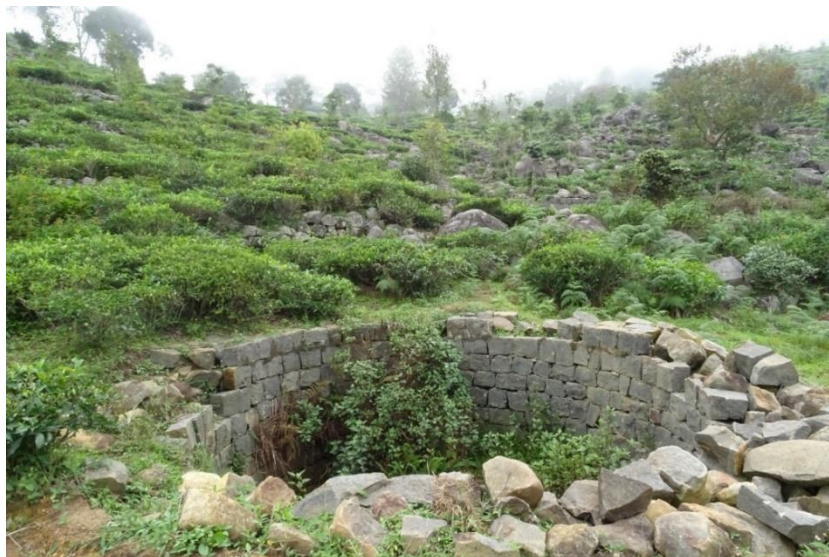
Photo 7: An abandoned well in a tea estate near Pambarai village (Photo courtesy – Keystone Foundation)

Along with springs, open wells were also studied. The wells are not very deep, typically varying between 5-7 metres in depth and 3-5 metres in diameter. All the observed wells were lined or constructed till the base with stones or cement, thus implying that the rock profile is loose and weathered (Photo 7). This top weathered portion constitutes the main aquifer for the wells. Similar to springs, wells are also used by locals for drinking and domestic uses. While some of the wells have pumps (usually 1-2 HP motors) installed in them for abstracting water, in others it is done manually with the help of buckets.

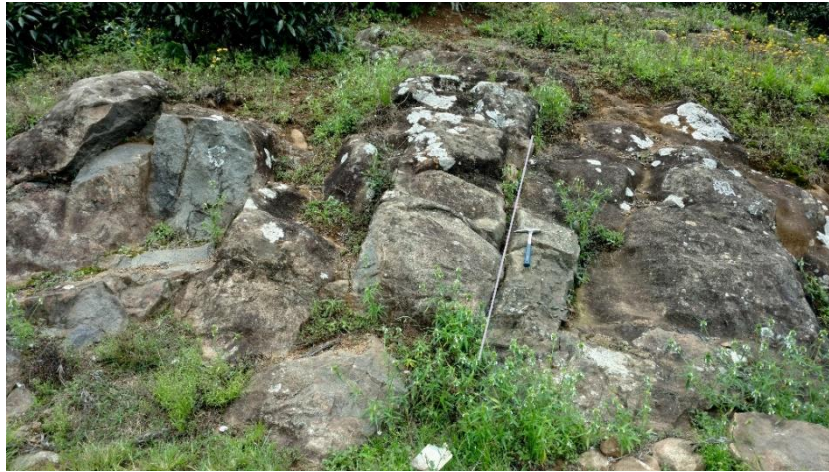
Photo 8: Charnokite outcrop with fractures

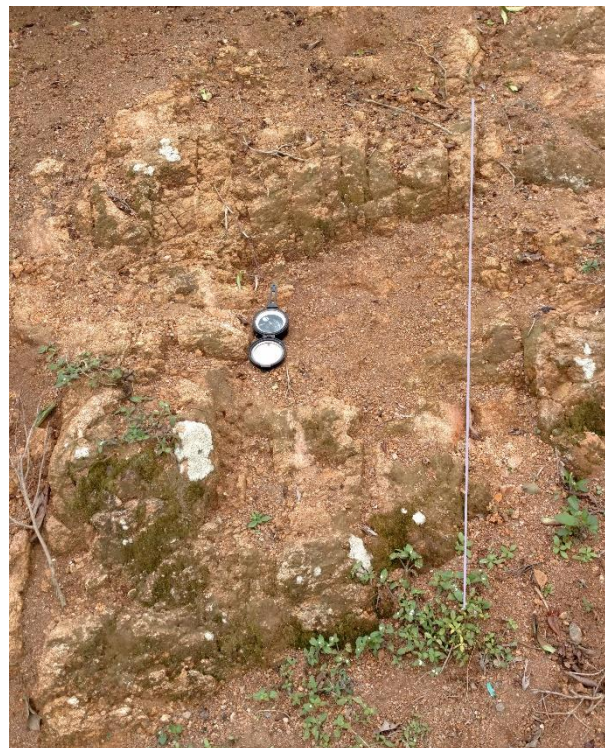
Photo 9: Traces of parallel fracture sets visible in a highly weathered rock

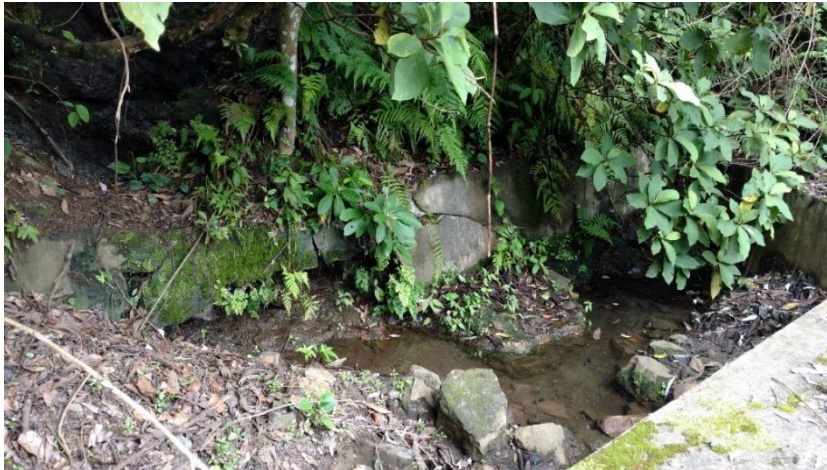
Photo 10: Two springs emerging at an elevation of 1568 metres above msl that is collected in a spring box.

In Coonoor catchment, two springs, one in Hulical panchayat and the other in a village close of Jogheecombai village along with two wells in Bambalacombai village were studied. While the one situated in Hulical panchayat is categorised as a fracture spring that is perennial, the second could be a depression type spring. The fracture spring has a small spring box constructed around it with a system of pipelines that takes water to Korangametla village to meet their daily domestic and drinking water requirements (Photo 10).

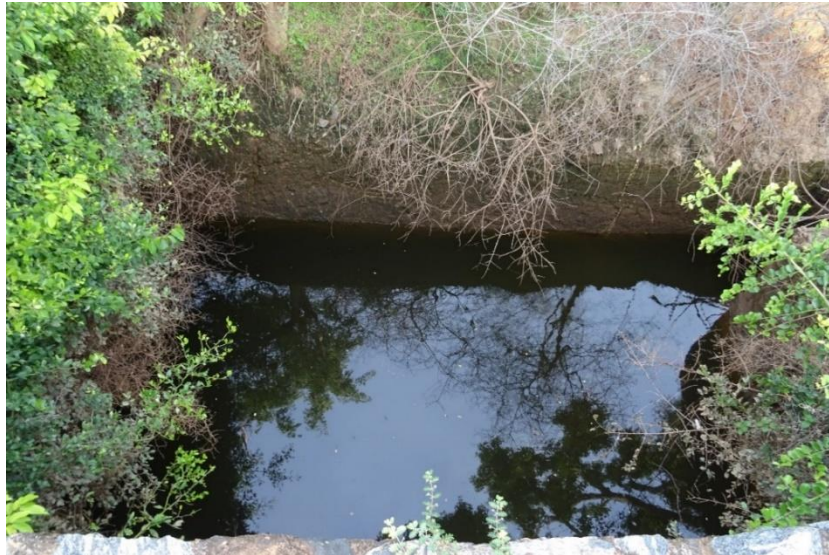
Photo 11: A large rectangular well located in Chemmanatham village reveals the weathered subsurface strata (Photo courtesy – Keystone Foundation)

In the northern slopes of the Nilgiri hills, few rock exposures along stream beds and in wells can be seen. The wells here are lined in the top 3-4 meters concealing the highly weathered and friable rock which is underlain by slightly weathered and fractured charnockite. This soft, weathered rock could be either weathered material formed by the in-situ weathering of charnockites and gneisses or it could be loose sediment material brought down from the hills and deposited at the foothill (Photo 11).

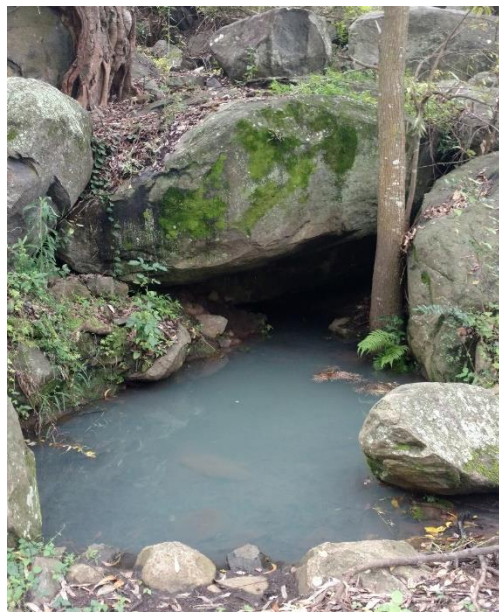
Photo 12: Sakot spring emerging at an elevation of approximately 1360m above msl in the southern hillslopes of Nilgiris

such spring named Sakot spring (KAD104) emerges at an elevation of 1366m (Photo 12). The spring has a perennial discharge and is categorised as a depression type. It is fed by an aquifer that comprises unconsolidated or weathered material deposited along the slope. Located in the forest area, presently it provides water for wildlife but soon this spring water will be tapped with the help of pipelines to supply drinking water to 50 households in Chokkanalli village. It is thought that many similar springs emerge from these mountains but are yet to be explored. Along with the high elevation springs, a few others such as springs SOLO01 and SOLO02 (at elevations of 920 metres) near Kurumbarpallam village emerge in streams that have a seasonal flow. The seasonal stream is usually observed to go dry after six months after the monsoon, post which water from these small springs is consumed for drinking water needs.

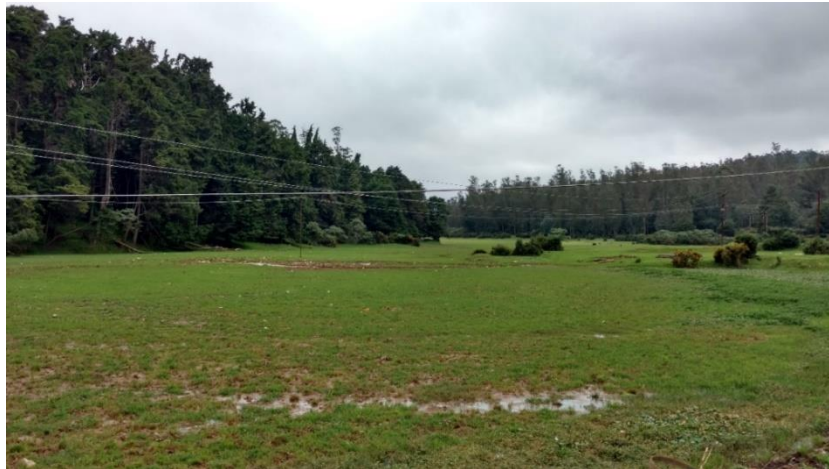
Photo 13: The main Thalaikunda wetlands of Ooty

The main Thalaikunda wetland (Photo 13), situated in the heart of Ooty town is a large wetland spread over nearly 2 km² and fed by numerous other smaller wetlands located in smaller valleys of the surrounding hills (Figure 6). This wetland had been dammed in the west by a small, approximately 250m dam wall. The smaller wetlands are located in streams that drain into the main wetland. The southern and south-eastern portions of the catchment cannot be accessed as the area falls under private lands or under the forest jurisdiction. However, certain northern and eastern parts of the catchment could be traversed. Nearly 5 smaller wetlands were recognised that feed the Thalaikunda wetland. Some of the wetlands had small rivulets flowing through them during the time of visit, while some others didn't show the presence of any surface flow. However, the marshy appearance suggests the presence of subsurface flow.

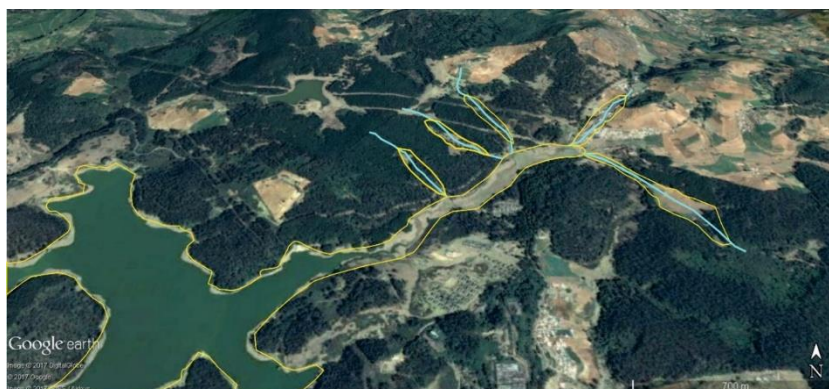
Figure 6: Streams and small wetlands that feed the main Thalaikunda wetland of Ooty marked on google earth

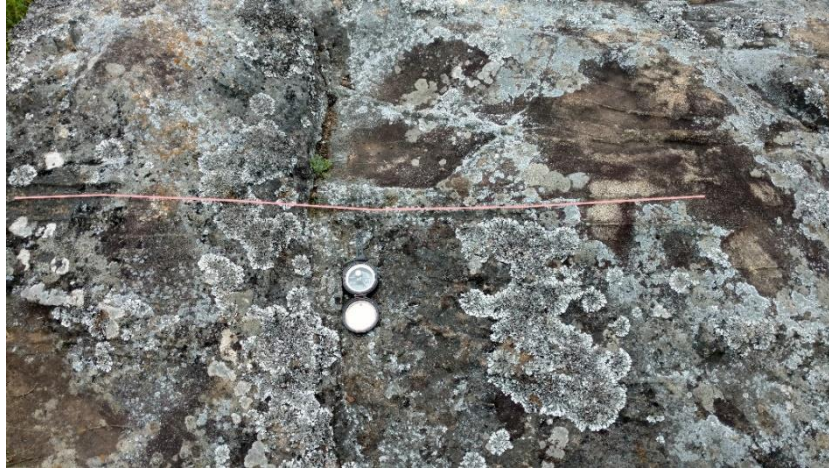
Photo 14: Weathered charnockite rock exposed along a ridge between two wetlands

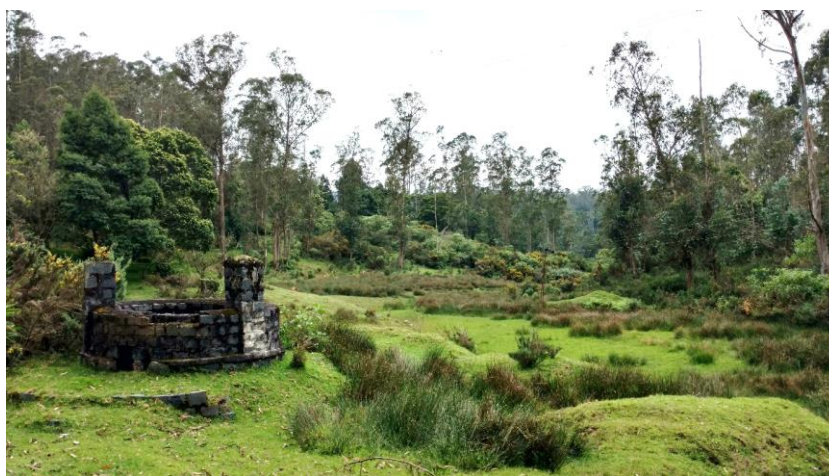
Photo 15: An old well located in one of the small feeder wetlands

Two among the five wetlands are small in areal extent compared to the others. Most wetlands have open wells situated in the central valley portions (Photo 15). All the wells have water throughout the year and are primarily used for drinking and domestic purposes. However, in some of the valleys,

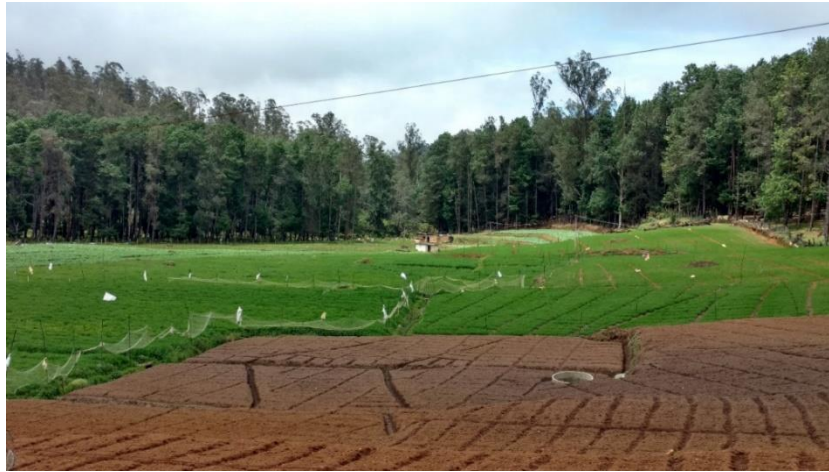
Photo 16: Large scale farming of carrots and potatoes in one of the wetlands

they are used for irrigating mainly carrots and potato which is the main produce from this region that is later sold to Mettupalayam town. One of the valleys situated to the north-east of the main wetland has been completely altered into an agricultural area with large scale cultivation of potato and carrot (Photo 16). A simple in-situ water quality test conducted on one of the wells used for domestic and drinking suggests that it is of good quality.

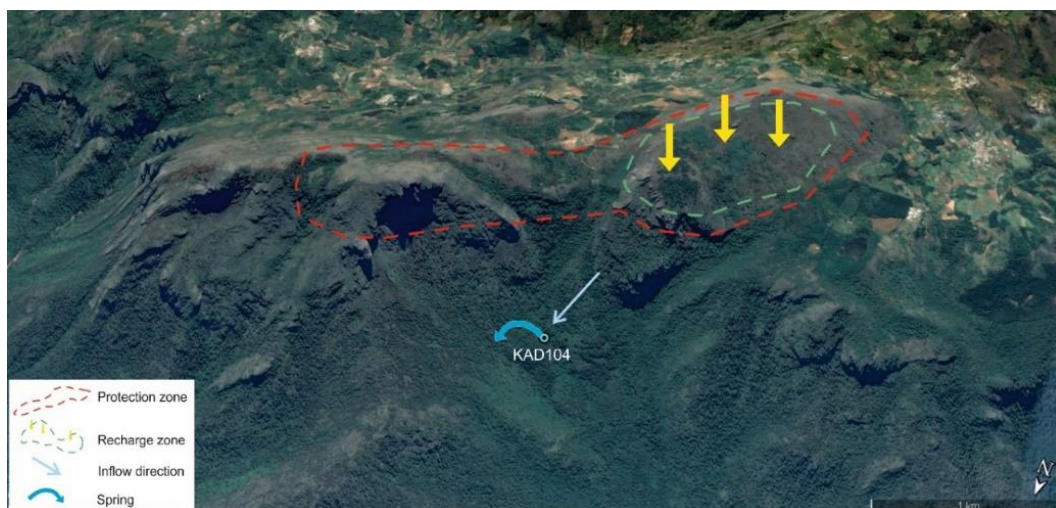
Figure 13: Google earth image showing the protection and recharge area of a spring near Chokkanalli village, Aracode
