Critical Water Resources, Kotagiri Town Panchayat

A report by Keystone Foundation, 2018

Introduction

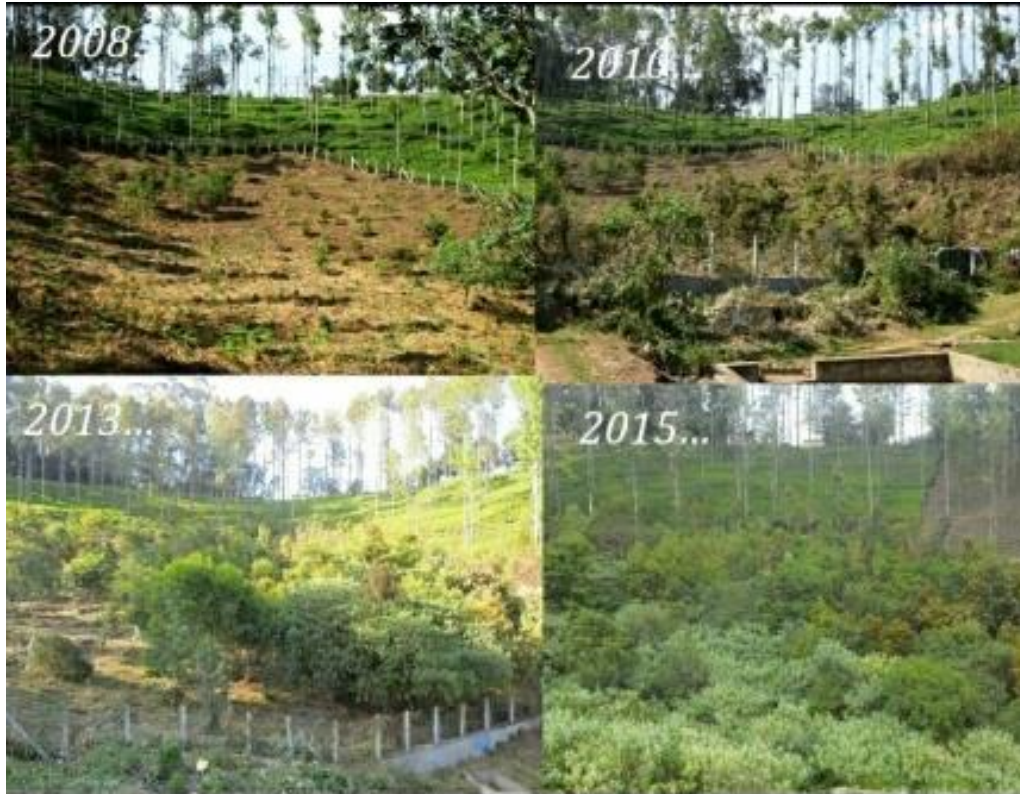
Status: Happy valley is a spring and wetland is located in the Valley part in the mission compound area and is an important drinking water source for Mission compound and Kambaikadai area. The spring catchment has 1 acre of Panchayat land which was used for open defecation and waste dumping by the settlement nearby. In 2006 under the Wetlands conservation program, Keystone along with Panchayat, School children and the neighbourhood community planned to restore the 1 acre land that was used as an open defecation site of the locality into a shola forest. The restored patch has now grown into a small patch of forest and has become a reason for the spring and wetland to be perennial. Happy Valley stream crosses 150-160 houses concentrated in 3 Panchayat wards- ward 17, 18 and 19. People from the locality had almost occupied land as close to the stream as possible. There are few houses located right on the stream.

Transition from a waste dump to a shola

- To clear the invasive plant species and other over grown plants around the spring-box.
- To have a covering for the spring-box that would prevent entry of solid wastes and run-off water during rainy seasons into it.
- To repair the spring-box to facilitate efficient monitoring of the spring discharge on a daily basis.

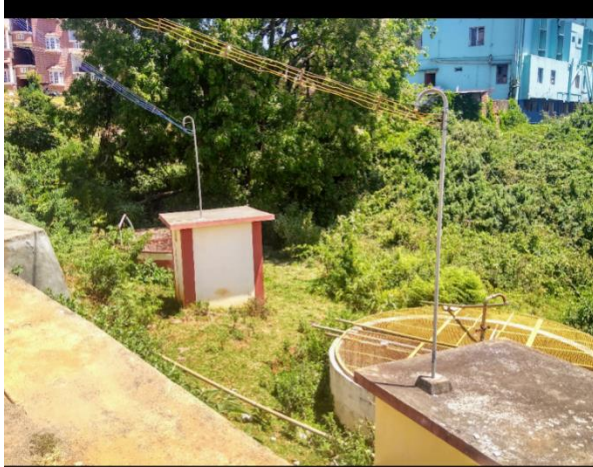
Status: Spring source behind Kotagiri Old Police station was the main source of water that was supplied to Kotagiri police quarters had been dried. Alternatively, there are two Panchayat wells that supply water to the quarters' area. Water from both the wells gets collected, and distributed from a GLR.

OLD POLICE
STATION SPRING

- Informing the community residing in and around the spring-shed area to stop dumping household garbage in the spring-shed area.
- Clearing invasive plants around the spring to get a detail idea of the sewage system around the spring source.
- A broken pipeline has to be fixed to prevent drainage water entering into the spring source.
- Educating people in the locality about importance of springs.
- Panchayat board was open to do some kind of restoration initiatives in the water-shed region. They also suggested that the place could be a replication of Happy Valley with the help and support from community and Keystone Foundation.

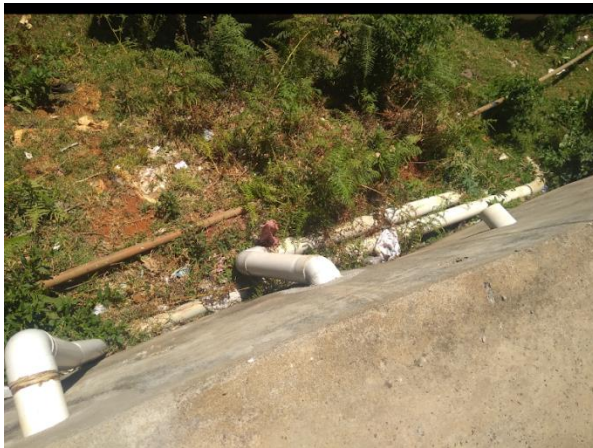
Source details: The spring-shed area behind the Old Police station is approximately 0.77 acres. The water is supplied to people in Kotagiri bazaar area. The type of spring is a depression spring with a spring-box with a 5ft depth from the ground level from where the water is diverted to a filtration tank. The filtration tank is filled with plants which make the water to be stagnant. The area around the spring is turned into a dump yard by the houses and shops in the region. There are few households who have diverted their drainage towards the spring source. Additionally, there are some unattended broken pipelines that carry household drainage from the locality, and because of over growth of plants the leakage grey water gets stagnant and contaminates the source. Thus, the grey water from households contaminates the source from both sides.

GREY WATER
DIVERTED INTO THE
SPRING-SHED AREA

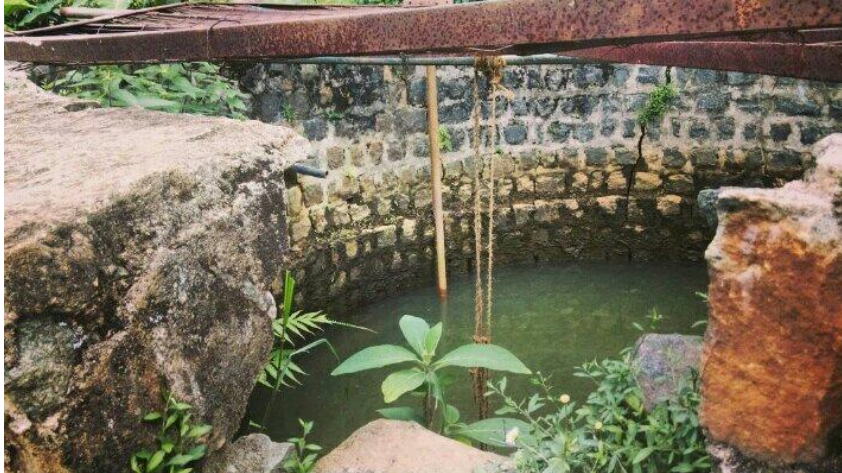
Status: The Darmona Panchayat well is situated very close to drainage, and people have said that they could visibly see the sewage water getting mixed into the well through some seepage holes in it. During rainy seasons the water from the upper areas flows beside the well and thereby bringing all the litters from the roadside into the well. The water well tested positive for fecal pollution. The water in the well overflows. The houses nearby to the well are finding it very difficult to deal with this problem.

Panchayat well that supplies water to Govt. hospital, Kotagiri market, Darmona

- Closing the cracks or gaps in the side walls of the well, and covering the space where the pipe that taps wetland water into the well especially during rains and prevent the well from getting it contaminated with sewage water.
- Regular de-silting of the well, at least once after every rainy season.
- Identifying the seepage hole in the well from where the drainage water gets mixed into the well.
- Informing the Kotagiri Government Hospital about the presence of fecal coliform in their well water, and taking temporary alternative measures to treat the water before direct consumption.

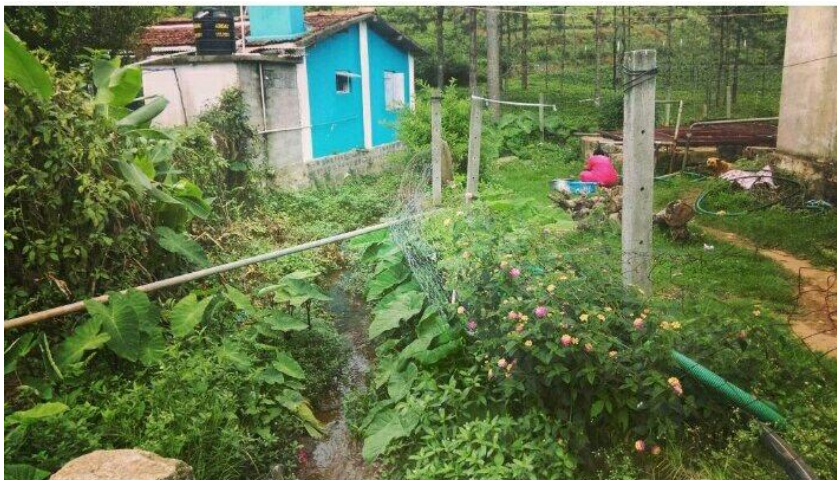
Source details: Seepage water from wetland next to Kota hall joins in a stream that flows in Darmona. The stream carries drainage water from the locality. A Panchayat well that supplies water to Kotagiri market and Government Hospital (GH) is located next to the stream bed. Before 10 years, the drainage path was much deeper with regular desilting works, and the Panchayat well water was cleaner. The well was protected with cement walls around it which helped to prevent seepage of drain water into the well. But, due to lack of maintenance the wall has been removed. Now, the stream bed has come up due to washing of soil with lot of bushes on either side of the stream/ drainage.

Stream beside Panchayat well

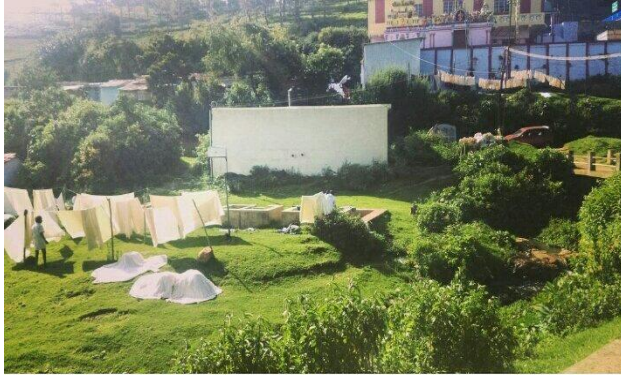
Source details: The spring source is used by people for household purposes, and by dhobis to do a final rinsing of clothes after washing them in stream water. The quality of water is not good as the spring is close to the stream which carries drainage and polluted water. There are no other water sources in the locality except for the recent bore-well by the Town Panchayat in June, 2017. When there are unattended issues with the pipeline, uninterrupted supply of water from the bore-well to the locality becomes a question mark. There are 15 houses and the people wanted a storage tank. The community practices OD as they don't have toilet facilities.

Dhobi-ghat washing area

- To seal the spring box facing towards the stream.
- To place a new valve for water outlet on the other side of spring to avoid sewage water seepage.
- Regular de-silting and cleaning of spring box.
- Providing a water storage infrastructure for the locality.

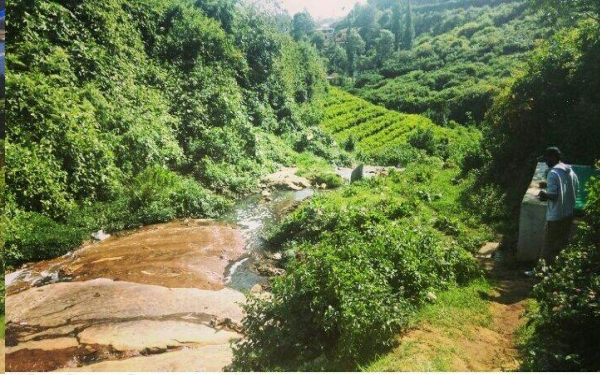
Status: The Dhobighat spring is located alongside a stream that carries the Kotagiri town's drainage water. During rainy season when the stream water flow increases, it results in drainage water entering the spring-box via its outlet and contaminating the spring water. In order to avoid this contamination, the locality people have blocked the outlet pipe where the spring water is collected. The people are satisfied with the quality of water from the source, but for this contamination during rains. As the spring-box has not been regularly cleaned, and due to the formation of algae in the floor and sides of the walls has made the colour of water green.

Dhobi-ghat spring source

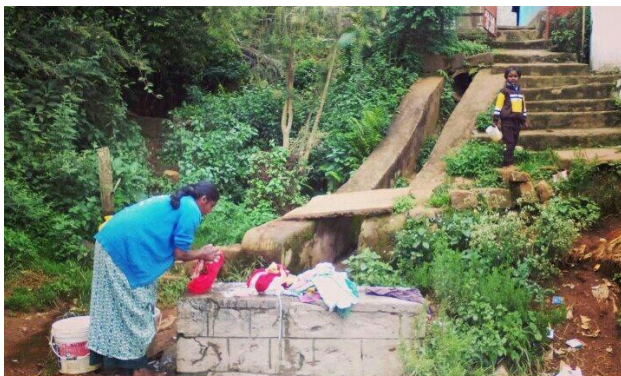
Spring source at Dhobi-ghat line

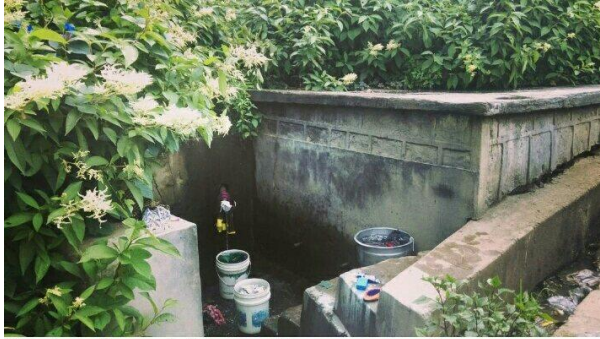
Status: The spring at Baptist colony is in a very poor state because of the sewagewater from Gore House and RKC Colony has been diverted towards the spring. The locality people, especially women expressed that the water from the spring is not used during rainy season because of visible contamination. The water contains worms of red and white thread like structures. The drainage system from Gore House is diverted by digging a channel in the land above the spring source. The channel goes unsettled with the solid wastes from household in the upstream. This is the main cause of contamination to the spring water. During rainy season, the households take water from a private well in owned by one of the households to meet their drinking water demand. There has been a new well dug below the Colony to meet drinking water demand of the households, but this is not functional yet.

Spring-box right next to sewage at Baptist colony

- Identifying the owner of the land from where the spring water has its source.
- To set a proper drainage channel to avoid mixing of sewage drain water with the spring.
- The drainage system of the RKC Colony has to be rectified to avoid further seepage of sewage water into the Baptist Colony's spring-box.
- To repair and maintain Baptist Colony's spring-box, and use it as a storage structure.
- To have a separate pipeline to channel water from the spring-box to households.

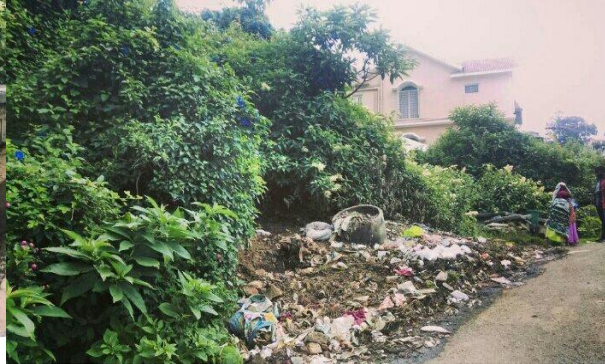
Source details: There are nearly 30 Households that are dependent on the spring as their main source of water. The spring-water storage tank was built by the then area Counselor before 10-15years. But, due to the defects in construction where drain water seeps through the tank, and mix with spring water, the tank has not been put to use. People directly take water from the tap using cloth filter. The water-shed area is over grown with lantana and other weeds. The community collectively collects around Rs500 to clear the patch. But, they are tired of collecting, and clearing the patch which regrows within a month. Added to the filth from water-shed area, it is also the heap of garbage dump next to the water tap that affects the quality of spring water in the tank. Sanitary workers from Town Panchayat come once a week to collect garbage, but people prefer to dump it on the road-side near water source.

Waste dumps near the spring source

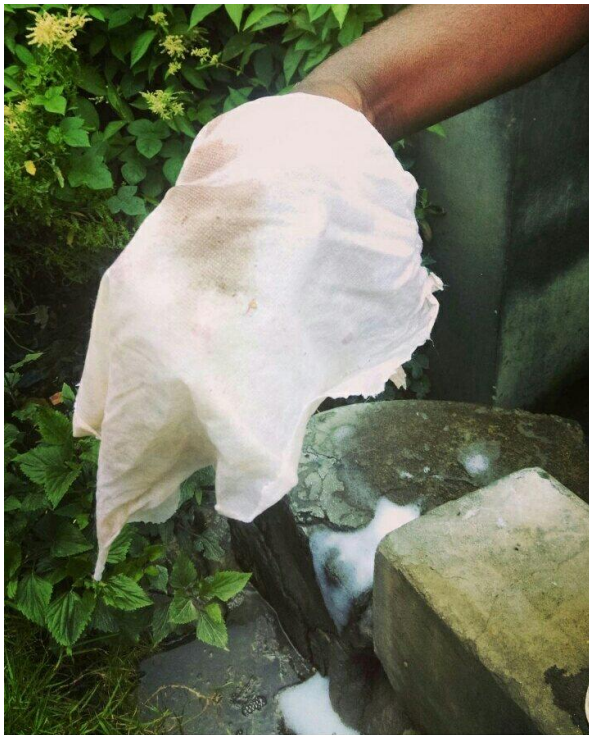
Women worried about quality of spring water at Baptist colony
