*Detailed hydrogeological mapping in parts of the Nilgiri
Biosphere Reserve*

Detailed hydrogeological mapping in parts of the Nilgiri Biosphere Reserve

Technical Report Number: ACWA/Hydro/2018/H68

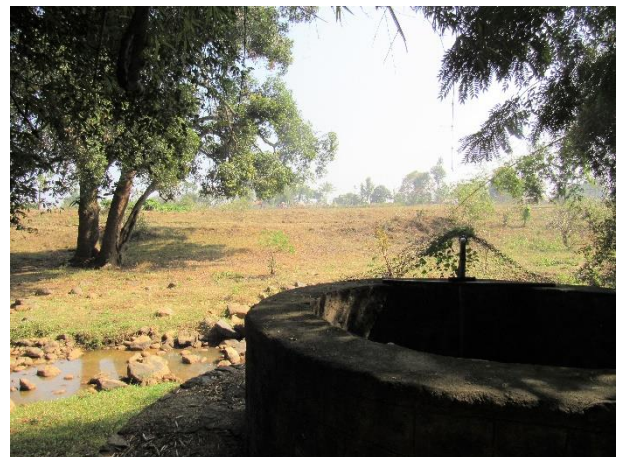
The 10.58m deep panchayat open well (KADW004) constructed in 2002 is the main drinking and domestic water source. Sometimes, during the summer season, when there is very little water in the well, spring water located close to the well is used. The village has two Ground Level Reservoirs (GLRs). Water from the community well is pumped for approximately 30 minutes on a daily basis into the two GLRs which have storage capacities of 10,000 lits and 30,000 lit.

Photo 1 : Main community drinking water well for Chokkanalli village

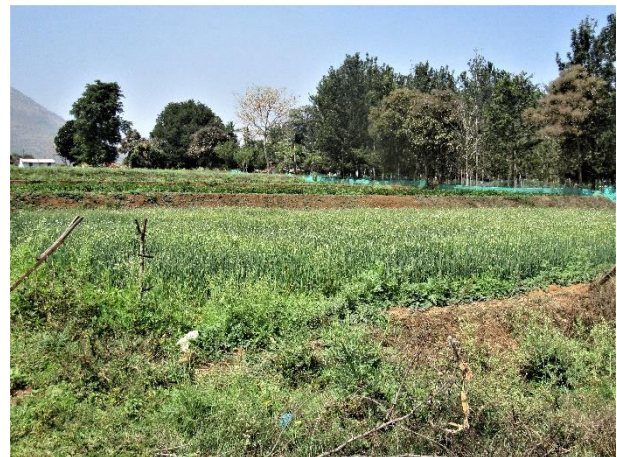
Agriculture lands located to the southwest of the village, across the stream, were also studied to help develop a subsurface understanding. Here too, the lining in open wells and absence of fresh, un-weathered rock outcrops suggests that a thick weathered profile exists below the surface. Bore wells were also surveyed in this region to reveal the presence of deep seated water bearing fractured rock that are yielding water to these sources (Photo 2).

Photo 2: Agricultural land parcels to the southeast of Chokkanalli village, irrigated through bore wells

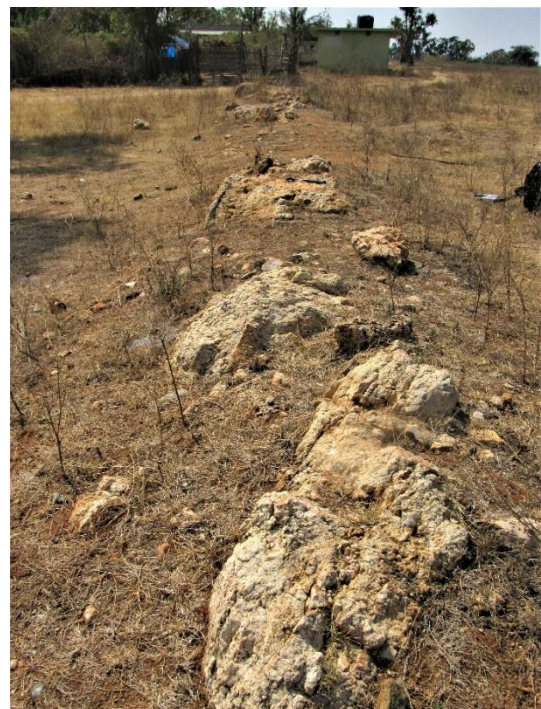
Photo 3: 2m wide pegmatite vein intruding in to charnockites in Chemmanatham village

Unlike Chokkanalli, in Chemmanatham village, numerous surface exposures along with exposed well sections helped in better geological mapping. The dominant rock type here is foliated garnet bearing charnockites. The foliations trend in the east-west direction with dips towards the north. The thickness of weathered rock that overlies the massive charnockite is variable along the topography. To the south-west this thickness maybe upto a maximum of 0.5 – 1 m given the prevalence of several rock exposures. The weathered section increases in thickness towards the northeast direction up to almost 6-7 m. To the northeast of the village, a 2m wide hard, resistant pegmatite vein running along the northwest-southeast direction is seen intruding into the charnockite (Photo 3).

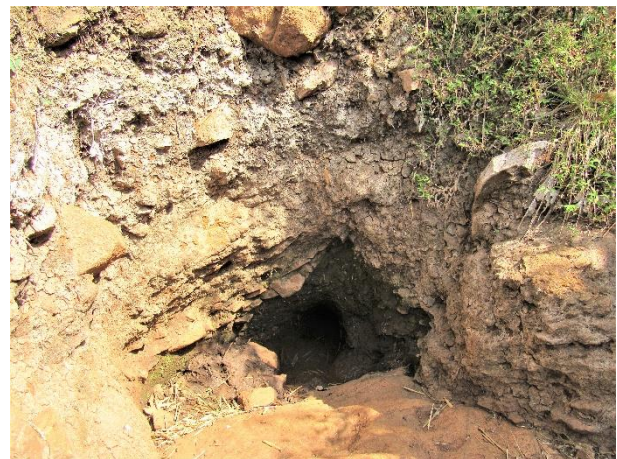
Photo 5: Nearly dried up Kongarai spring in Samaigudar village in February 2018

Kongarai spring emerges at an elevation of 1015m above msl at the contact between weathered rock and garnet bearing charnockites. The charnockite has foliations that run east-west and dip by approximately 50° to the north. Several parallel semi-vertical fracture sets trending north-south are observed to the north of the spring. At higher elevations, above the spring, 3-4m of thick weathered rock is seen (Figure 16).

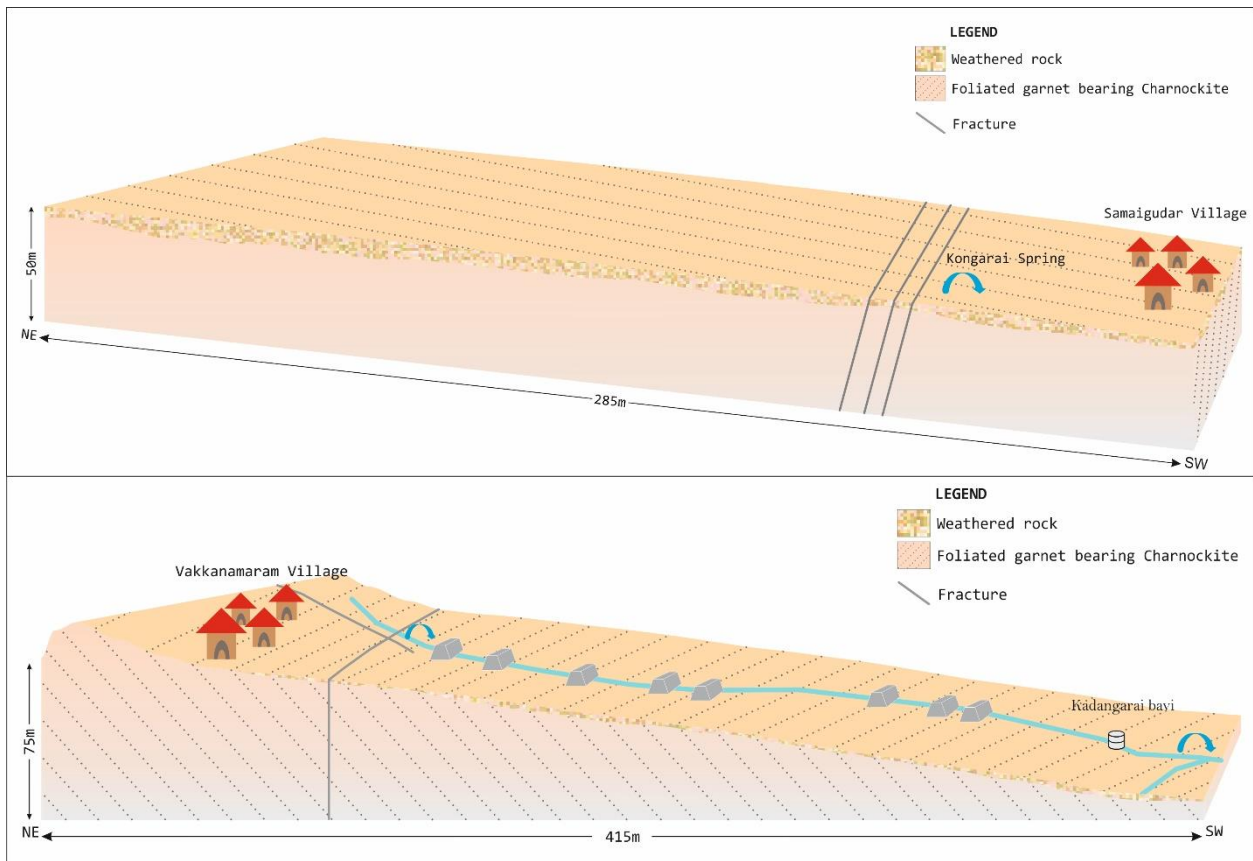
Figure 16: Geological cross section of two springs and one well in Samaigudar village

Kadangarai well located in the middle of the valley below Samaigudar village is 3.2m deep and 2.5m in diameter. It is completely lined till the base with stones exposing fresh rock at the base. To the upstream, the flow in the stream is impeded at several places with nearly 8 small check dams. Here, the rocks are fresh and show very less degree of weathering compared to that observed on the eastern slopes of the valley. Another spring emerges at nearly 1008m above msl below Vakkanamaram village. The rock surrounding the spring is semi-weathered in nature and it springs out between the contact of the weathered layer and hard compact charnockite.

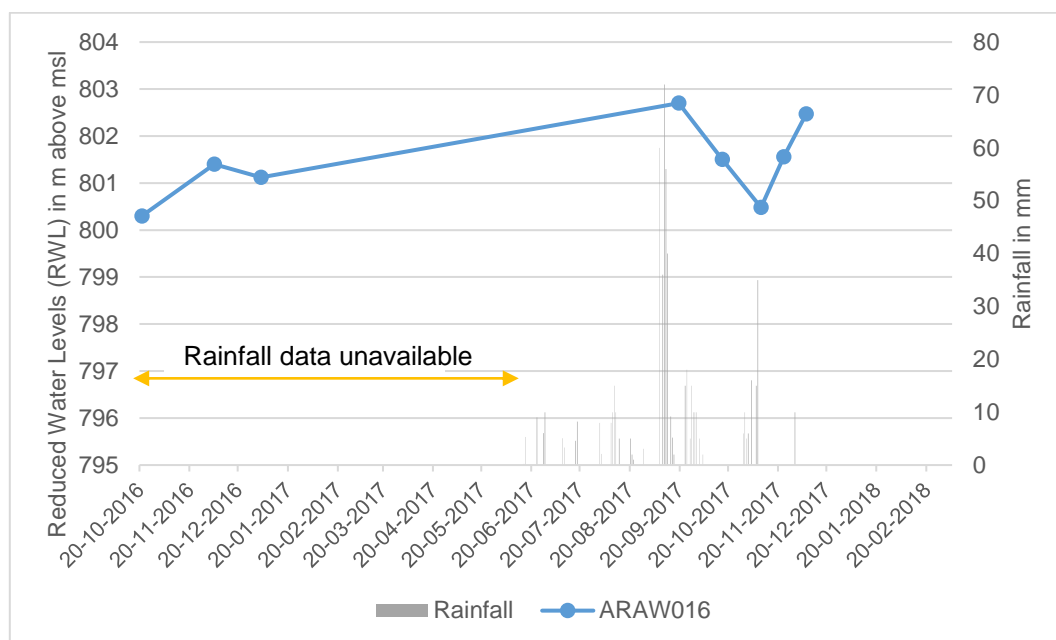
Figure 17: Hydrograph for Kadangarai well over a period of 1.5 years

there are large fluctuations in the water level. The highest water level in the well was reached in mid-September and the shallowest in mid-November. There is a slight delay of almost 10 days between the maximum rainfall events and the highest water levels, thus implying a delayed recharge in to the aquifer. However, high frequency data over at least one to two years is essential to understand the aquifer dynamics.

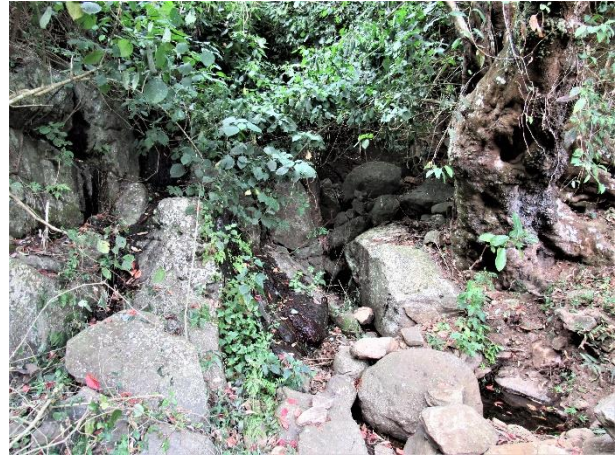
Photo 6: Vekkikere spring emerging out of fractures near Garikyur village

The Vekkikere spring located just below the road, emerges at an elevation of 1250m above msl (Photo 6). The main rock around the spring area and the springshed region is charnockite. These rocks have foliations running in the north-south direction and dips of 30-40° to the east. The rock also has fractures with low angle dips of 10-20° (Figure 25). This fracture when traced uphill, gives rise to another spring (ARA002) at 1280m above msl, located along the road side. Both springs emerge at the intersection of the fracture with the topography. Here the degree of weathering is very limited. Thus, on the basis of the rock structure these springs are termed as fracture types.

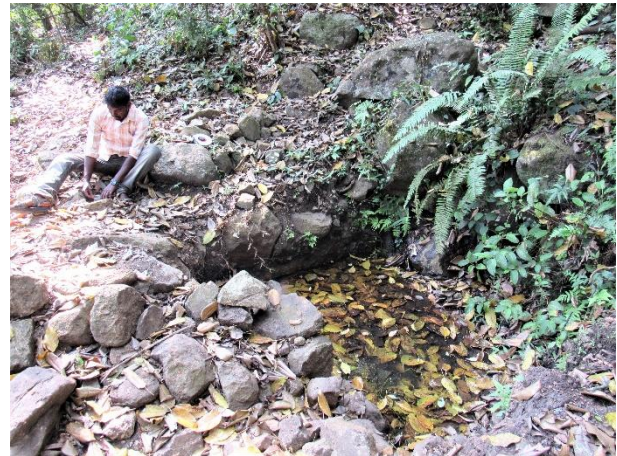
Photo 7: Water quality measurement carried out for water from Pannaikadevu spring

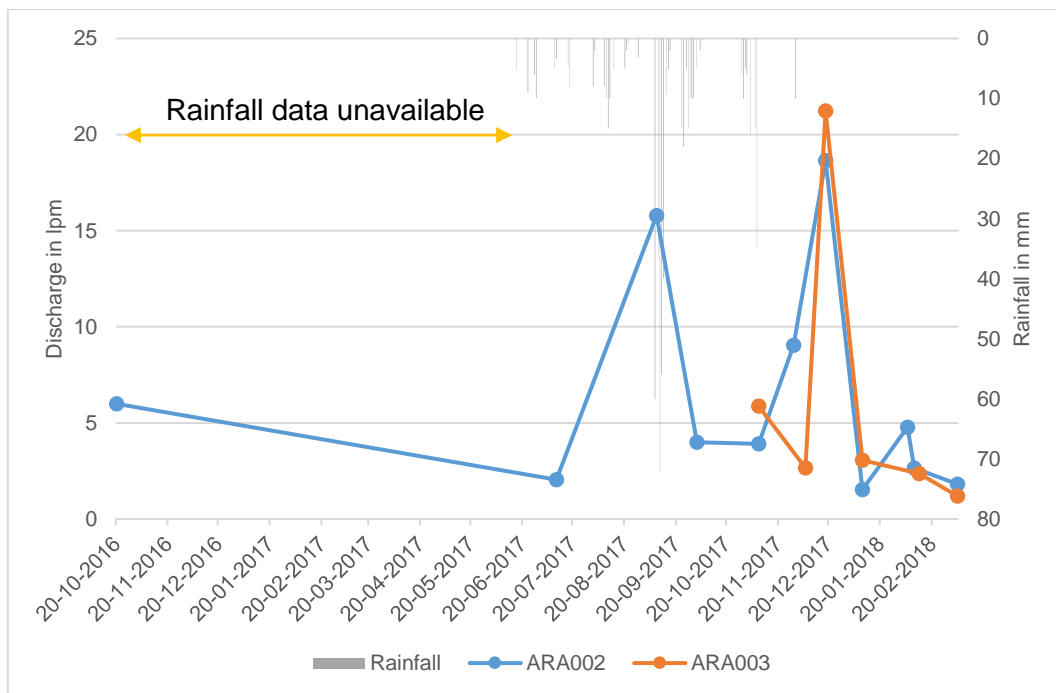
Figure 28: Spring hydrographs for two springs between October 2016 and February 2018 in Garikyur village

Discharge data of springs ARA002 and ARA003 between mid-October 2016 mid-February 2018 shows that the values range between 1.5 lpm and 19 lpm for the former and 1.2 lpm and 21 lpm for the latter. For ARA004, ARA005 and ARA006 the discharges measured in a span of 4 months between November 2017 and February 2018 is highly variable. While the minimum discharge is less than 1 lpm the maximum is around 3-3.5 lpm.

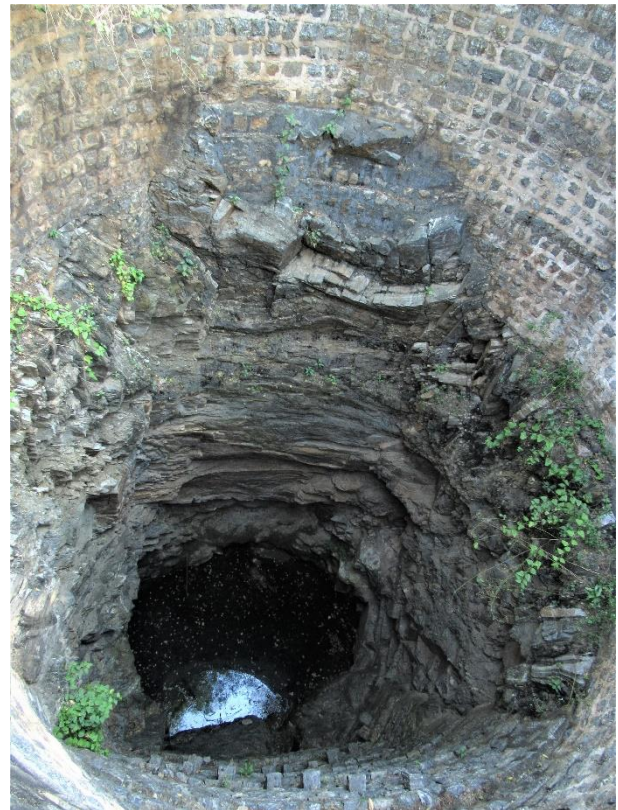
Photo 8: Old well exposing the subsurface geology in Poochamarathur village

With respect to the underlying geology, a thin layer of loose weathered rock overlies hard and compact banded granite gneiss. These rocks are foliated in the northeast-southwest direction. They are seen exposed in the old community well below 5m from the ground surface. A fracture trending in the NNE-SSW direction is also visible in the well.

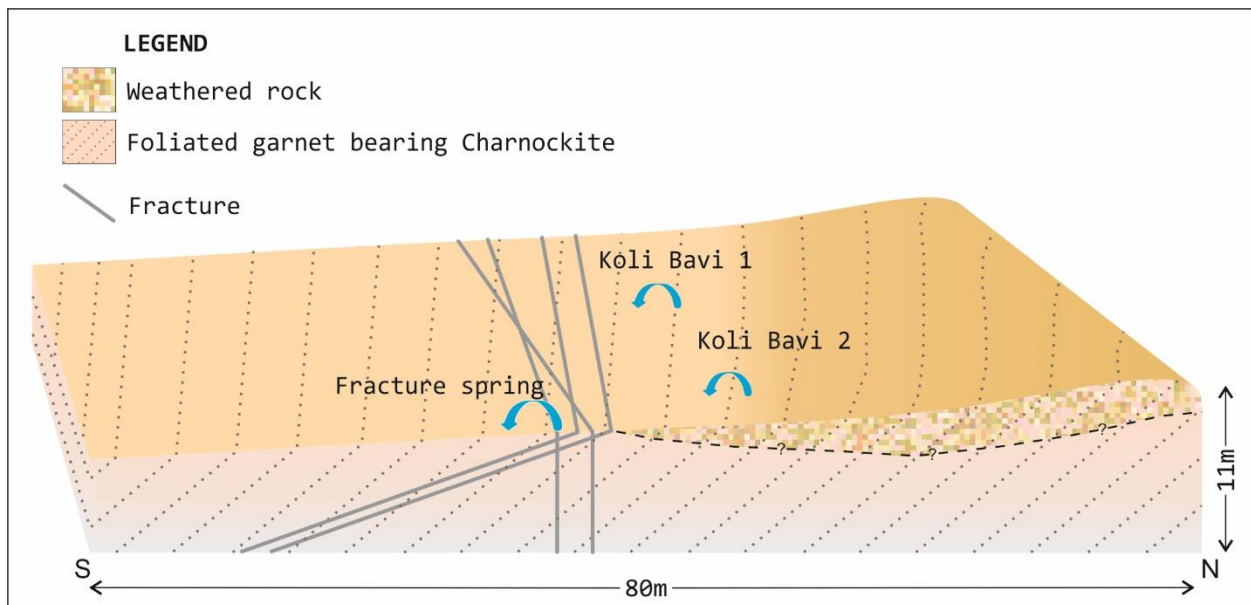
Figure 35: Lithological cross section of region underlying the Koli bavi and fracture springs

The entire region surrounding the springs exposes garnet bearing charnockites. The extent of weathering of the rock is quite variable in this region. Two of the three springs namely Koli bavi 1 and 2 emerge at the top of the hill at 1300m above msl. Here, the charnockite is highly weathered with loose material being nearly 3-4m in thickness. Another spring emerges a few metres downhill at approximately 1295m above msl. Here, fresh foliated and fractured charnockites are seen. The foliations dip to the south by an angle of 40-50°. There are 2-3 vertical fractures and a few open low dipping fractures which trend east-west (Figure 35).

Thus, Koli bavi 1 and 2 are classified as depression or a combination of depression and contact type and the other lower spring as a fracture spring. Water from these sources is used by habitants of Koovakarai village.

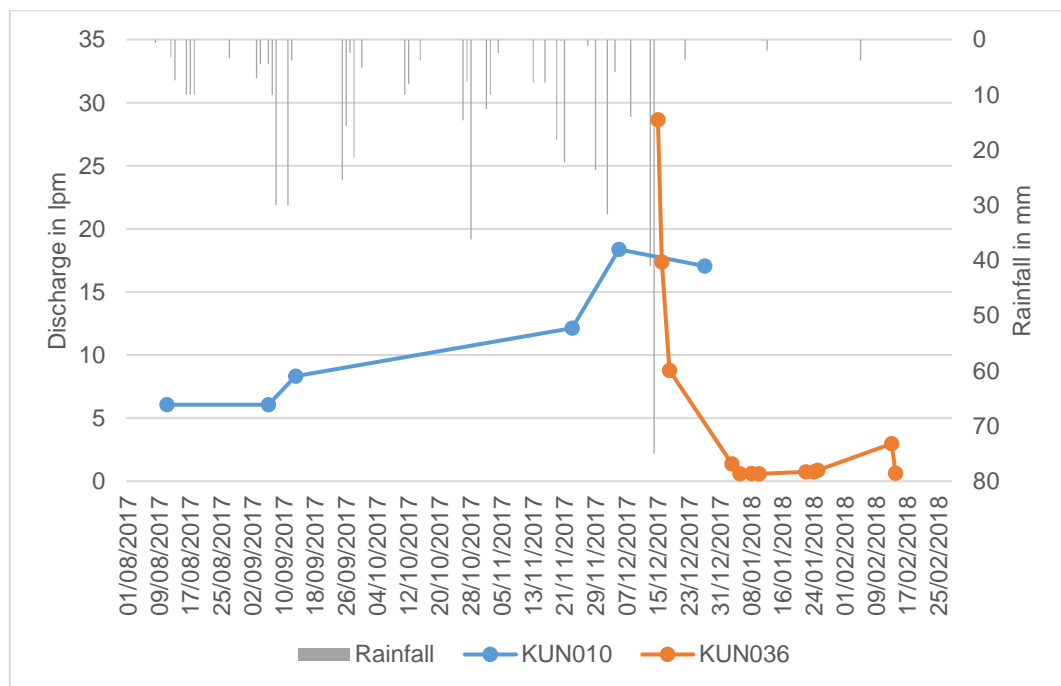
Figure 38: Spring hydrograph for KUN010 and KUN036 between August 2017 and February 2018

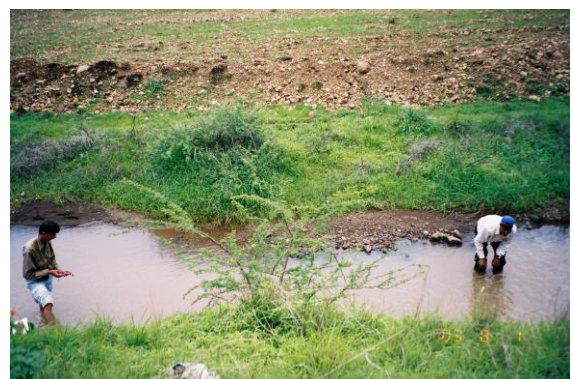
Discharge in flowing stream

- Firstly channelise the spring water in such a way that all of the water flows through the stream, freely, without obstruction
- Measure a certain length of the stream and mark it with the help of small twigs or any other resistant object
- Measure the average breadth and depth of the stream within the selected stream length
- Now collect small leaves of approximately the same size and drop them one by one in to the water and note the time taken for it to travel the known length of the stream
- Volume in m^3 = Length x Breadth x Depth
- Discharge in lpm = Volume in m^3 / (Time taken in minutes x 1000)
