# NOTE ON POST DIASER LANDSLIDE STUDIES IN MALAPPUAM AND PALAKKAD DISTRICTS, KERALA DURING JUNE 2018

(Field Season: 2018 - 19, Item No.: M4SI/NC/SR/SU-KRL/2018/21108)

Sachin R., Superintending Geologist &  
Vishnu C. S., Senior Geologist

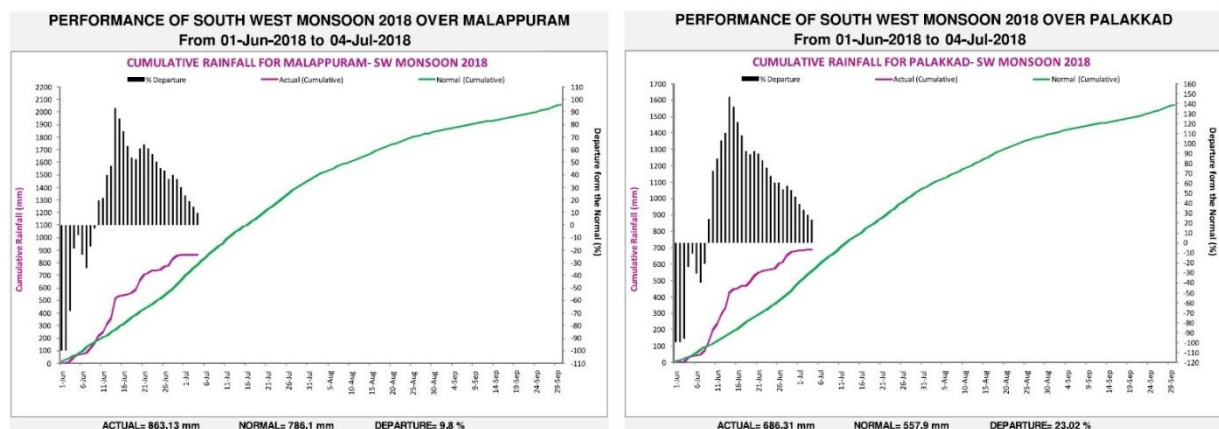
Incessant torrential rain which started from 08<sup>th</sup> of June, 2018 in Malappuram and Palakkad districts is assessed to be the triggering factor. The cumulative rainfall graph of Malappuram and Palakkad district during the SW monsoon is given below (Fig. 2).

Fig. 2 Cumulative rainfall graph of Malappuram and Palakkad district, June 2018
