SINDHUPALCHOK SPRING HYDROGEOLOGY, NEPAL

Based on fieldwork for WLE project in partnership with ICIMOD

January 2017
Technical report no. ACWA/HYDRO/2017/H53

Advanced Center for Water Resources Development and Management

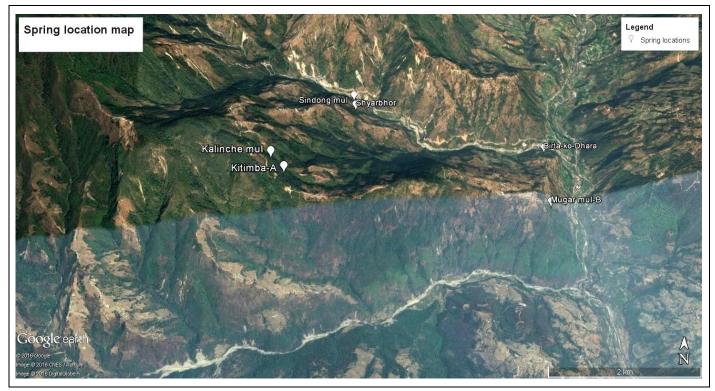
Figure 3: Locations of the springs in Mahankal VDC

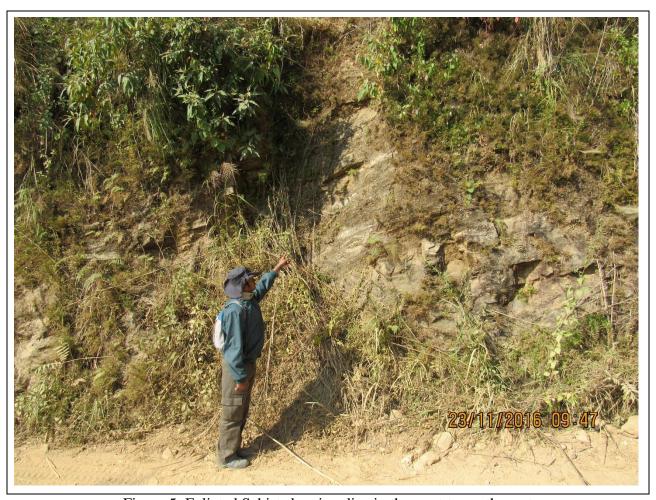
Figure 5: Foliated Schists bearing dips in the west to south-west

Schists and Gneisses with Schist having regional dips in the west (Fig.5) prominently dominate study area. Ridges trend mostly North-south and few East-west. Weathering and fracturing is present across the whole area. Two sets of fractures are prominent with one dipping in ESE (100°) and traversing NNE-SSW with gentler dips while other one dipping SSE (160°) traversing ENE-WSW with steep dips. Foliation dips of the Schist are in the southwest. Gneisses are found at the higher elevations. The gneisses show a general dip towards NW/W at a varying amount of 20°-40°.

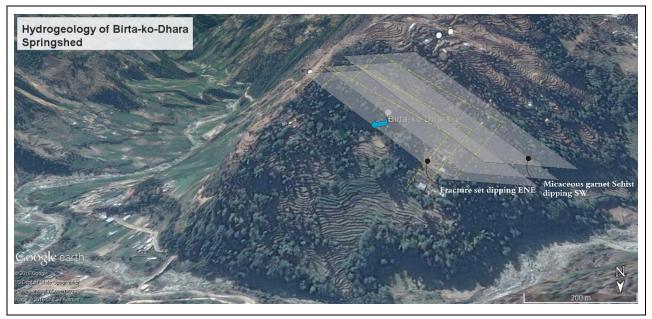
Figure 8: Google image depicting hydrogeological observations

The springshed is comprised of westerly dipping Foliated Schist with dips ranging from 25° to 30°. Spring emerges on the NE facing escarpment slope. Springshed is also traversed by two set of fractures viz. one set dipping in the ENE while the other dipping in the SE. Fracture set dipping towards ENE; trending NE-SW clearly controls the spring emergence and thus becomes fracture spring. Fracture system in Schist controls the storage and transmission of groundwater. Continuity of fractures is clearly seen in the field. Another interesting fact about this spring is that it was perennial for all these years until the earthquake, which took place last year, but this year it is running dry. Large amount of loose material was seen scattered near the base of the spring and outcrop on the top of the spring was found exposed which indicated that the earthquake brought all the loose material down which was actually a local aquifer system feeding the spring. This unconsolidated material was the primary storage for groundwater, which was helping this spring to remain perennial. Thus spring was earlier a depression spring which is now a fracture spring due its emergence through a fracture and storage also being within the fracture system (*Fig.8*).

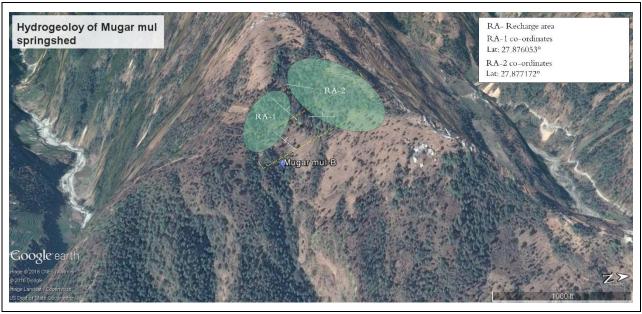
Figure 13: Google image depicting hydrogeological observations depicting potential Recharge area

The identified potential recharge areas comprises of two locations (*Fig.13*). RA-2 lies on the escarpment slope which seems to be quite barren in terms of land use which can be treated with staggered contour trenching depending on slope percentage (*Dhara Vikas manual, Sikkim*). RA-1 lies on the dip slope which can also be treated with staggered contour trenching. Some portion of the recharge area is cultivated, where trenching won't be possible. In such cases, randomly spaced small dimension deep trenching can be planned. Plantation should accompany while carrying out physical interventions.

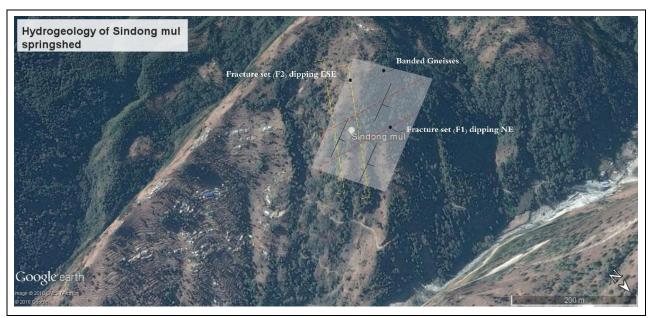
Figure 14: Google image depicting hydrogeological observations

The springshed is comprised of north westerly dipping banded Gneisses with gentler dips. The spring is found emerging on the dip slope. This spring is a classic example of fracture spring. Two fracture sets are found traversing the springshed, one dipping NE traversing NW-SE while the other one dipping ESE traversing NNE-SSW (*Fig. 14*). The spring emerges out through one of these fracture sets. Gneisses being hard and compact do not possess any primary porosity but the fracture network provides it a secondary porosity making it a potential aquifer feeding the spring.

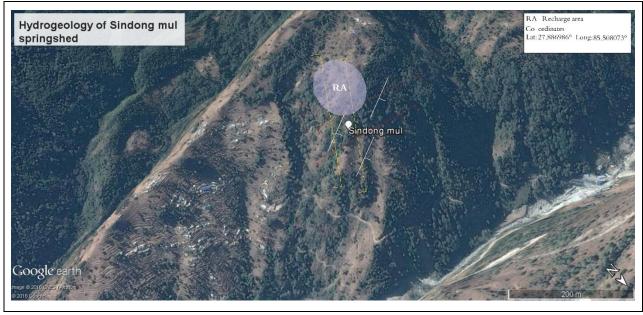
Figure 16: Google image depicting hydrogeological observations depicting potential recharge area

The identified recharge area lies on the slope facing SE direction with slopes ranging from 50-60%. Depending on the land cover/use, activities can be planned. Staggered contour trenching can be designed in case of barren lands which are not used for any other activities. Agricultural field terraces can be raised with inward sloping faces. Plantation activity would be very important to arrest soil erosion because of steeper slopes.

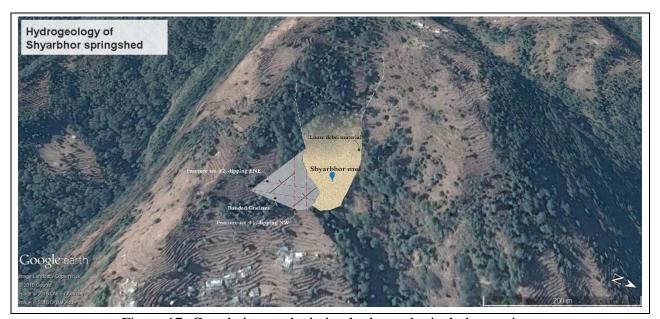
Figure 17: Google image depicting hydrogeological observations

There are multiple discharge points through which the spring emerges making it a classic example of depression spring. This system of debri material is found in narrow valley with gneisses underlying it. A small outcrop on one side of the valley was found where measurements were carried out. Gneisses are banded and dips in the south-west direction with amounts ranging from 20-30°. They are traversed by two major set of fractures, one dipping NW trending NE-SW while the other one dipping ENE trending NNW-SSE (*Fig.17*). Spring emerging out through the thick pile of loose unconsolidated debri becomes a potential aquifer feeding it. The fracture system also adds to some amount of contribution to the existing aquifer.

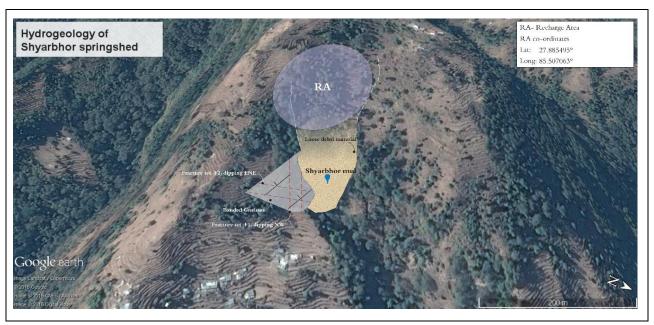
Figure 19: Google image depicting hydrogeological observations depicting potential recharge area

Identified recharge area lies on same slope as that of the spring. Most of the area that falls in the recharge area is covered with agricultural field terraces. In such a case, contour trenching would be bit difficult. Vegetation cover seems to be quite good which needs to be preserved along with some additional plantation. Small dimension continuous trenching towards inner side of the field terraces will be beneficial to facilitate recharge to the underlying aquifer system.
