HYDROGEOLOGY BASED SPRINGSHED MANAGEMENT PLAN IN KHAR, DARCHULA DISTRICT, NEPAL

INCLUDES CONCEPTUAL MODELS AND SUGGESTIONS FOR GROUNDWATER RECHARGE

Technical Report no: ACWA/Hydro/2016/H46

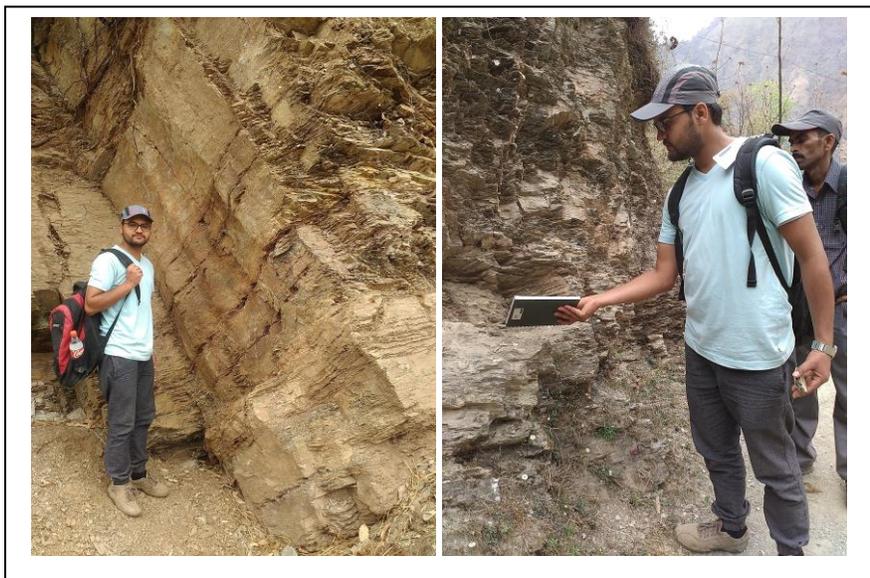
Figure 2: Massive Slates (left) and sheared Slates (right) observed in the field area

The regional structural setting of the study area is controlled by tectonics. At places, the limestones are metamorphosed to dolostones and slates exhibit phyllitic character due to metamorphism. Owing to the competency fractures in limestone beds are sparsely developed with sharp edges while slates are highly crushed and appear ‘crumbly’. According to the present study, shear zones (Fig.2) are observed at three different places accompanied by joints and fractures across the VDC. The rocks observed along shear zone are highly fractured than the rocks seen in the nearby region. This may be a reflection of a continuous shear zone trending ENE-WSW. The rocks are also subjected to folding as it is evident by rotation of the strike direction in the region.

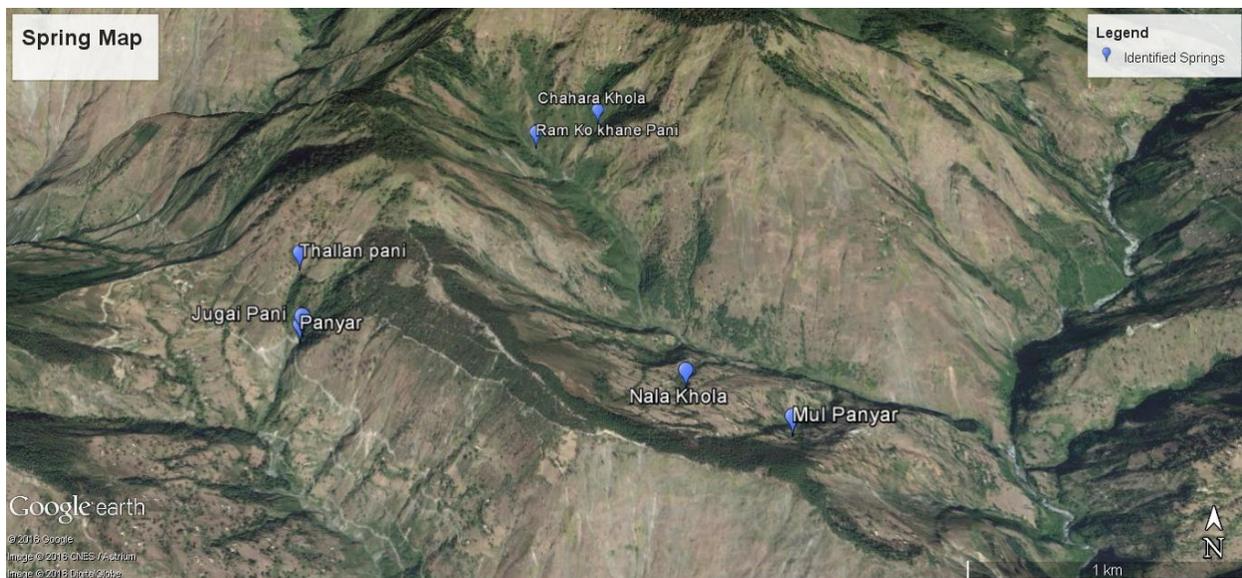
Figure 3: Google Earth Imagery showing locations of Identified Springs in Dallekh-Sundamunda Springshed.

The major streamlets in the Dallekh Watershed are Khar Khola and Gundharu Khola while a 40m high Spring Fall and Ghalle Khola are found in the Sundamunda Watershed. Both the watersheds are adjacent to each other, with Sundamunda on the north-eastern flank of the ridge separating the two watersheds (Fig.3). Streams from both the watersheds drain into Nau-Gad, which flows from North to south in the west. Interestingly in combination they form a springshed, which can be referred to as 'Dallekh-Sundamunda Springshed' from here onward and the details of which are discussed later in the report.

Springs are mostly found in the valley parts. A total of 48 springs were identified previously in the area which includes both perennial and seasonal springs. Most of the springs shown in the map below are perennial springs forming main source of drinking water in this region. Few springs are tapped by constructing a collection tank from where water is supplied to village through pipeline.

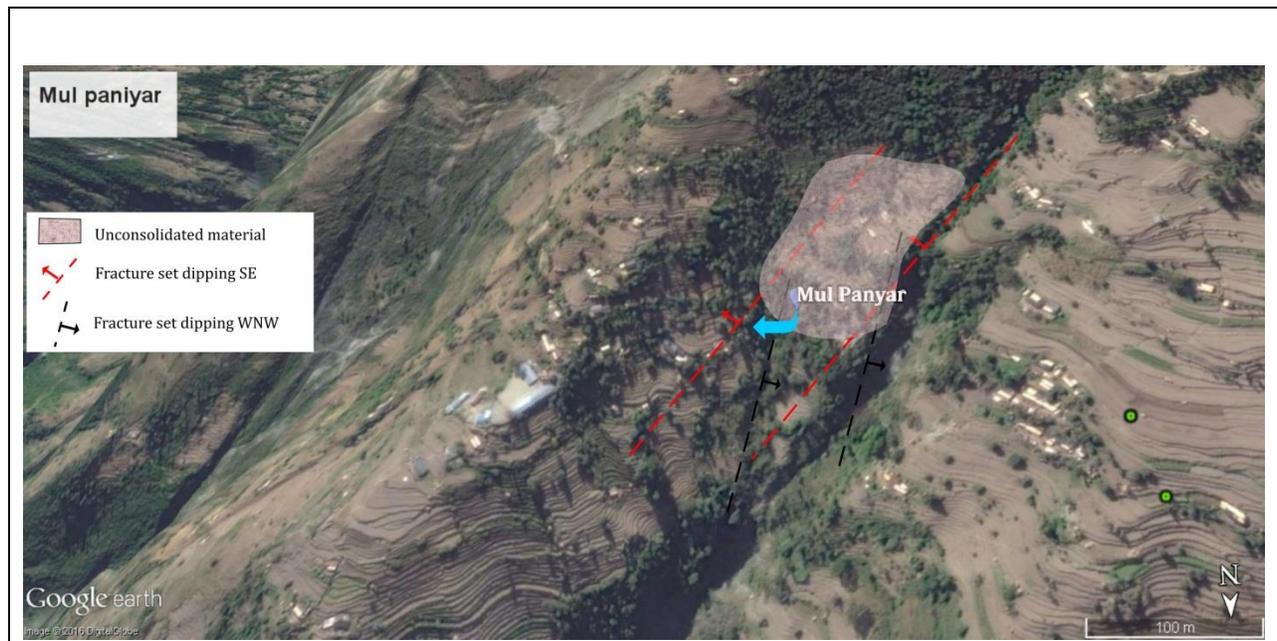
Figure 5a: Overlay of geological setup for Mulpanyar spring on Google Image

The massive and sheared slates are observed in the vicinity of the springs exhibiting phyllitic characteristics. The dip amount ranges from 25°-40° while their dip direction is generally towards NW. Two sets of joints are measured, trending NE-SW and NNE-SSW directions and dipping steeply (60° -70°) in the SE and WNW direction respectively. The rocks above the springs are highly crushed and have formed loose debris, predominantly slaty in nature through which the spring emerges. This spring shows similar characteristics as that of the Nalakhola spring except for its emergence through loose unconsolidated debris making it a combination of Fracture-Depression spring and it is clearly indicated by the discharge data obtained in the month of April mentioned in the table above. Interesting feature of this spring is that it is fed by three aquifers viz. Phyllitic slates dipping towards spring, fracture sets traversing across the springshed and loose unconsolidated debris. Loose debris bears large storage for groundwater as compared to that of phyllitic and fractured slates. A deep valley formed by a stream along the existing NNE-SSW trend is evident even in the Google image. Upper reaches of the ridge above the spring is covered by pristine forest (Refer to Fig. 5a and 5b).

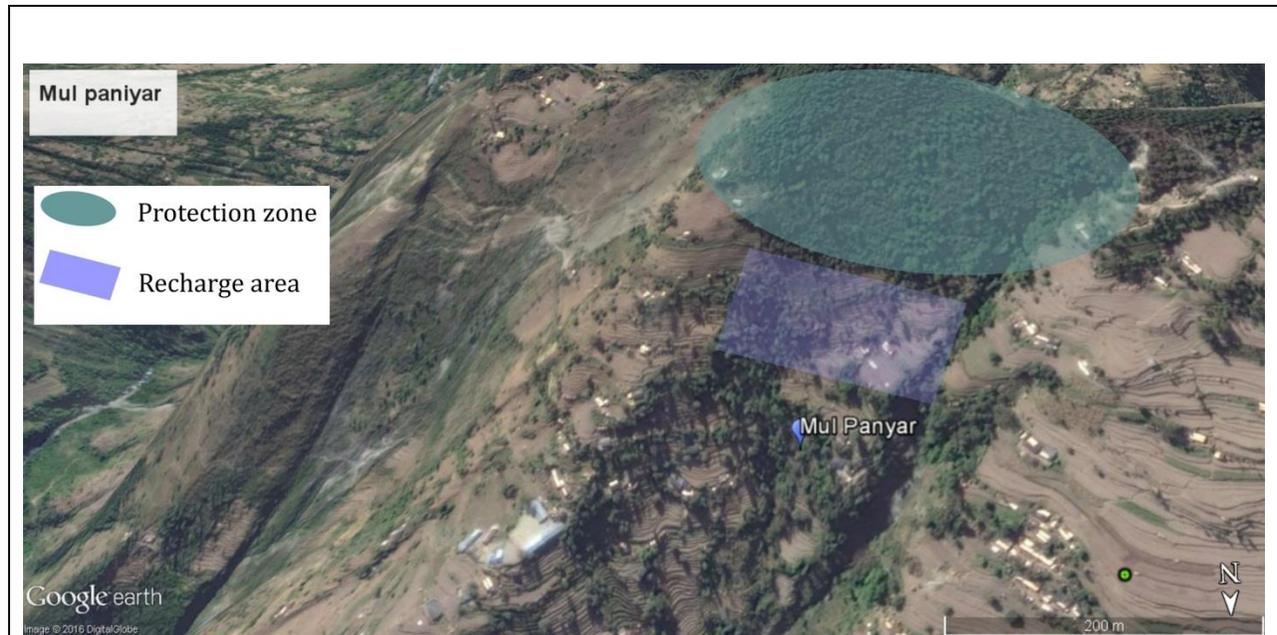
Figure 5c: Overlay of recharge zone on Google Image (Mulpanyar springshed)

As mentioned above, the existing forest cover should be kept virgin and demarcated as protection zone. Deforestation, waste disposal and open defecation should be strictly prevented in this zone to ensure good quality water emerging in the spring. Further below the forest cover where loose debris is found, recharge interventions should be implemented. Field observations show that this area is covered by farm lands and thus it will get difficult to implement traditional recharge structures like contour trenches etc. In such cases, deep trenches of smaller dimensions in the farms can be useful in recharging the aquifer system. Taking into consideration the dips of the beds recharge should be focused on the ridge in the east of the spring. Availability of land type will be important in deciding on structures that need to be implemented. The valley created by stream besides the spring can be treated by constructing small check-dams and gabion structure to facilitate recharge in the fractured slates. (Refer to Fig. 5c and 5d).

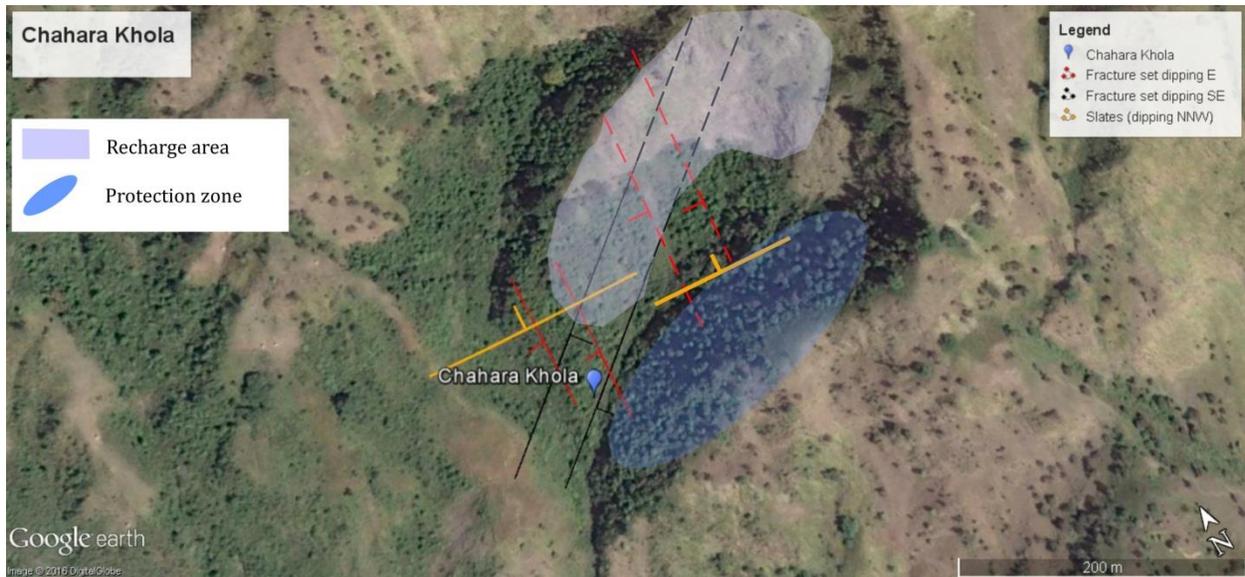
Figure 6c: Overlay of recharge zone on Google Image (Chaharakhola springshed)

Recharge area demarcation becomes crucial while taking into account the varied conditions present in the springshed. The slopes in the south of the spring bearing dense vegetal cover should be demarcated as protection zone. On the other hand the slopes in the north bearing grass cover and further barren land on the top will be suitable location for implementing recharge measures. Staggered contour trenches can be implemented as per details included in *Dhara Vikas Handbook (Govt. of Sikkim, GIZ publication)*. Gadhera can be treated with gully plugs for additional recharge in the springshed (Refer to Fig. 6c and 6d).
