# **SIGUR PROJECT**

**Project Concluding Report by Keystone Foundation, Kotagiri**

**Keystone Foundation, October 2007**

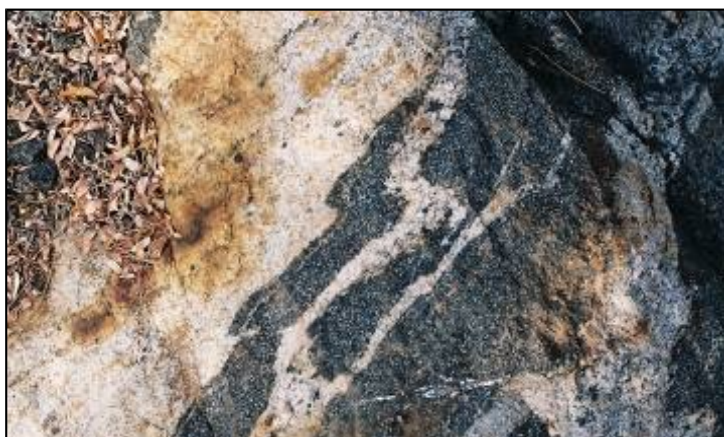
Picture 1: Biotite hornblende gneiss - the most common rock type

Based on field study of geology by Mr. Ashok Kumar<sup>1</sup>: During field visits in Sigur, the rock types predominantly seen were the hornblende-biotite gneisses (in all the

villages of Bokkapuram, Vazhaithottam, Anakatti, Sيريور, etc). The only exception was Moyar where garnetiferous quartzo felspathic gneiss, micaceous quartzites (and charnockites, not as exposures) were seen. It seems that some of these like the charnockites and garnetiferous quartzo felspathic rocks may have been transported here.

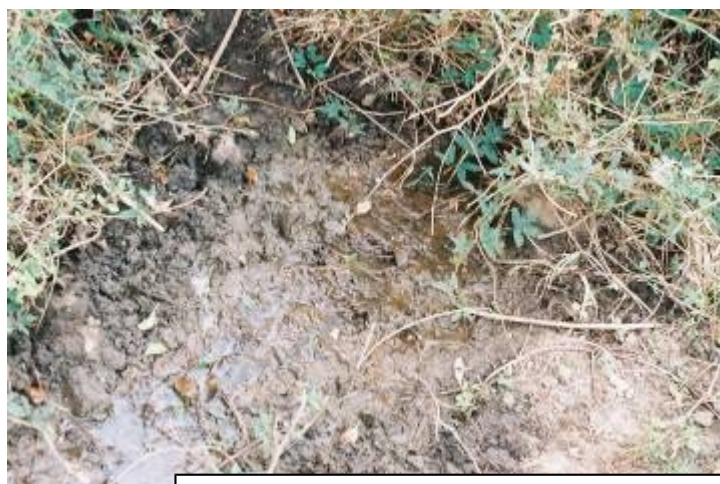
**Picture: Spring emerging from soil at Anaikatti**

The availability of springs within the Sigur Plateau, in comparison, with the other hilly tracts of the Nilgiris is relatively low. During the field visit in the month of February, 2006 (after an unusually high 2005 rainy season), only two surface springs were seen. Technically, many more are present, as a spring is defined as “water emanating at the soil / rock surface. Where the expression of the water table is above the rock or soil surface, a spring can form and these could be perennial or temporal. The evidence indicates that the springs at Anaikatti are perennial and dependable low flow springs

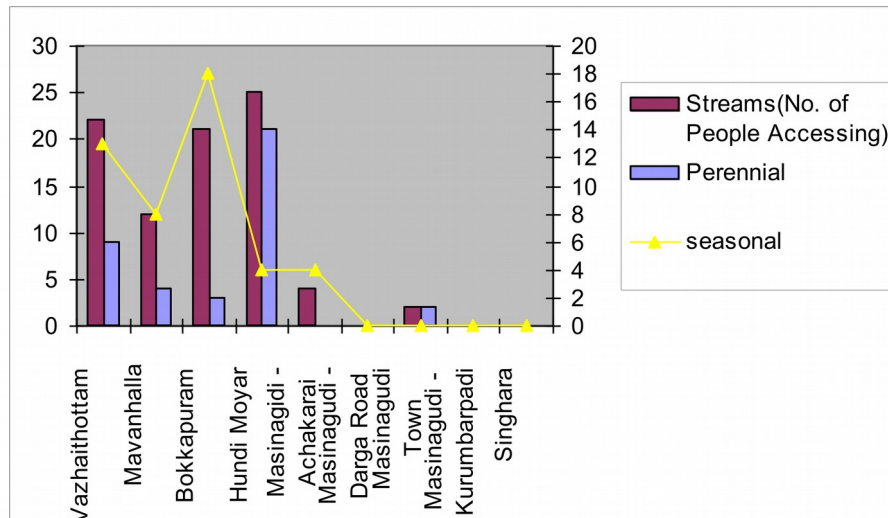
**Graph 9. People depending on streams for irrigation at Sigur which are perennial as well as seasonal during the cultivated period.**

The highest number of people accessing seasonal stream is from Bokkapuram & the minimum people accessing seasonal stream is from Hundi Moyar & Aachakarai (Masinagudi).

The maximum number of people accessing perennial stream is from Hundi Moyar & the minimum people accessing perennial water is from Masinagudi.

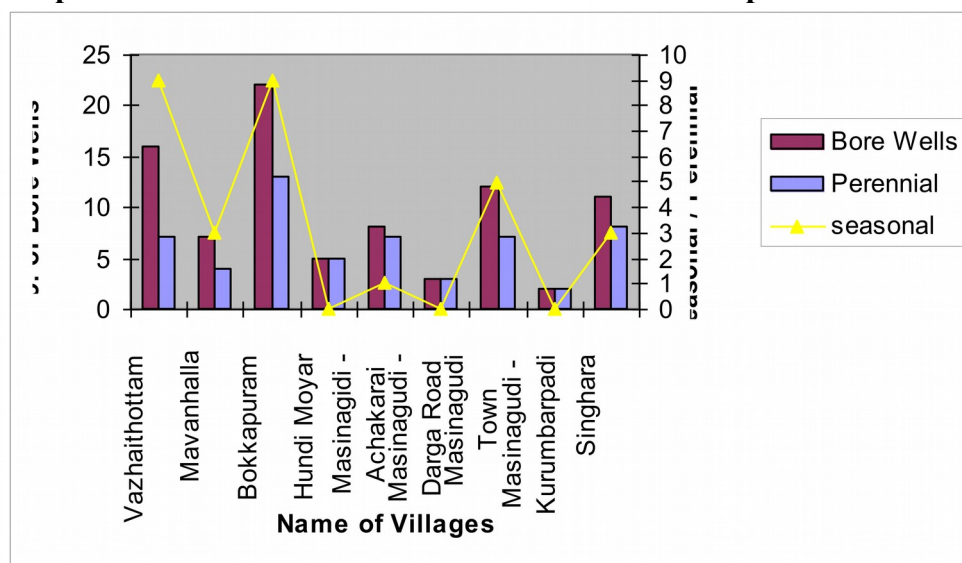
**Graph 10. Number of bore wells which are seasonal & perennial in the villages.**

The bore wells which are high and perennial are from Bokkapuram & low are from Kurumbarpadi (Masinagudi). The bore wells which are high in seasonality are from Vazhaithottam & Bokkapuram, but the lowest is from Aachakarai.

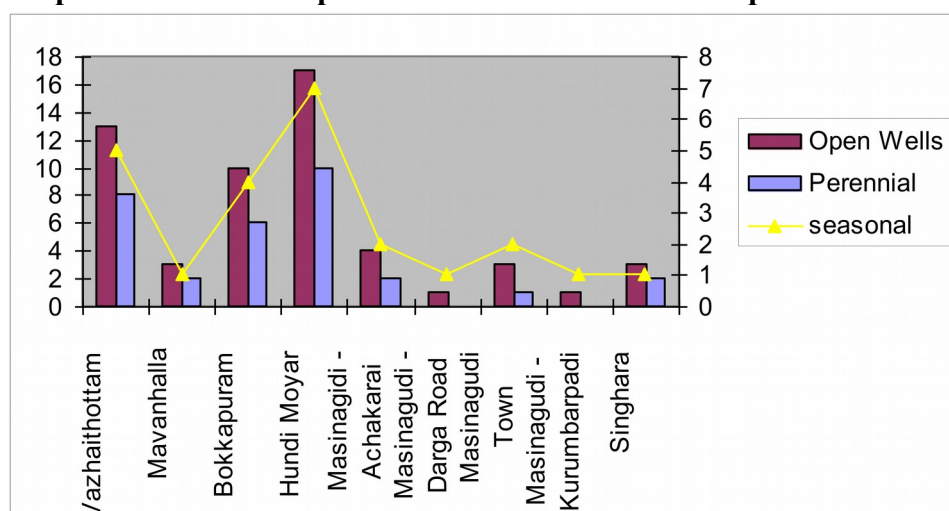
**Graph 11. Number of open wells which are seasonal & perennial**

The open wells which are perennial and more are from Hundi Moyar & Vazhaithottam & which are low are from Mavanhalla followed by Singhara.

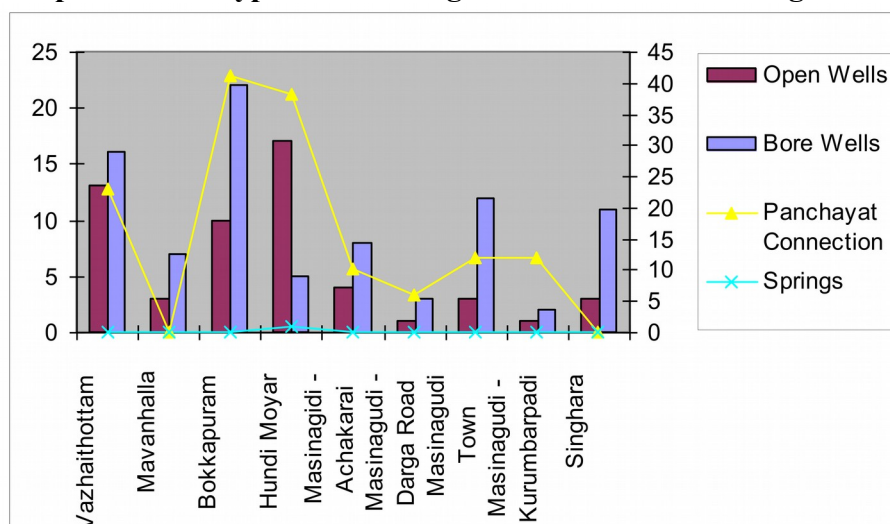
**Graph 12. Total types of Drinking Water Sources in the Sigur Villages**

The highest number in types of drinking water sources is from Bokkapuram area and the lowest types is from Mavanhalla & Masinagudi Durga road area followed by Singhara area.

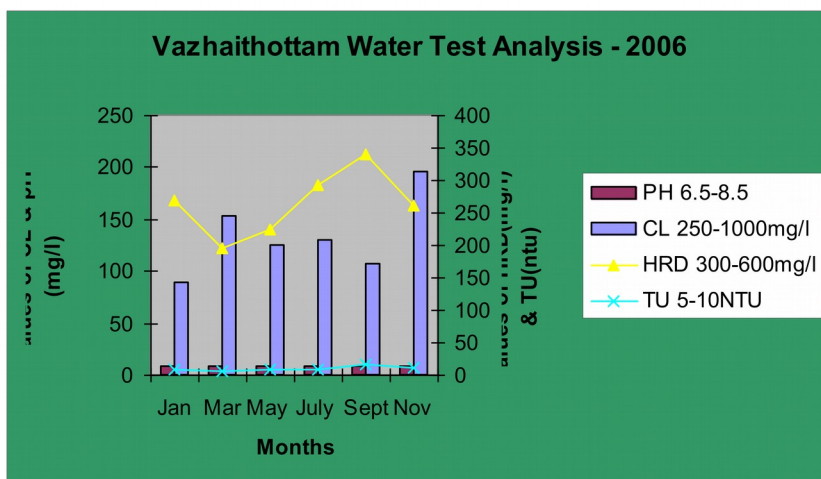
**Graph 14.** Water Analysis for Vazhaithottam Village in Year 2006

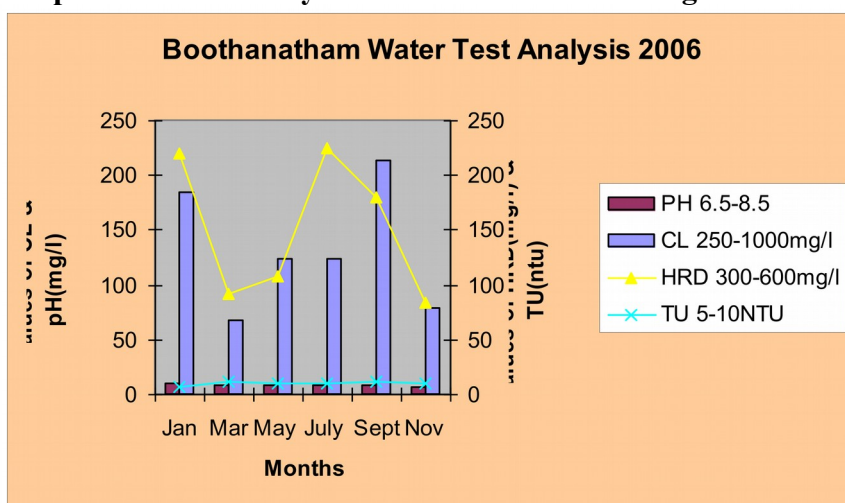
**Graph 15. Water Analysis for Boothanatham Village in Year 2006**

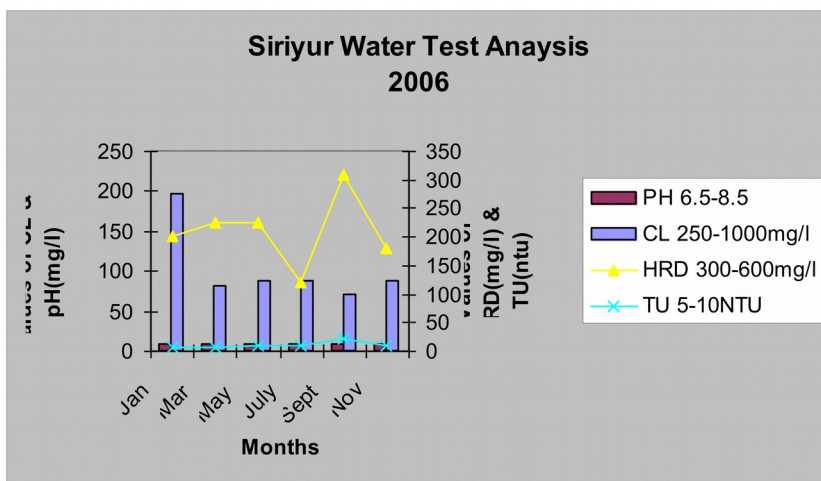
**Graph 16. Water Analysis for Siriyur Village in Year 2006**

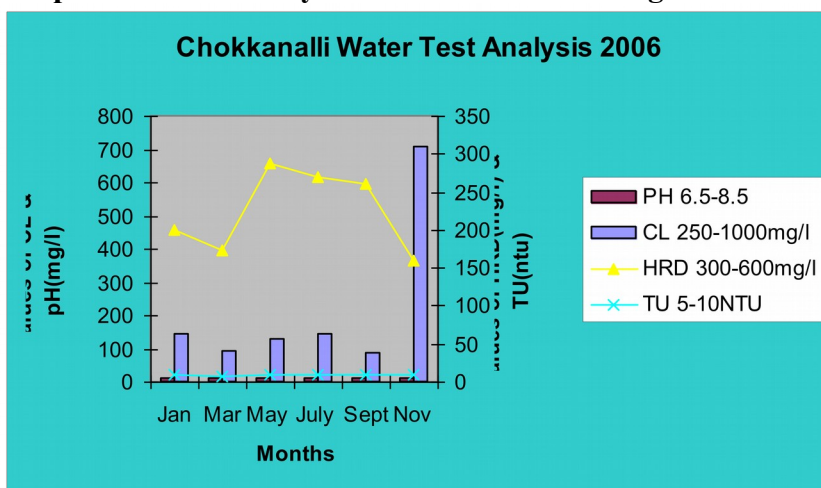
**Graph 17. Water Analysis for Chokkanalli Village in Year 2006**

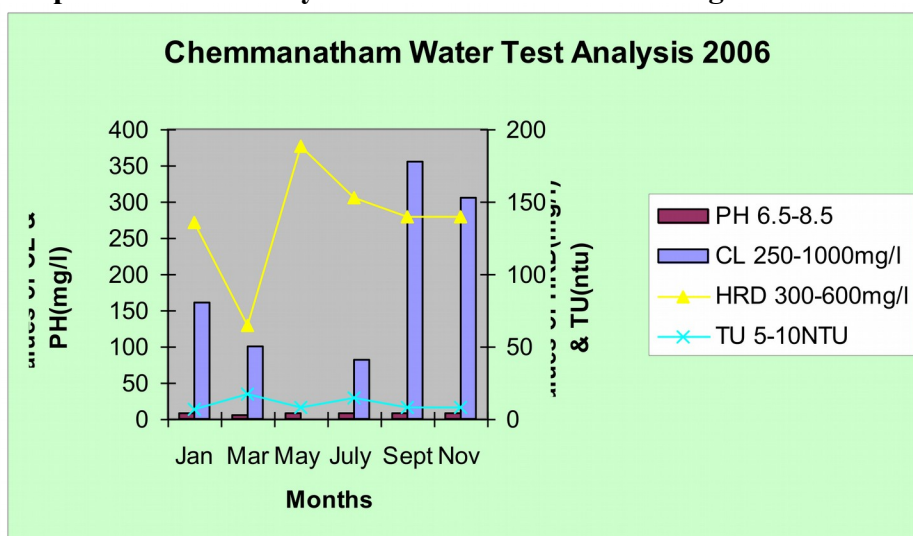
**Graph 18. Water Analysis for Chemmanatham Village in Year 2006**

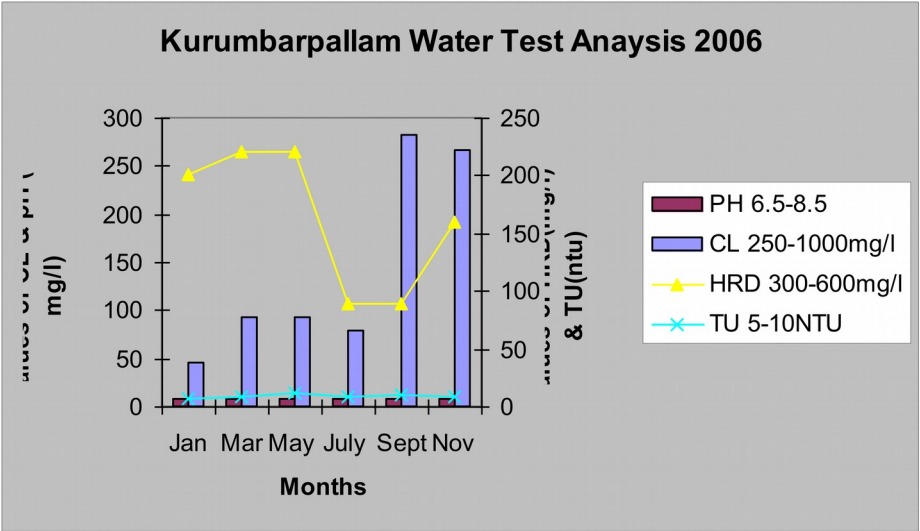
Graph 19. Water Analysis for Kurumbarpallam Village in Year 2006<sup>2</sup>

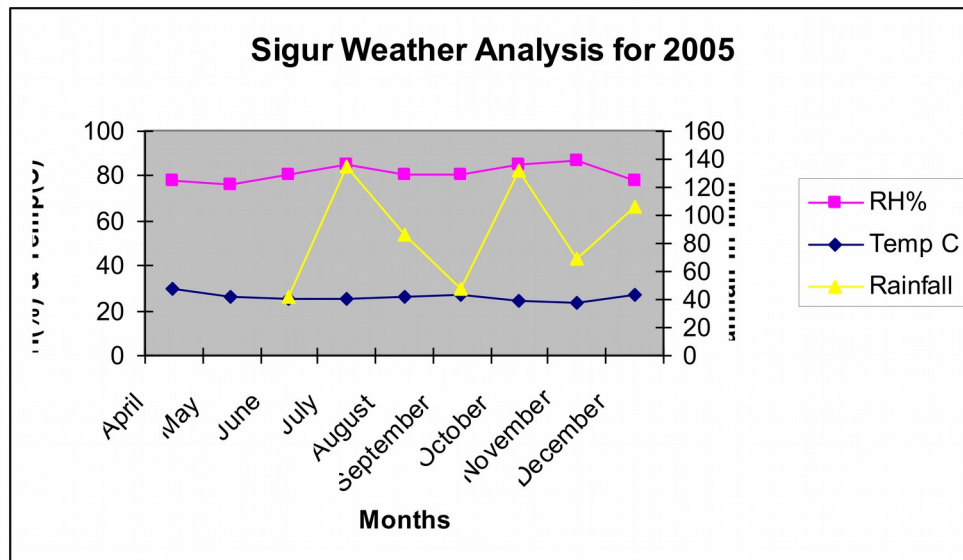
Weather station has been established and data has been collected regularly to see the changes in the weather pattern in terms of rainfall, relative humidity & variation in temperature of the region. The graph below shows the weather analysis for the three years period from 2005 – 2007.

**Graph 20.** Weather Analysis for 2005

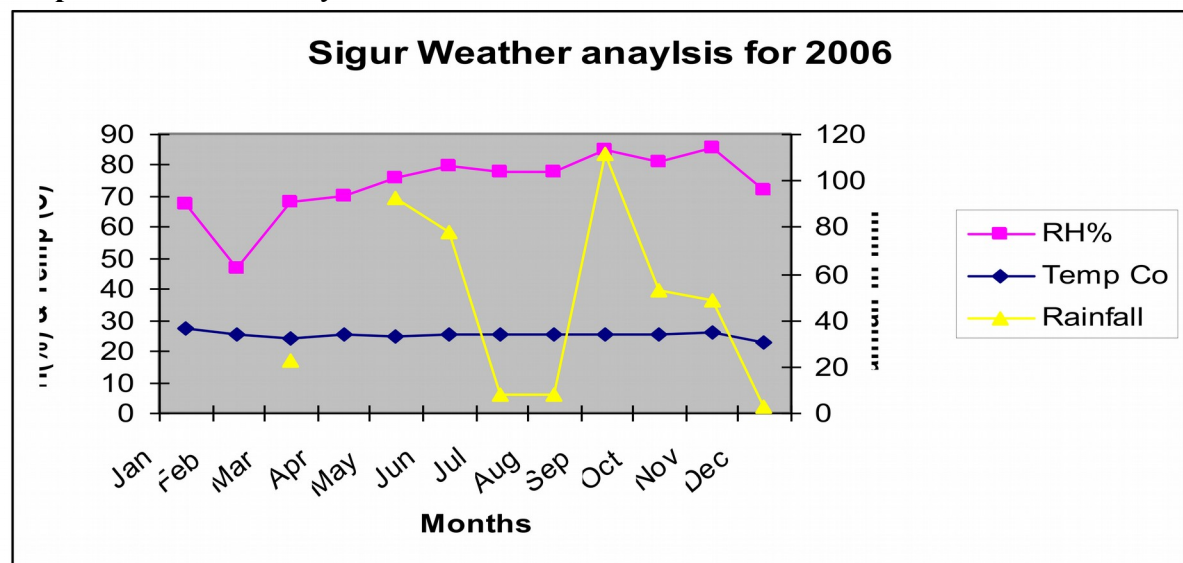
**Graph 21.** Weather Analysis for Year 2006

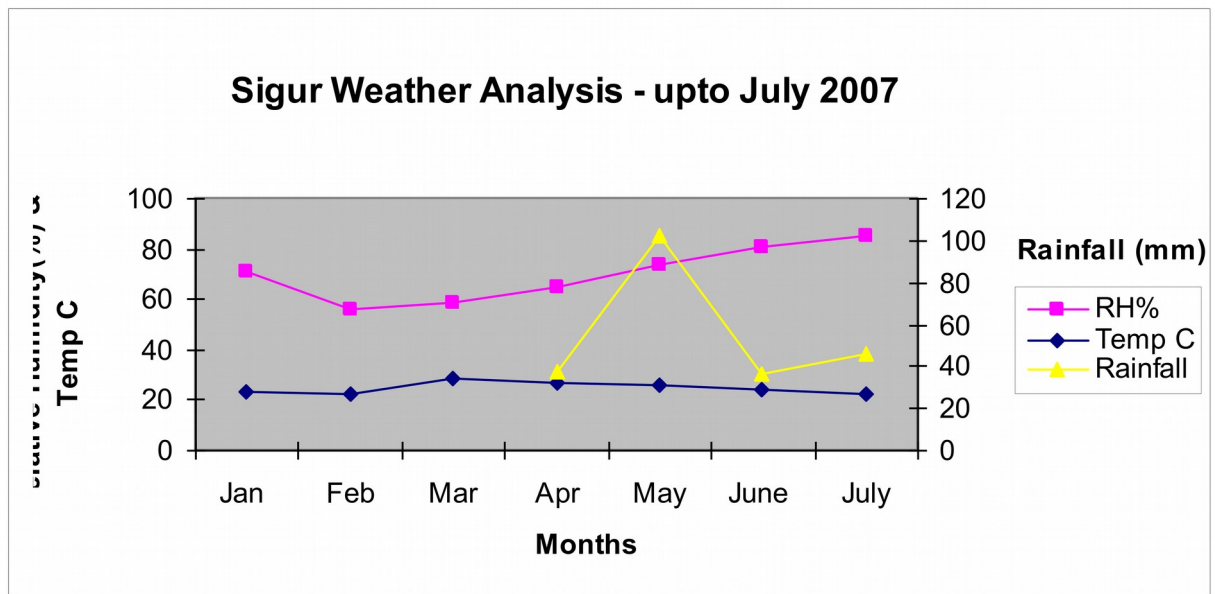
**Graph 22.** Weather Analysis for Year 2007

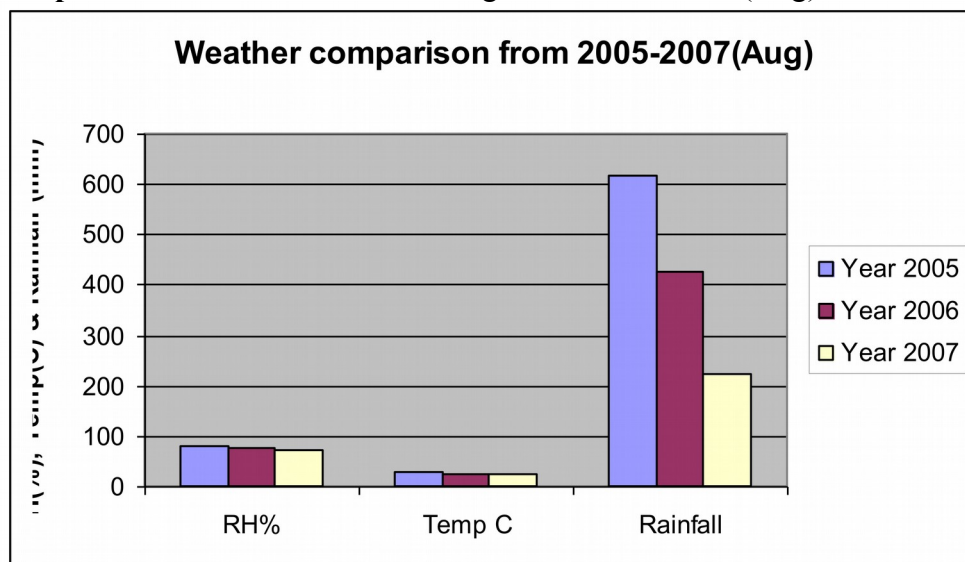
**Graph 23.** Difference in rainfall at Sigur from 2005-2007(Aug).

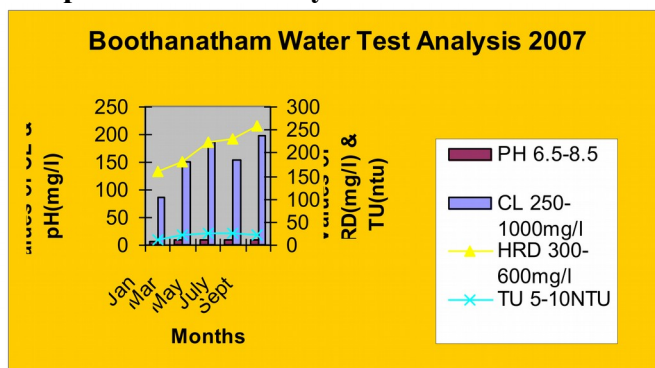
**Graph 28. Water Analysis for Boothanatham Village in Year 2007**

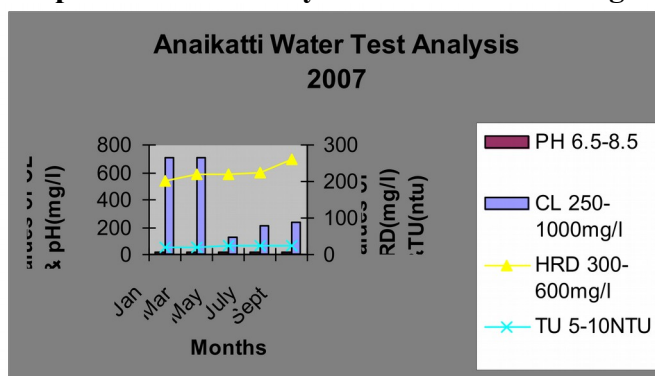
**Graph 29. Water Analysis for Anaikatti Village in Year 2007**

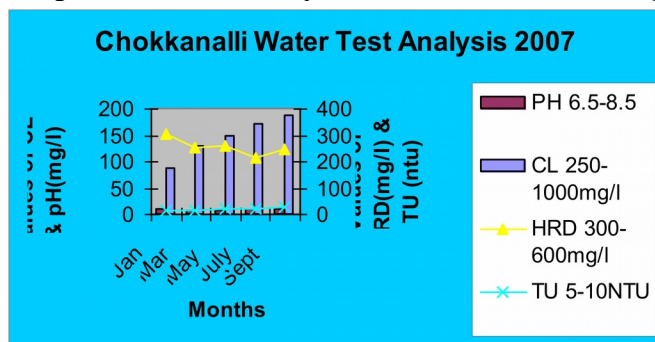
**Graph 30. Water Analysis for Chokkanalli Village in Year 2007**

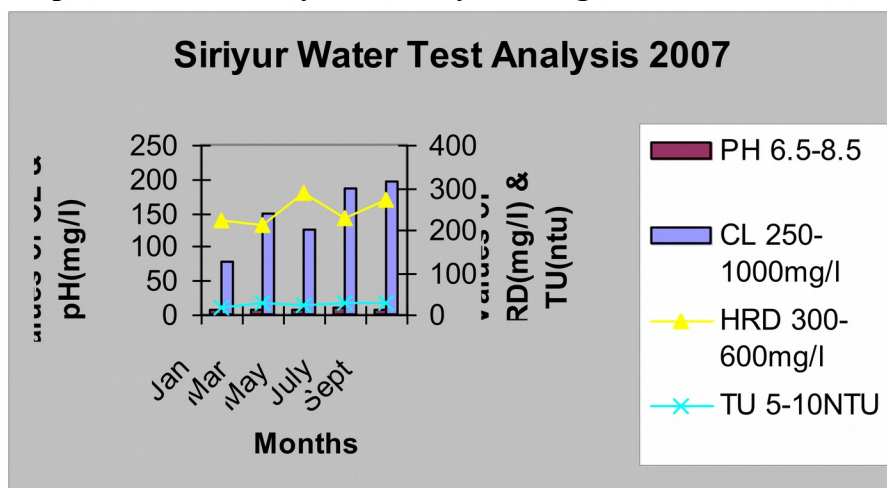
**Graph 31. Water Analysis for Siriyur Village in Year 2007**

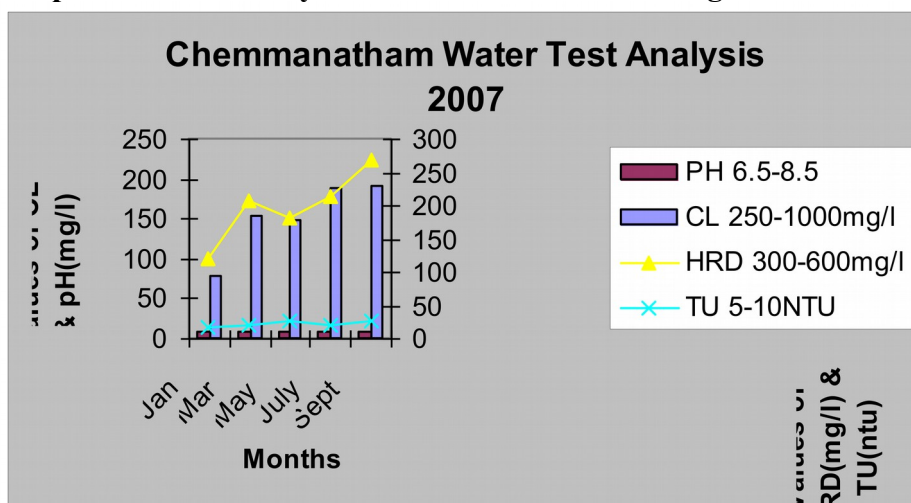
**Graph 32. Water Analysis for Chemmanatham Village in Year 2007**

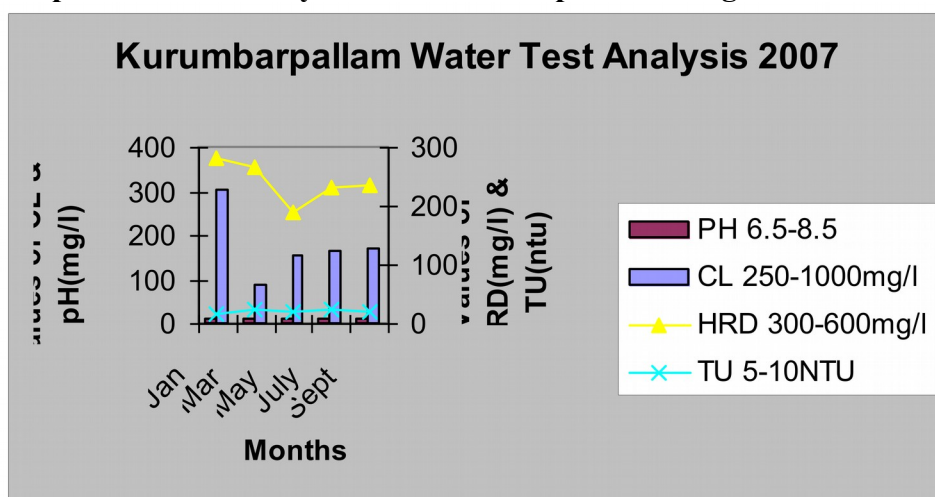
**Graph 33. Water Analysis for Kurumbarpallam Village in Year 2007**
